**Post-flood investigation in the
Lower Chao Phraya River Basin**

Post-flood field investigation in the Lower Chao Phraya River Basin 23 - 27 January 2012

Findings of the Thai - Dutch Reconnaissance Team

Organized by ENW: the Dutch Expertise Network for Flood Protection

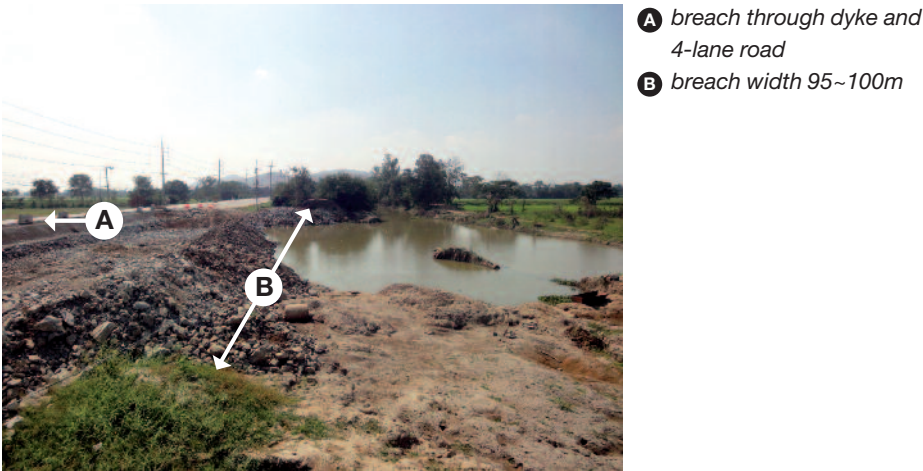
Figure 3.4
Breach in the Manorom dyke near Chainat (location km 2 +650)

Location	Situation	Breach closure operations
Manoram dyke km 2 +650	<ul style="list-style-type: none">■ dyke failure including breach■ including a 4 lane asphalt road■ moderate water velocities	<ul style="list-style-type: none">■ 3 weeks needed for reparation■ sheet piles, gabions, sand bags■ access by road (4 lane highway)
Kali mountain dyke km 12 +500	<ul style="list-style-type: none">■ dyke failure■ moderate water velocities	<ul style="list-style-type: none">■ 1 week preparation and 4 weeks closure operations■ side 1: sheet pile walls (access by road)■ side 2: rock/gabion closure (access with barges)
Pra Ngam floodgate	<ul style="list-style-type: none">■ transition zone failure■ approx 11 m deep erosion pit■ approx 2 m/s high water velocities	<ul style="list-style-type: none">■ 1 week preparation and 1 week closure operations■ rock/gabion closure (8 gabion packages needed)■ rock/gabion closure (8 gabion packages needed)■ access by road

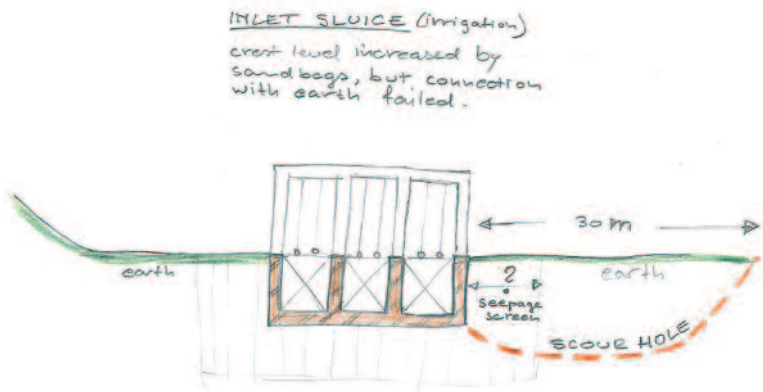
- Because the structures are mainly designed for irrigation purposes with small water heads, provisions to prevent seepage / piping during floods seem to be limited, especially on the connection with the adjoining dykes or dam. Thereby scouring and breaching could occur besides the structures. This is illustrated in Figure 3.8 (Klong Ta Nueng floodgate) and Figure 3.9 (Pra Ngam floodgate), which show a photo of the situation and a sketch of the failure.

- A** sand fill at the original breach
- B** regular flow
- C** flow during flooding

Figure 3.9
Failure of the Pra Ngam floodgate

- A separate rock-fill closure dam was constructed behind the Pra Ngam floodgate to close the canal. For the initial closing of the gaps gabions and loose rock fill were used. In the last stages of the closure single gabions were washed away due to high flow velocities. In that case up to 8 gabions were tied together. Later the rock fill is covered with compacted clay and revetments. These are temporary measures.

- It was indicated by employees from RID that seepage screens / front walls will be placed in permanently repairing the floodgates. The use of rock fill and gabions introduces a new problem. It is very difficult, if not impossible, to drive sheet piles through the rock fill or to excavate trenches to construct seepage walls next to the structure. A point of attention is the size of the screen. The screens should be wide and deep enough to prevent seepage and erosion of materials under and besides the structure. A last point of attention is the connection of the front wall / seepage wall to the structure. At the field visits no reinforcing steel rods were seen sticking out of the structure. Therefore it is expected that there was no connection between the structure and the original front wall that could transfer loads.

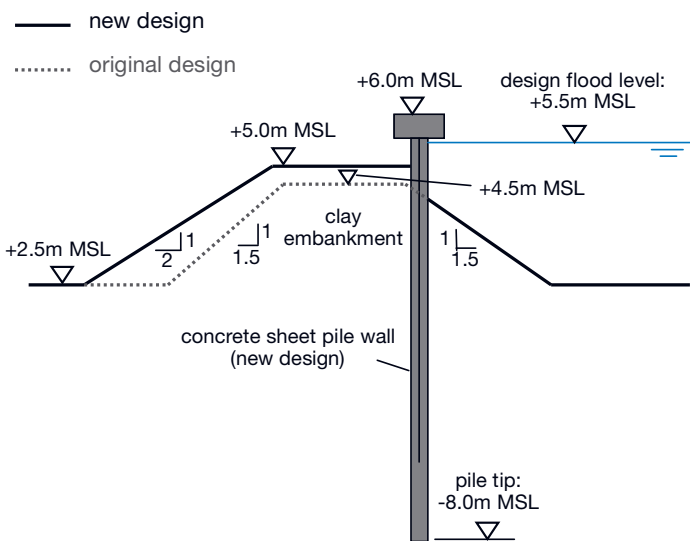
Figure 3.13
Original and new design of the dykes around Rojana estate

At the time of the visit the industrial estate already had plans to reinforce levees around the area before the next flood season. The figures below show the original as well as the new designs. In the new design, the earthen dyke is strengthened and heightened by 1.5m by means of floodwall. About 10m long sheetpiles are used to prevent instability and seepage.

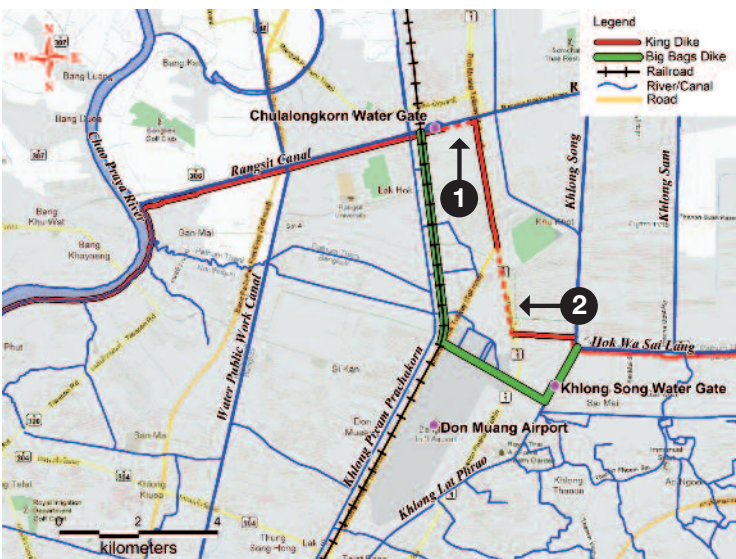
The team has made a short visit to parts of the King’s dyke around Bangkok. At most of the locations the dyke is integrated in the road system and has a limited elevation ranging from +1.0 to 2.9m (MSL). At some locations the dyke is not present. The team visited one of these sections. The flooding that occurred due to missing sections of the dyke resulted in flooding of parts of Bangkok, including the Don Muang airport.

Figure 3.16
Openings (1 and 2) in the King’s dyke on the Northern side of Bangkok and the temporary dyke of big bags

During the floods a dyke of bigbags of several kilometers was constructed to protection Bangkok. The railway line and existing objects (concrete walls etc.) were used as part of this flood defence.
