Retrogressive Breach Failure Events at Amity Point, Australia and their Interaction with Built Defences

Konrad Beinssen and David T. Neil

School of Geography, Planning and Environmental Management, The University of Queensland St. Lucia, Queensland, Australia

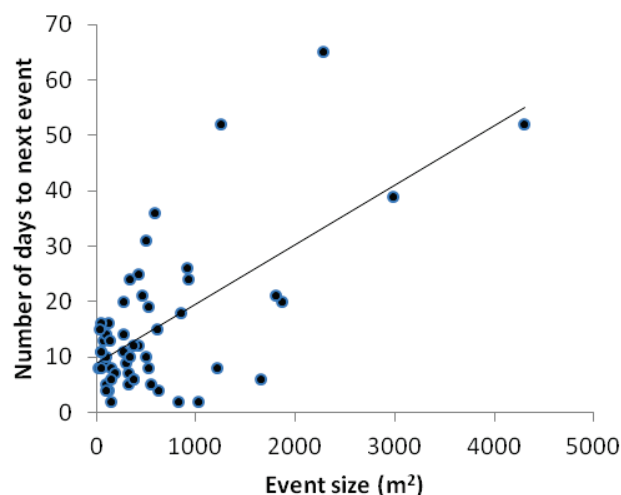
We tested the relationship between the magnitude of events (measured planform area at termination) and number of days to the following event. Magnitude of events was positively related to the number of days to the next event ($R^2=0.42$, $p=9.6E-8$), explaining 42% of the variability in the dataset (Fig. 2). This indicates that the larger the event, the longer it takes to rebuild the beach with sand brought to the site in the longshore current to set the conditions for the next event to be triggered. Beach infilling is a function of the rate of sand delivery to the site and time.

Fig. 2: Regression of event size (explanatory variable) by days to the next event (response variable) for the study site at Amity Point.

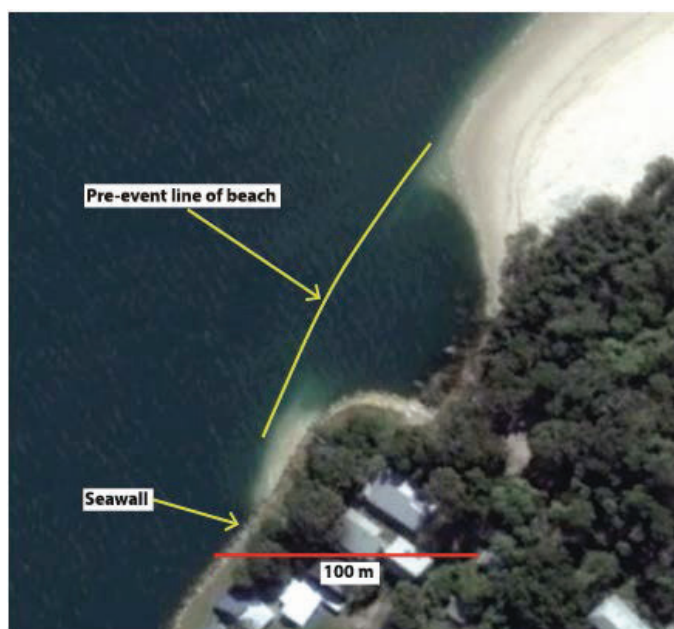
An image (Google Earth) acquired 18.8.2014 shows an RBF site at Amity Point (Fig.3) which was witnessed and monitored in the field on the previous day starting at 11pm. This event encountered the seawall but did not undermine its foundations so the wall remained stable. The event's active phase lasted about 1.5 hours. The typical post-event 'amphitheatre' morphology is evident. Sand infilling by longshore drift from NE at this site is rapid and in this case, the pre-event beach profile was restored within a month.

Fig. 3: Image (Google Earth) of an RBF 'scar' at the Amity Point study site. Note the pre-event line of beach.

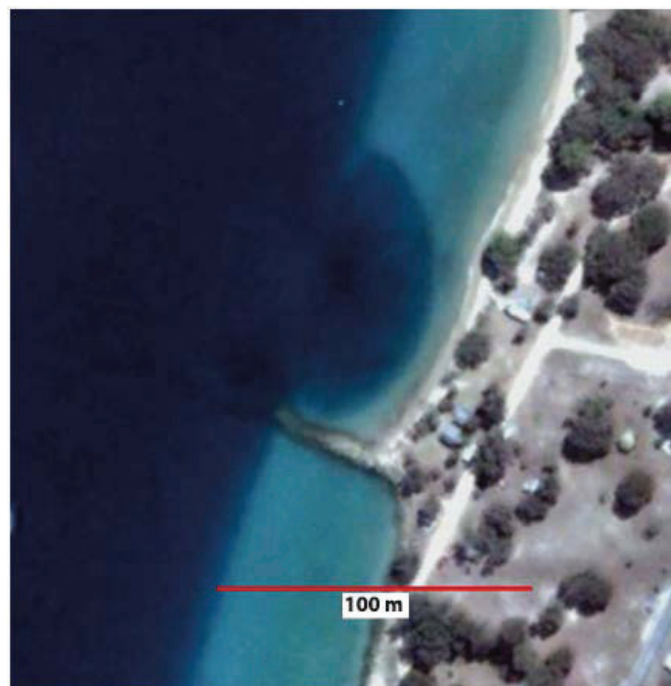
Another image (Google Earth) acquired on 17.10.2004 shows an RBF site at Amity Point at 27°24'12.49"S, 153°26'11.93"E (Fig. 4). The date on which this event occurred is unknown. Note that the event occurred between two groynes but did not impact the subaerial beach. This site can still be identified on Google Earth images over 10 years later because longshore drift carrying sand is minimal here so sand infilling is slow.

Fig. 4: Site of an RBF event between groynes at Amity Point.

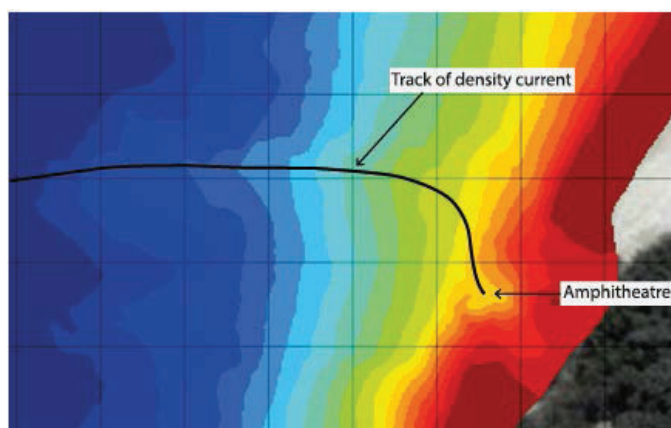
A bathymetric scan recorded at the study site on 18.10.2014 about 17

hours after an RBF event (Fig. 5) shows the typical morphology on the upper beach and also the tongue of sand deposited offshore by the density current.

Fig. 5: Bathymetric scan following an RBF event at the Amity Point study site. Grid lines are 40m apart.

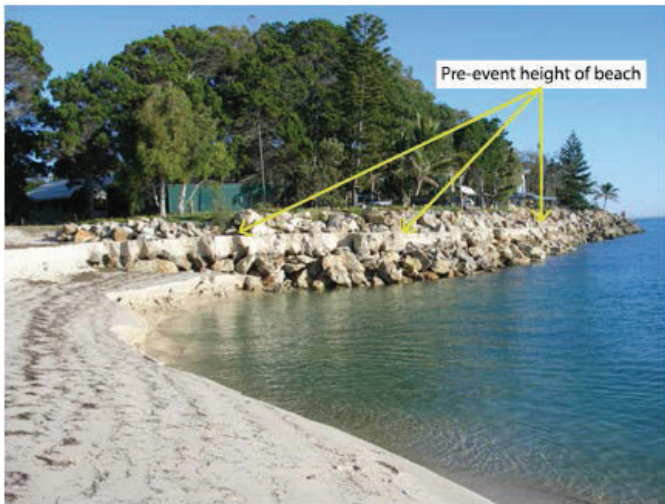
An image acquired at the study site on 6.5.2008 about 8 hours after an RBF event (Fig. 6) shows the typical post-event 'amphitheatre' morphology at ground level. The pre-event height of the beach can be seen by the line of sand still adhering to the seawall.

Fig. 6: The study site at Amity Point, viewed towards the South, showing the post-event morphology of an RBF.

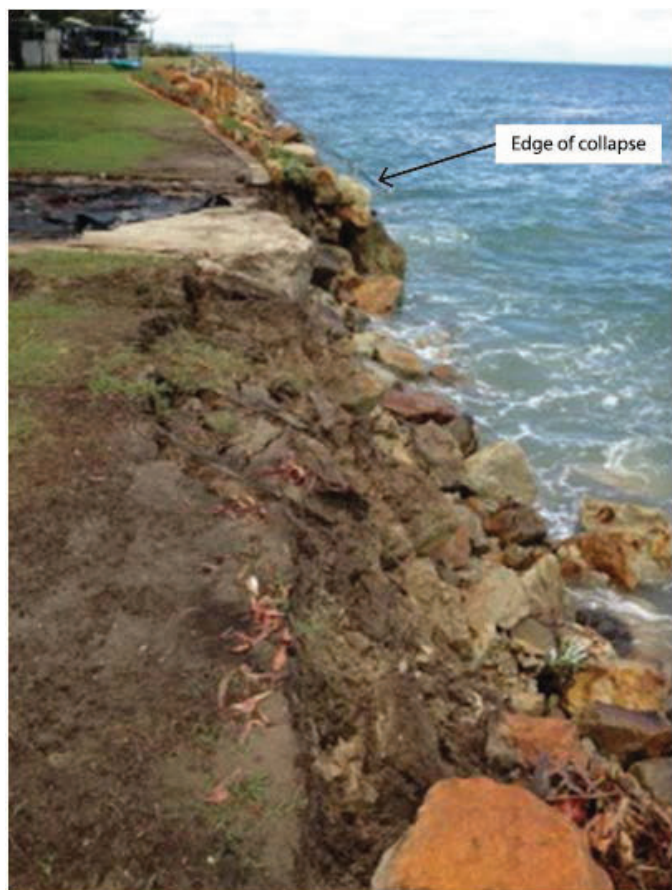
simply stops because it runs out of sand. If the base of the breach is deeper than the foundations of the seawall, the breach continues under the wall and destabilises it. When this happens, the rock foundations move deeper and repairs are made by adding rock to the top. The seawall so becomes progressively less vulnerable to future events. Seawall building has proven to be an iterative process. Experience also shows that repairs after seawall slumps caused by RBF events must be quickly carried out to avoid secondary erosion of exposed sand scarps.

As an example, a 22m wide slump of the seawall (Fig. 7) occurred during an RBF event on 7.12.2014. This slump was repaired within two days by the addition of 140 m³ of rock. Observers report the RBF event which caused it remained active for over an hour.

Fig. 7: A 22m wide seawall slump at Amity Point occurred 7.12.2014.
