Study upon the possible influence of animal burrows on the failure of the levee of San Matteo along the Secchia river.

Modelling of groundwater flow with precipitation and water level changes and mechanism of collapse of the Secchia Failure with particular attention to burrows geometry and their influence to the stability of the dike (19th January 2014, San Matteo, Modena, Italy).

Maria Luisa Taccari
Student number: 4326482
MSc Thesis Civil Engineering
Geo-Engineering Section
Civil Engineering and Geosciences - TU Delft

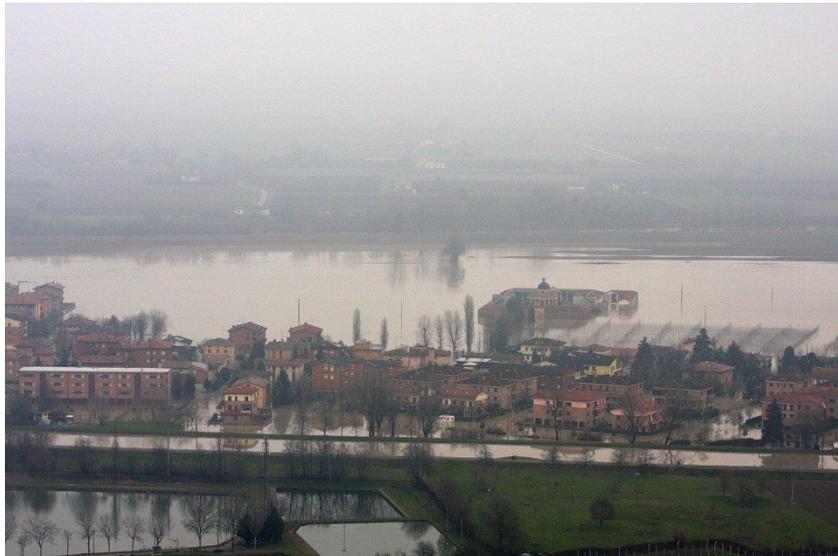
Figure 1.1 Flood in the Modena province (19 January 2014)

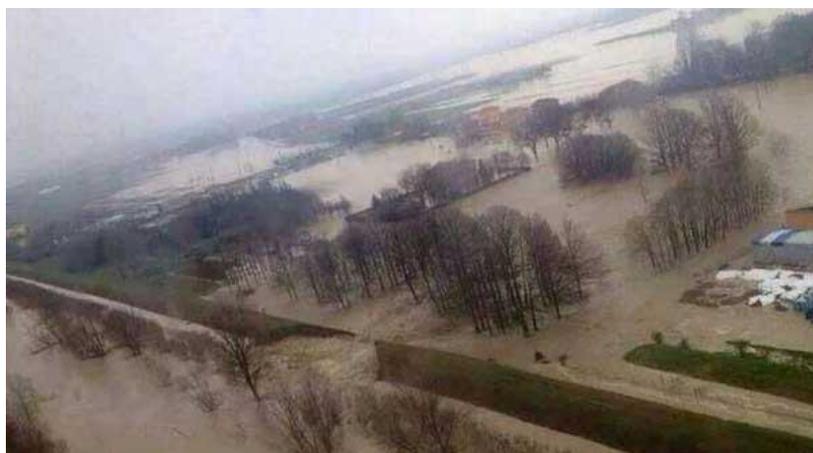
Figure 1.2 The breach at San Matteo, Modena (19th January 2014)

Two witnesses reported that the breach started from an opening located in the upper part of the dike. Giovanni Russo, who lives nearby the location of the failure, saw, around 6.30am, water flowing out of the dike from an opening placed 2 meters beneath the crest: the width of the breach was around 2 meters at 7am and, at 8.30am, it increased to 6 meters.

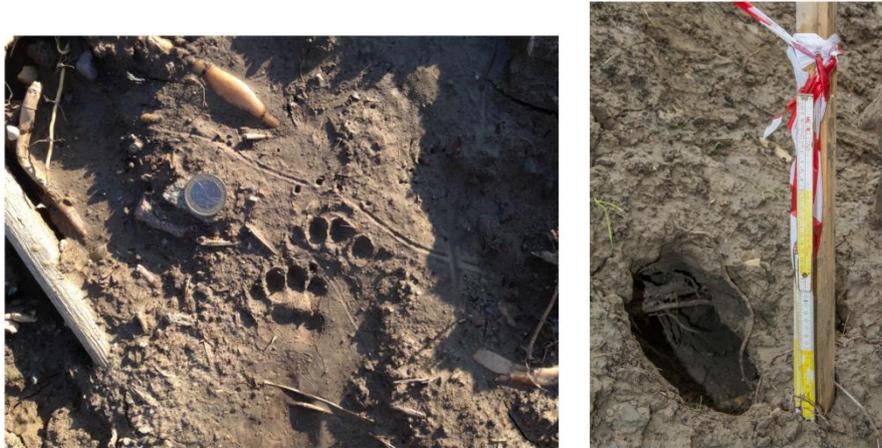
Presence of animals in the locations is proved by pictures of footprints and dens taken during the same day of the breach and days after of the event. In particular, the footprint belongs to a badger (Figure 1.3).

Figure 1.3 Footprint of a badger and animal burrow near the location of the breach

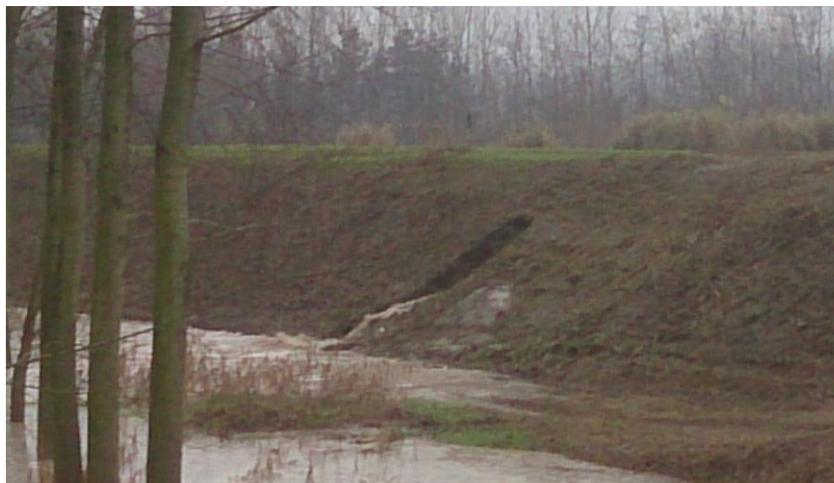
Moreover, on the 19th January another breach happened in the right riverside of Panaro river, in Tronco street, around 10 kilometres far from the breach location (Figure 1.4). The breach was due to internal erosion, as it is possible to see from the picture. The breach was immediately repaired by placing soil and a tarp above it. The same section was already under monitoring because of the large activity of animal burrowing, in particular of porcupines.

Figure 1.4 Internal erosion due to animal burrows in the right riverside of Panaro river (19th January 2014)

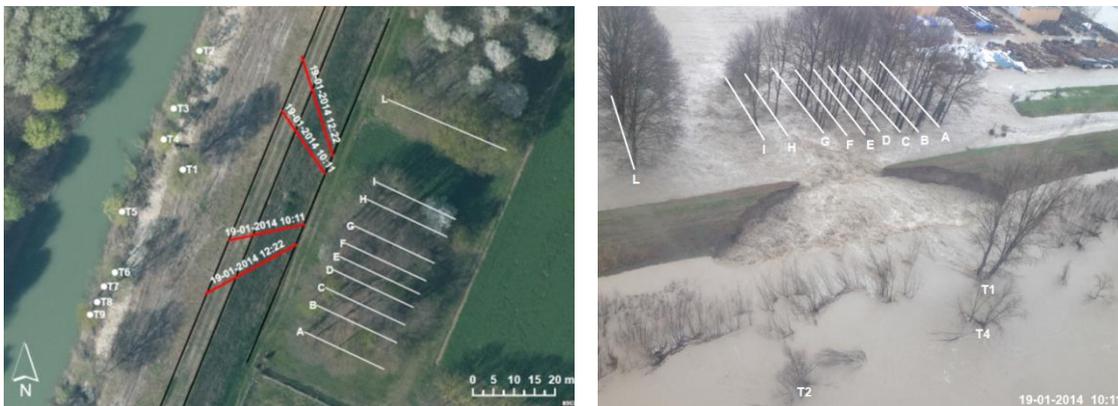
According to the reconstruction of the event, at 6am, a trapezium with base of 10meters and 2.5meters high, which is the top part of the levee, is removed and the crest drops till 35m amsl. The widening of the dimensions of the breach continues with time till reaching, 9 hours after (at 3pm on 19/01/2014), the maximum width of 80 meters, and maximum depth till the surface level (around 6 meters deep).

Figure 2.2 Reconstruction of the development of the breach at 10.11am and 12.22 (left) and picture of the breach at 10.11am (right). (D'Alpaos et al., 2014) (D'Alpaos et al., 2014)

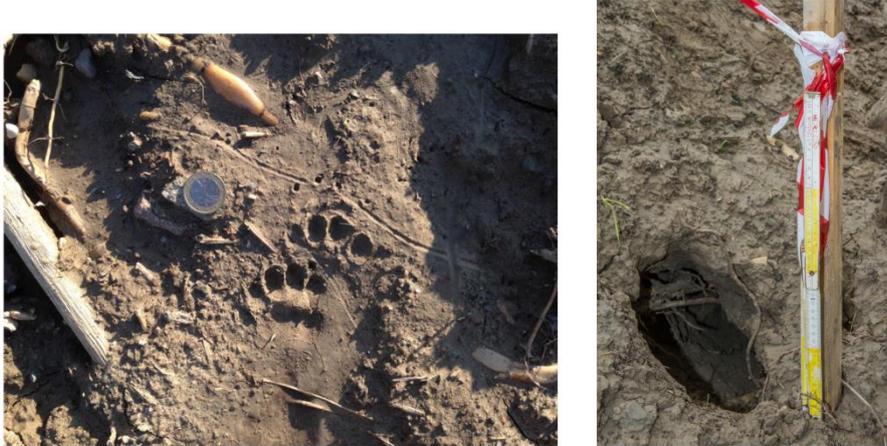
Presence of animals in the area has been confirmed during field visits with pictures of footprints and dens. The area was already under monitoring because of the large presence of animals. Photos in Figure 2.9 were taken during the same day of the breach and days after of the event. In particular, the footprint belongs to a badger.

Figure 2.9 Footprint of a badger and animal burrow near the location of the breach. (D'Alpaos et al., 2014).

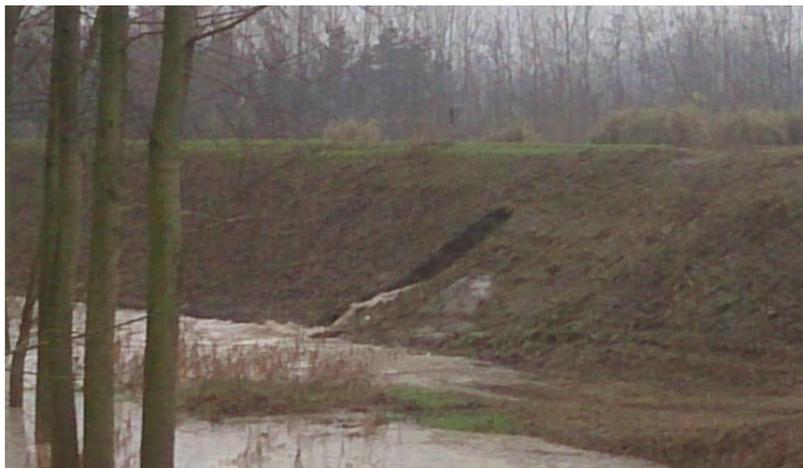
Moreover, on the 19th January another breach happened on the right riverside of Panaro river, around 10 kilometres far from the breach location.

Figure 2.10 Internal erosion due to animal burrows in the right riverside of Panaro river (19th January 2014). (D'Alpaos et al., 2014)

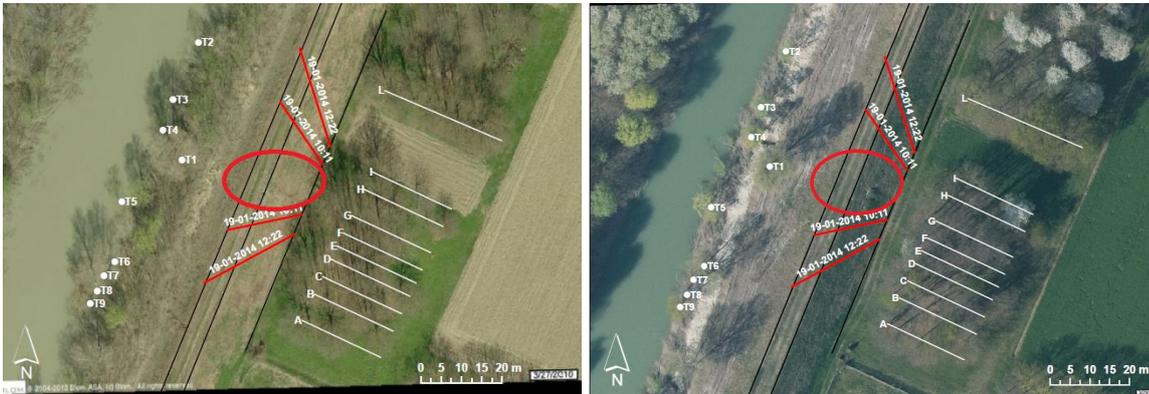
Figure 2.11 State of the levee on 27-03-2010 (left) and 29-03-2012 (right). The position of the burrows entrances is indicated by the red circle, T1, T2.. indicate trees used as reference points, while the red arrows indicate the development of the breach. (D'Alpaos et al., 2014)

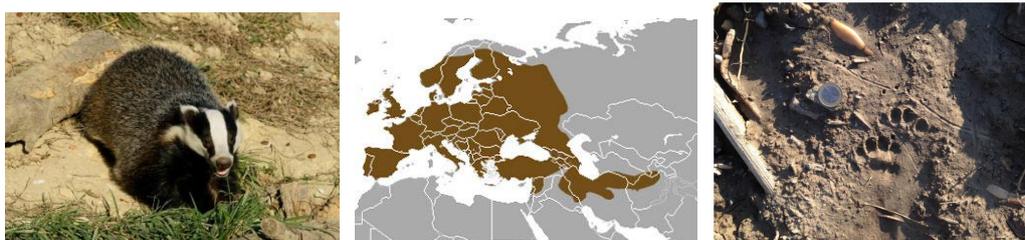
European Badgers are medium-sized omnivorous with nocturnal life habits. They live in Europe and eastern Asia, in clans, that are family groups up to 12 members. Their presence near the levee was confirmed by footprints taken near the location of the breach during the same day of the event.

Figure 4.1 European Badger (*Meles meles*): from left to right, the animal, the distribution and their footprints in the location of the breach

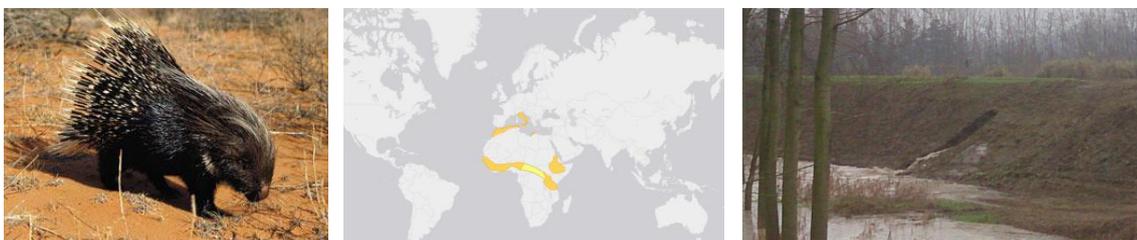
Crested porcupines are present in Italy, North Africa and sub-Saharan Africa and they live in different environments such as forests, dry rocky areas, farmlands and deserts. They are nocturnal animals, known to be solitary foragers that live in small family groups formed by the adult pair and several young members. The porcupines are monitored in the area of the breach and they were responsible for the breach that took place on the 19th January in the right riverside of Panaro river.

Figure 4.2 Crested porcupine (*Hystrix cristata*): from left to right, the animal, the distribution and the failure in the right riverside of Panaro river.

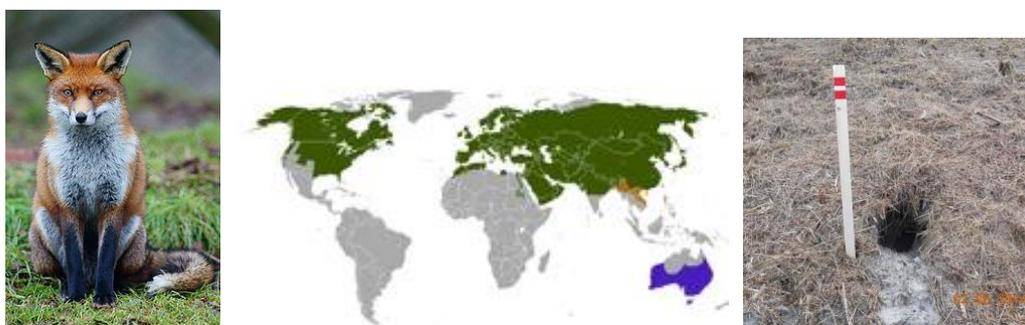
Red Foxes are present in Europe, Canada, USA, Asia, Australia and North Africa. They live in family groups even if their life habit is solitary and they are mainly active during the night. Dens created by foxes were observed few the months after the breach of San Matteo in Carpi, that is a town 15 km far away from the location of the breach.

Figure 4.3 Foxes (*vulpes vulpes*): from left to right, the animal, the distribution and their burrows in the close town of Carpi.

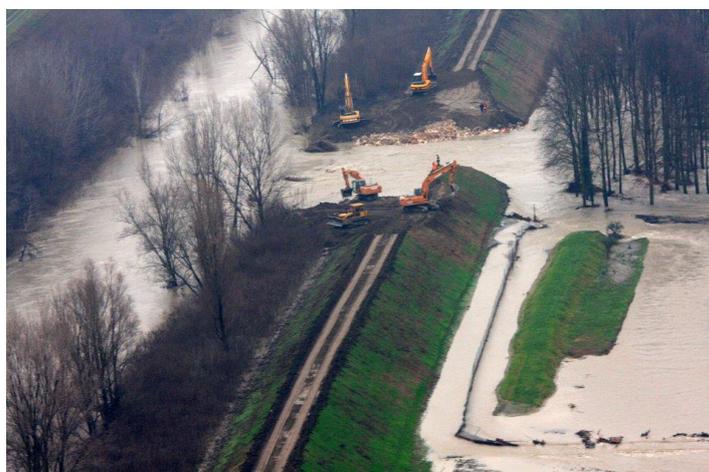
The height of the levee is around 7-8meters, ensuring dry places where to build setts, which are usually not reached by the water level in the river. The soil consisting on silty sand is also an ideal soil where to dig on.

Figure 4.7 Vegetation cover of the embankments of the Secchia river

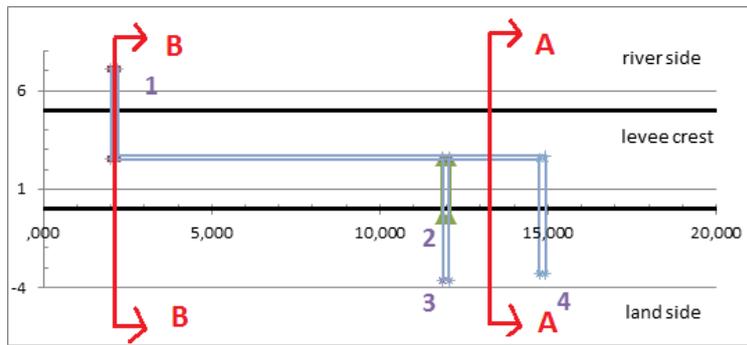
The system, which has been previously described in paragraph 4.4.3, is constituted by four burrow entrances, located at altitudes 36.3, 37.1, 15.1 and 34.8 m amsl, respectively from entrance 1 to 4 in Figure 7.6. The tunnels initially go down with a slope of 45° for 1-1.5meters and then they run horizontally until the centre of the levee. A central tunnel longitudinally crosses the dike for around 10meters linking the entrances at the inner and outer slope.

Figure 7.6 First scenario implemented in the 3d calculation.

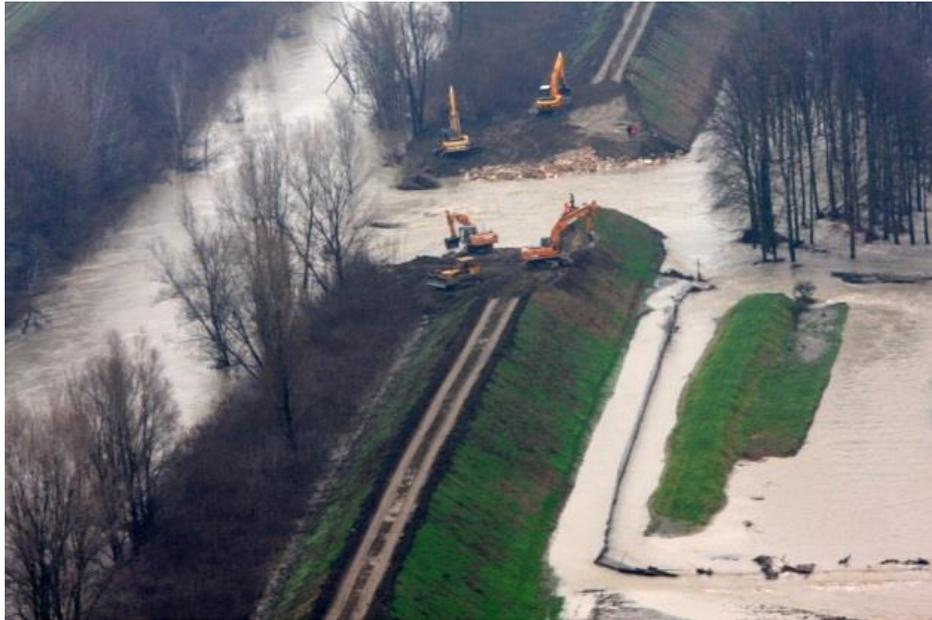
Photograph 1 Photo taken at the point of failure. River Secchia on the left, breach on the right side. Photo by R. Ferrari, Protezione Civile di Modena, 19-01-2014.

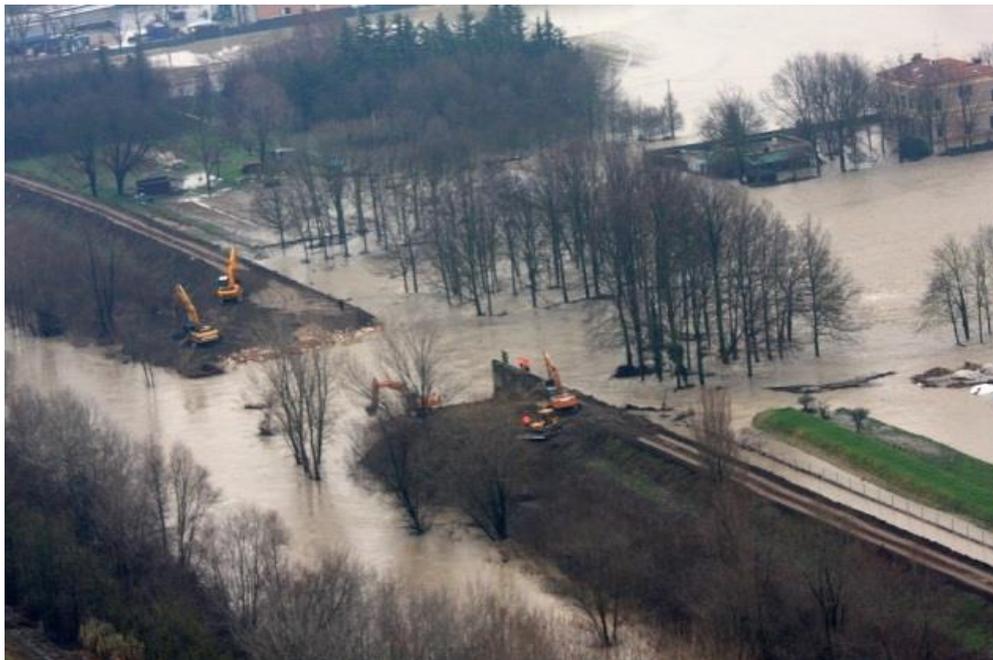
Photograph 2 Photo taken at the point of failure. River Secchia on the left, breach on the right side and flooded area on the right. Emergency measures are being taken on the top of the levee to close the breach. Photo by R. Ferrari, Protezione Civile di Modena, 19-01-2014.

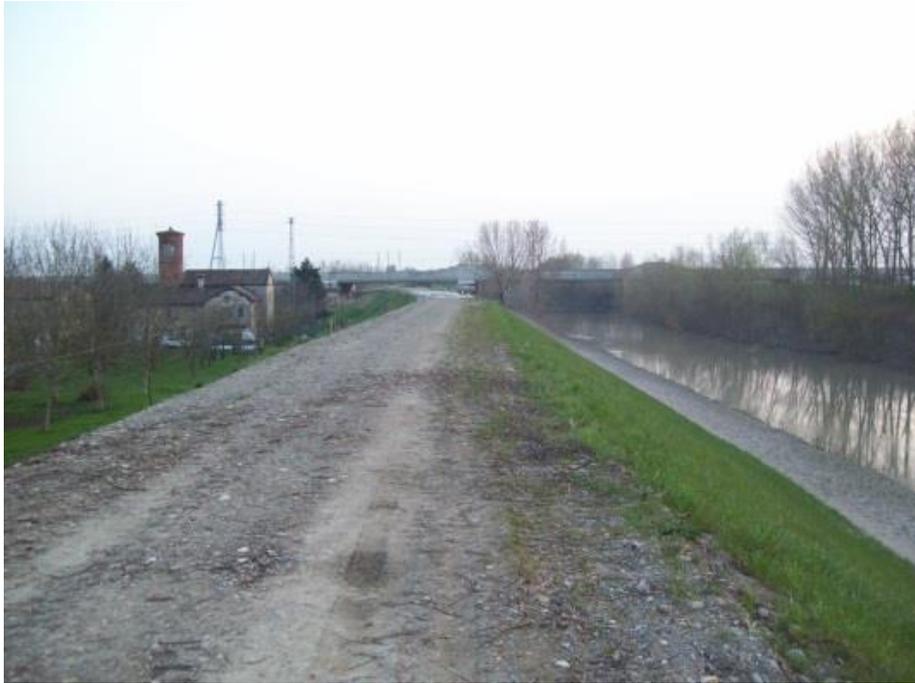
On the right side of Secchia river, the levee is covered by grass, while on the opposite side, the vegetation is more abundant. The levee has no inner and outer shoulders, which are only present in the location where the breach occurred and it was later rebuilt. Moreover no pipelines are present. The soil is muddy very wet: it is not possible to walk along the slope without sliding. When taking a piece of soil, it is easily to roll a thread, indicating that the soil is moderately plastic. Moreover, the hands are left almost cleaned after touching the soil. The soil has no organic content.

Photograph 4 View from the crest of the levee of San Matteo on the field visit during March 2015. Photo by M.L. Taccari, 23-03-2015

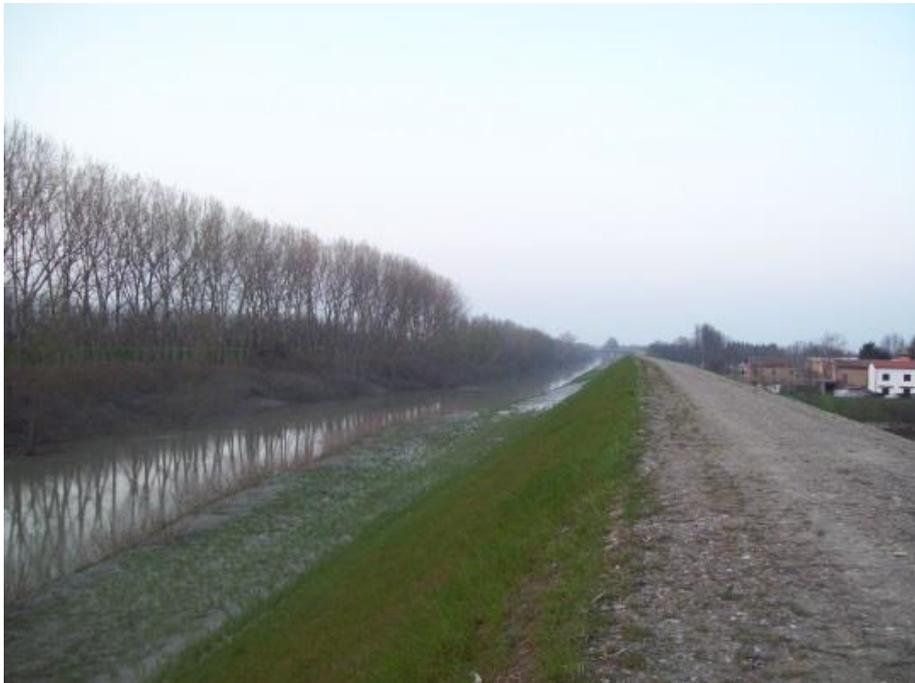
Photograph 5 Point of the breach of the levee of San Matteo on the field visit during March 2015. Photo by M.L. Taccari, 23-03-2015

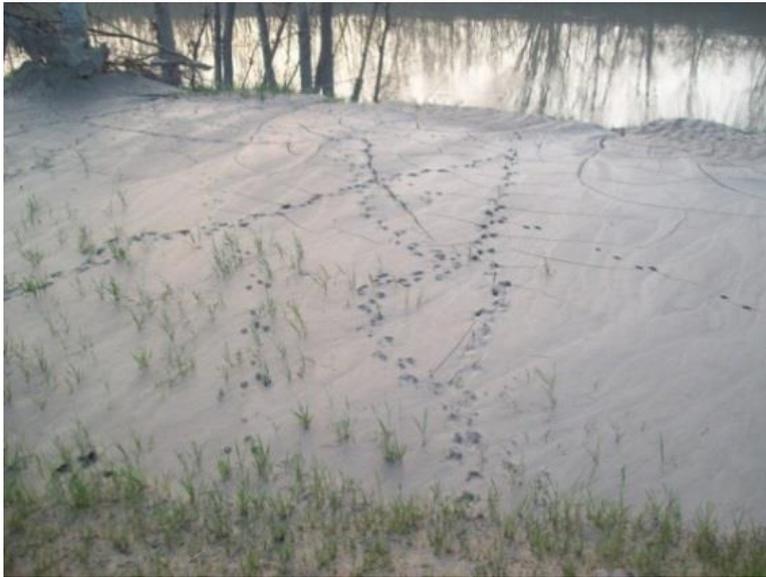
Photograph 6 Footprints at the outer toe. Photo by M.L. Taccari, 23-03-2015

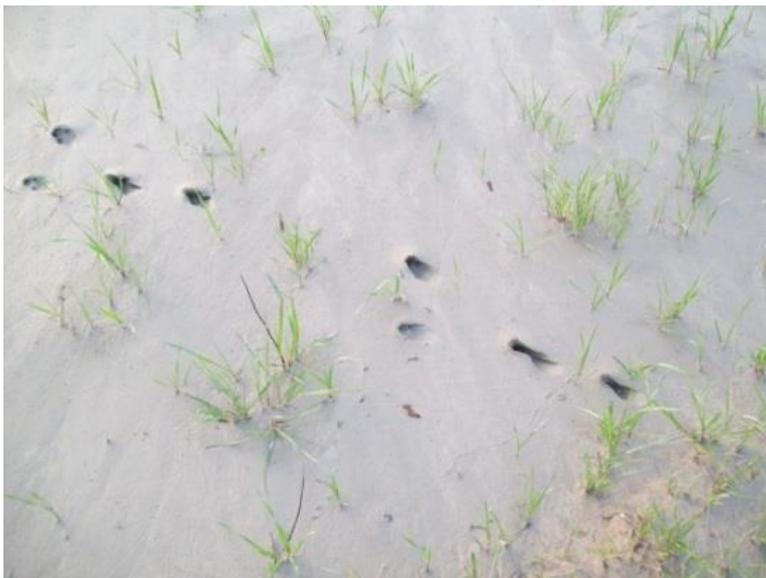
Photograph 7 Several rows of footprints at the outer toe. Photo by M.L. Taccari, 23-03-2015

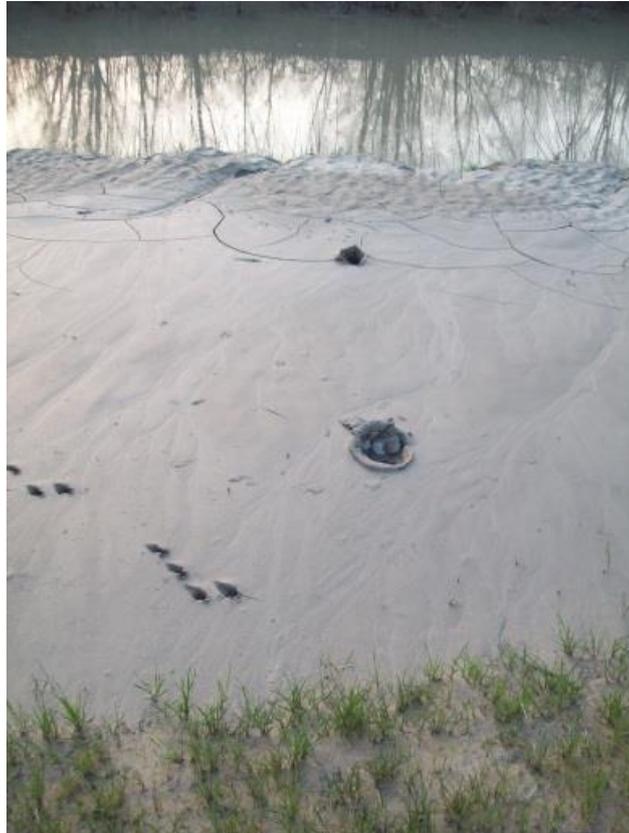
Photograph 8 Possible entrance of a burrow at the outer toe. Photo by M.L. Taccari, 23-03-2015

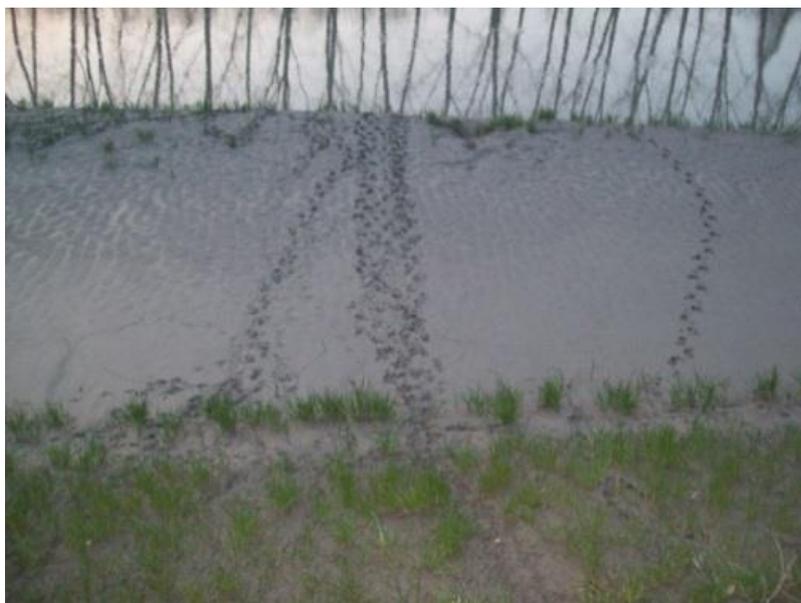
Photograph 9 Rows of footprints going from the river to the levee. They are a different type compared to those in . Photo by M.L. Taccari, 23-03-2015
