Development and Demonstration of Rapid Repair of Levee Breaching Technology

Donald Resio¹, Stanley Boc, Stephen Maynard, Donald Ward, and
David Abraham

¹ Coastal & Hydraulics Laboratory, Engr. Res. and Dev. Ctr., Vicksburg, MS 39180-6199

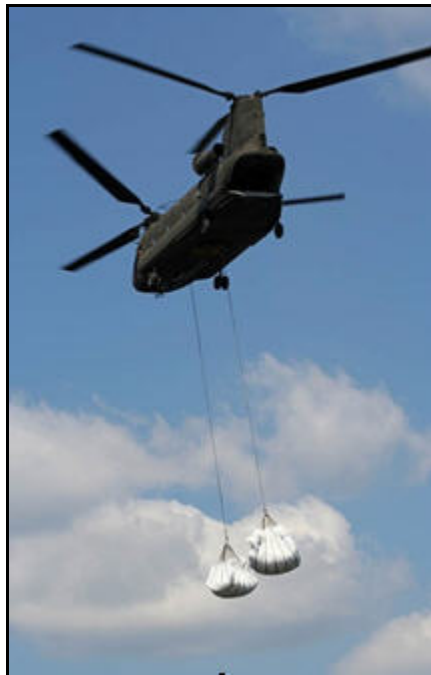
Figure 1.1 *Helicopter deploying sandbags at the 17th St. Canal following Hurricane Katrina*

related to the ongoing flooding, they can be very difficult to reach by overland routes. A prime example of the austerity of breach locations in terms of access and working conditions can be found in the breach in the 17th Street floodwall during Hurricane Katrina. At this site, the only method deemed feasible for repairing the breach, due to lack of ground accessibility and the high velocities of water moving through the breach, was to drop heavy (2000-lb) sand bags from a helicopter (Figure 1.1). This procedure took many days to complete. Since the water level in Lake Pontchartrain stayed high for several days (Figure 1.2), this allowed huge quantities of additional water to flow into the Metro New Orleans area, even after the hurricane had passed. As shown by the Interagency Performance Evaluation Taskforce (IPET) study, water flows into the Metro area from breaches in the 17th Street and London Avenue Canals (Figure 1.4) after noon local time on 29 August was much greater than the amount that entered during the storm itself. As can be seen in Figure 1.5, water levels within the Metro area of New Orleans continued to rise substantially for at least a day and a half following Katrina's passage. From economic analyses conducted by the IPET, this rise in water level contributed to approximately \$1.5 Billion of additional direct damages.

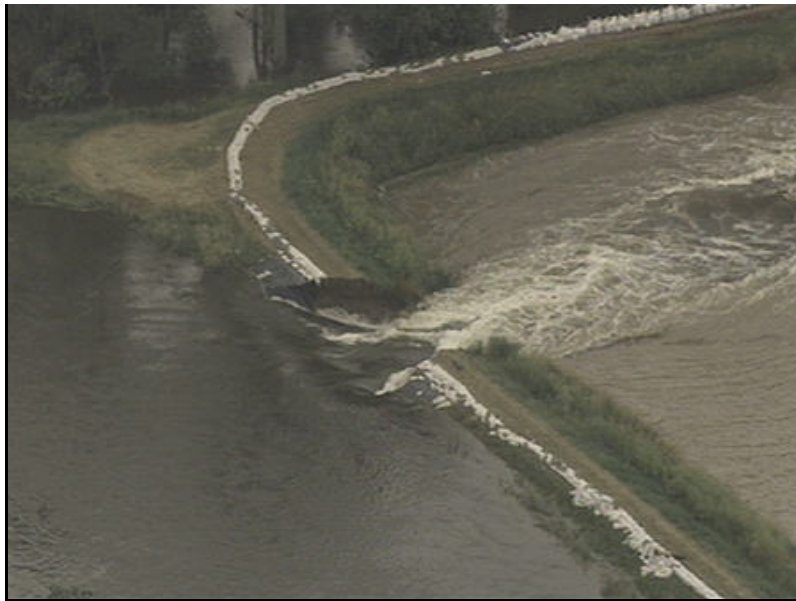
*Figure 3.1. Failure of the Pin Oak levee in Midwest.
Note sand bags atop levee used to fight rising water levels.*

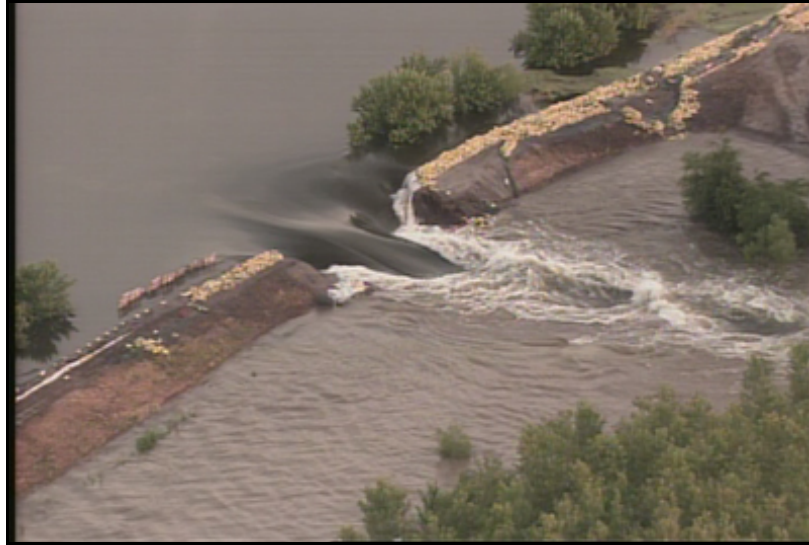
Figure 3.2. Failure of the Elm Point levee in Midwest.

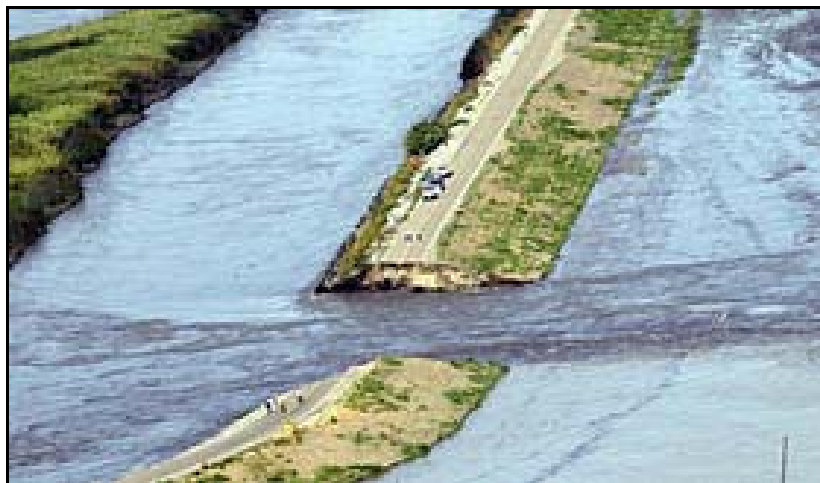
Figure 3.3. Upper Jones Tract levee Breach in the Sacramento-San Joaquin River Delta.

Another area where levee failures are of great concern is the Sacramento-San Joaquin River Delta area. Major flood events have occurred in 1950, 1955, 1964, 1986, and 1997. Mount and Twiss (2004) report that the projected subsidence of the Delta indicates that it will “become increasingly difficult and expensive to maintain the Delta levee system.” Some areas of the Delta are more than 8 m below sea level. This large amount of subsidence greatly increases the chance of piping related levee failures that will be discussed subsequently. Piping related failures are the major concern in these levees. Figure 3.3 shows the 2004 breach in the levee at the Upper Jones tract in the Sacramento-San Joaquin River Delta.

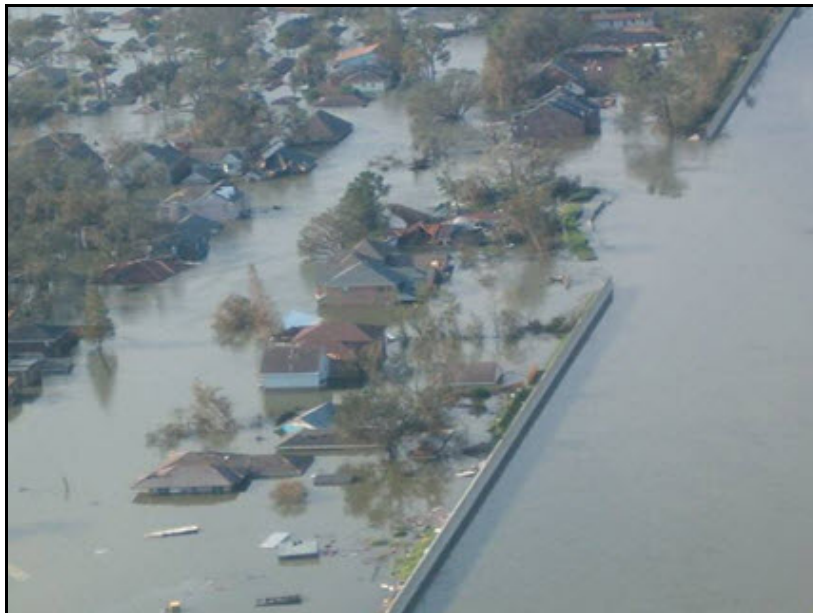
Figure 3.4. Floodwall failure on 17th Street Canal from Hurricane Katrina in New Orleans.

The current focus on levee breaches was brought about by the large number of levee and floodwall failures that occurred in the New Orleans area in 2005 as a result of Hurricane Katrina. The specifics of the failures are documented in the IPET report. These failures became the most costly disaster in the history of the US. During Katrina, levees and floodwalls failed as a result of most of the different causes that will be discussed subsequently. Figure 3.4 shows the floodwall failure on the 17th Street Canal.

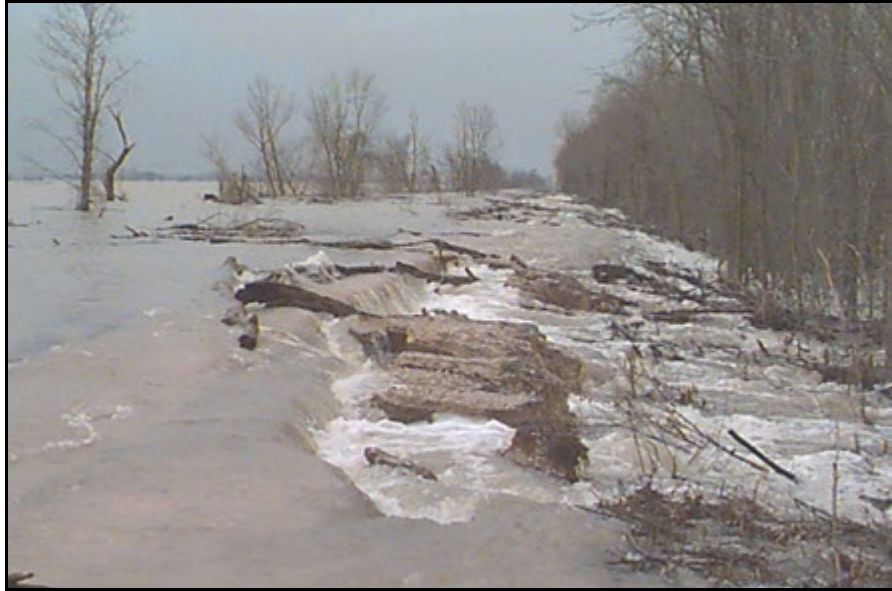
Figure 3.9. Overtopping of a levee over a wide area with a potential breach growing in foreground.

breaches during the 1993 flood on the Missouri River were caused by overtopping. Wave overtopping and breaching of the levee is similar to overtopping from excessive river water level except that a RRLB technique may have to be placed in waves and withstand wave forces. Figures 3.9 and 3.10 show a levee along a river being overtopped over a wide area.

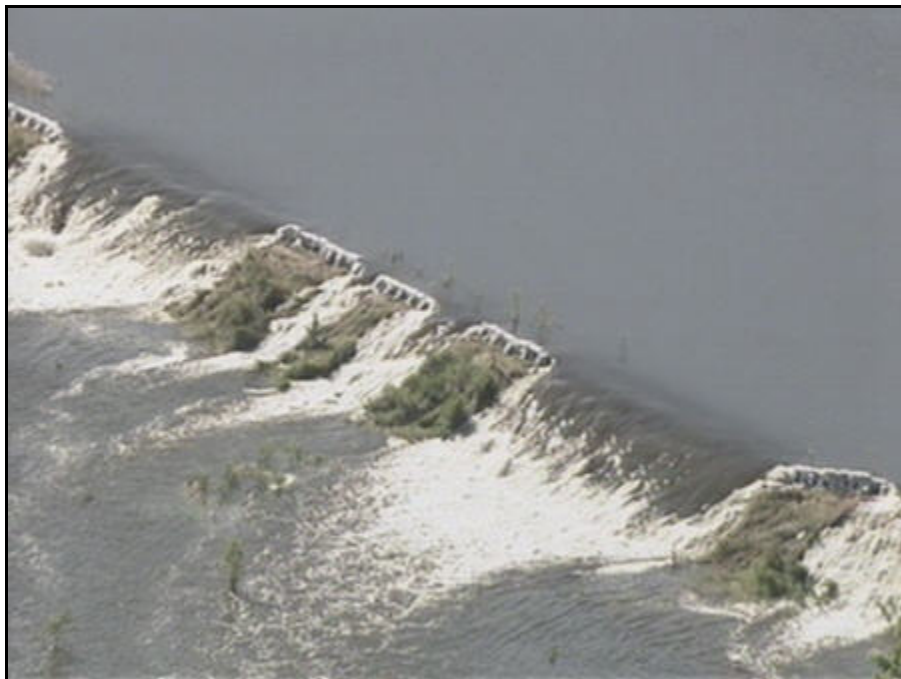
Figure 3.10. Overtopping of the Foley levee in the Midwest.

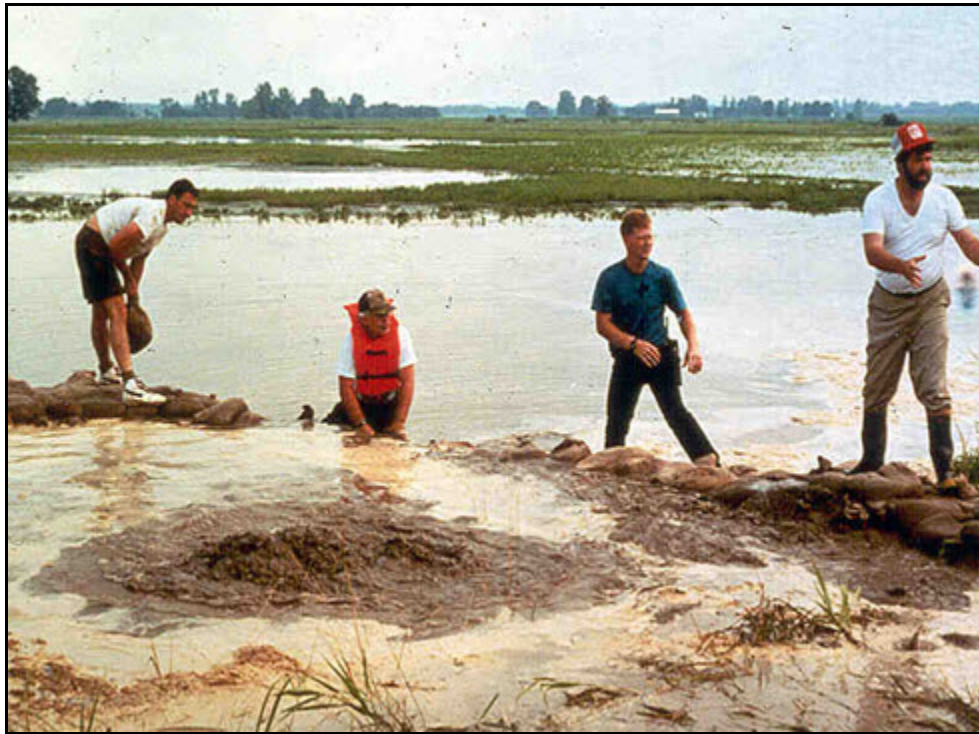
Figure 3.11. Sand bag levee around sand boil on Kaskaskia River. Notice that one guy in this picture, who appears to be the oldest guy, has doubts about whether this is going to work because he is wearing a life vest.

Figure 3.11 shows a ring levee of sand bags around a sand boil on the Kaskaskia River levee. Ring levees are one of the existing rapid repair techniques that have been used for many years with great success. Ring levees are placed only to the level that stops movement of sediment with the water. If placed to a greater height to stop flow, the increased head will likely result in the piping connection blowing out somewhere else. Prior to this picture, the ring levee had reduced the flow and stopped the movement of solid material. Suddenly, the levee foundation material started moving again as shown in the Figure. Efforts to further raise the sand bag levee and stop the material movement were unsuccessful and the full breach formed as shown in Figure 3.12.

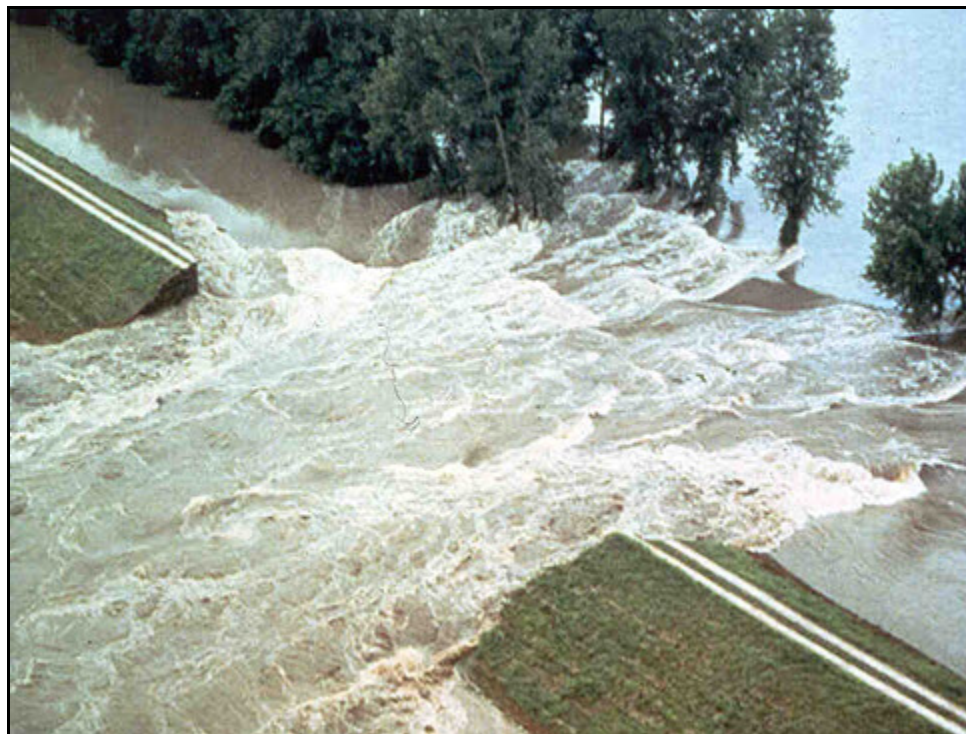
Figure 3.12. Kaskaskia River levee breach at location of sand boil.

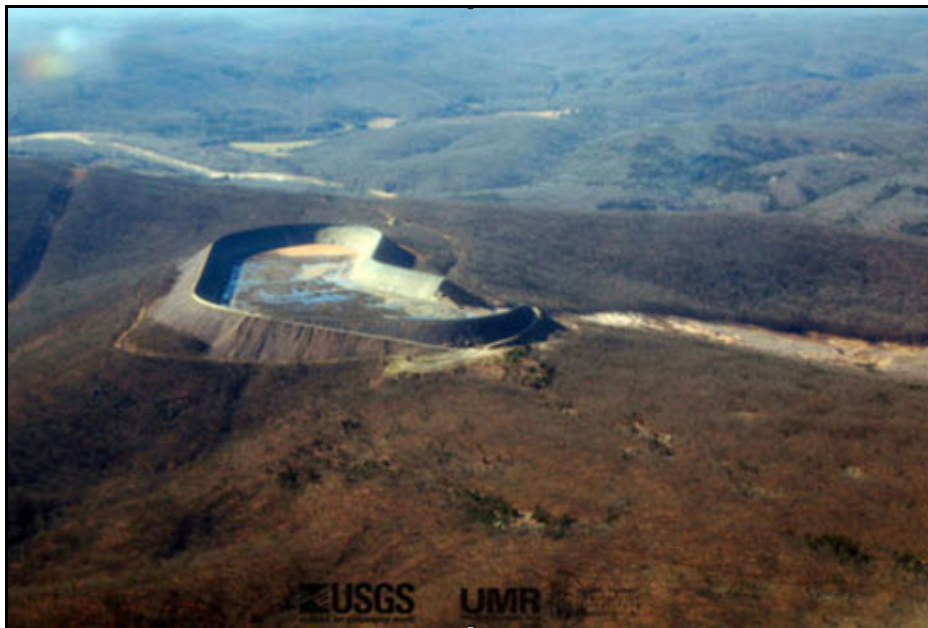
Figure 4.1. Aerial photo of the Taum Sauk Upper Reservoir, just after breach in December 2005.

This section documents a numerical simulation of discharge through a levee breach. The intent was to simulate a worst case scenario of discharge through a breach in order to determine the maximum forces that might be exerted on any object placed in the breach. In order to determine the dynamic hydraulic forces produced by the discharge through the breach, the velocity of the flow must be known. It is expected that the highest velocity will produce the greatest dynamic hydraulic force. Thus a major goal of the numerical simulation was to map the velocity through the breach in both time and space. Normally a breach forms slowly by overtopping, scouring or piping; but that is not always the case as exemplified by the failure of the Taum Sauk Upper Dam, Missouri, in December of 2005. Figure 4.1 shows a general view of the Taum Sauk Upper Reservoir near Ironton, Missouri just after the breach.

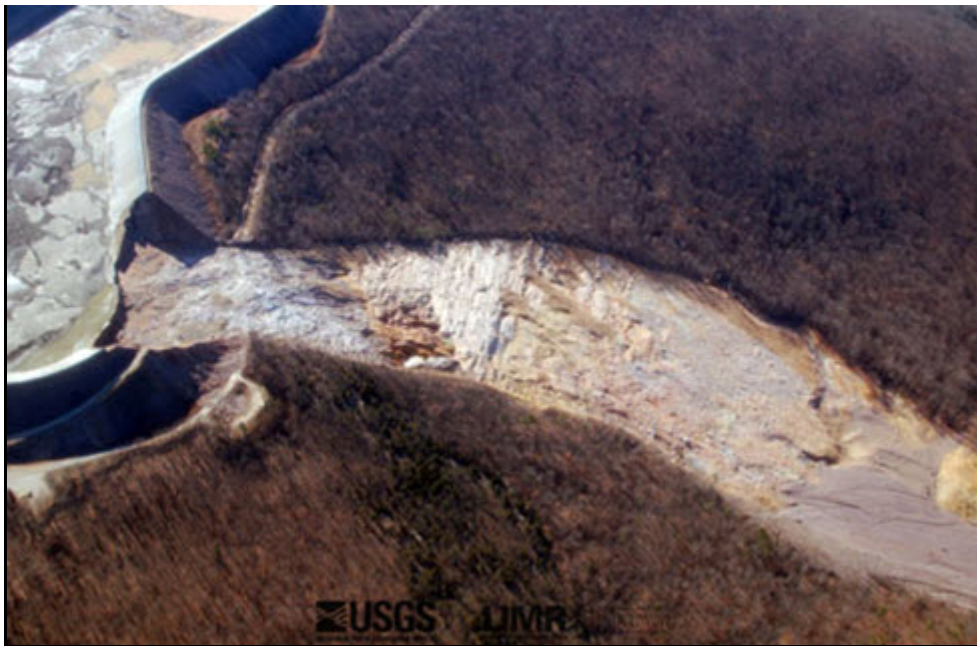
Figure 4.2. View of emptied lake and vicinity.

Figure 4.2 shows a closer view of the emptied lake and breach vicinity. In this case the lake wall was overtopped and also suspected of being undermined by seepage. When it collapsed the lake was emptied in a matter of 12 to 15 minutes. It is suspected that the 17th Street breach in New Orleans failed catastrophically after some initial period of overtopping as well. Knowing that such documented cases exist, for this study a worst case scenario was considered as an instantaneous removal of the levee wall, allowing flow to cascade out of the breach.

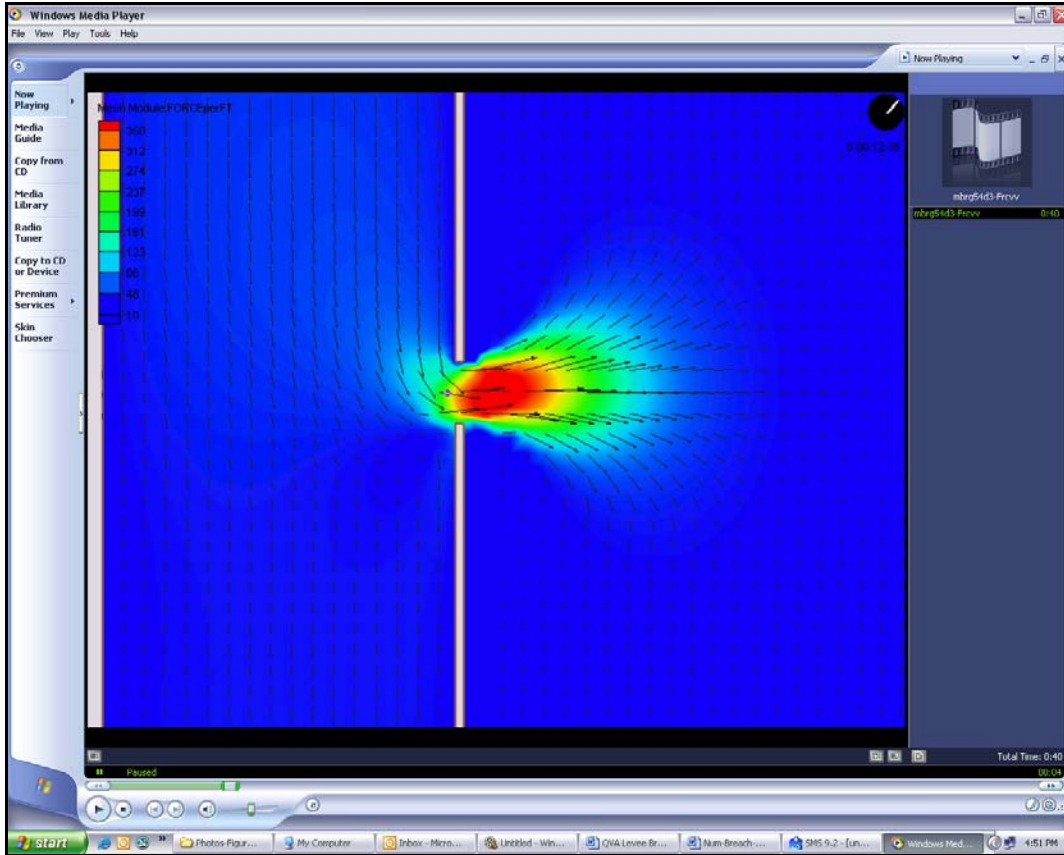
Figure 4.7. Modeled forces on a flat plate subjected to flows in vicinity of idealized breach.

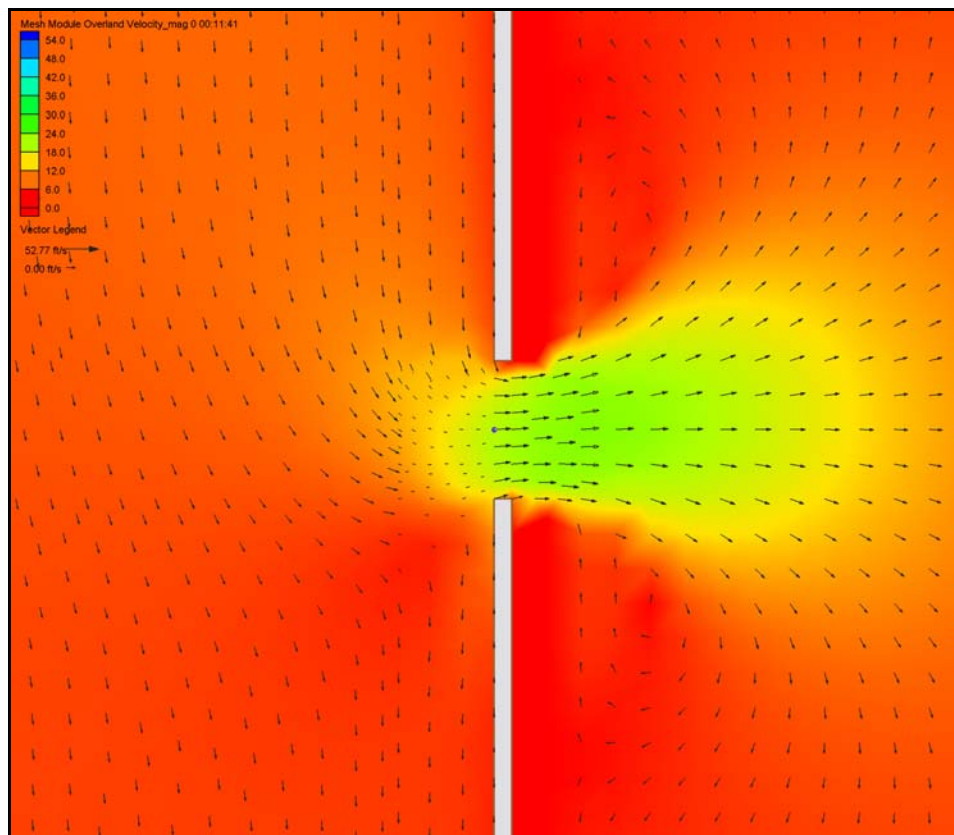
Figure 4.8. Force vectors (assuming a drag coefficient value of 2) for flow through an idealized breach.

affect the effort to position the closure device. For example, at the centerline of the breach opening and about 150 feet from the levee crest on the river side of the breach, the component of velocity in the breach-direction is 9.5 fps and the streamwise component is 3.3 fps. At the same distance from the levee crest but at the north abutment, the component through the breach is 2.6 fps and the streamwise component is 7.7 fps. So in moving a closure device a distance of only 100 ft in the streamwise direction and being 150 ft away from the levee crest, the velocity components change from 66% streamwise and 33 % breach-direction, to 66% breach-direction and 33% streamwise. This shows clearly that the streamwise components of velocity cannot be ignored when considering the logistics of moving a closure device into place, which will become a very important topic when discussions for the concepts of operations (CONOPS) for deployment are being developed.

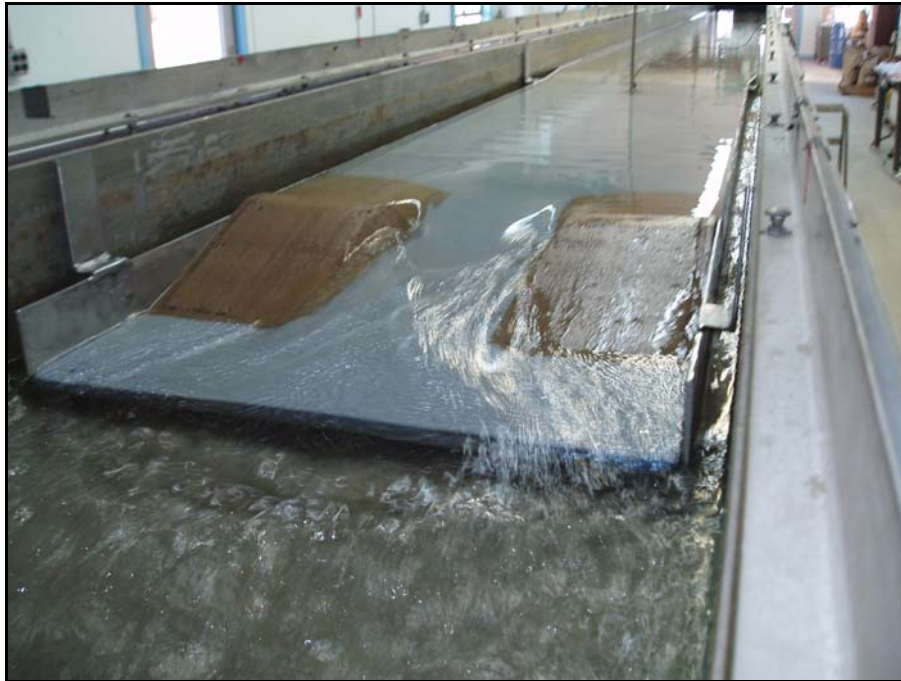
Figure 5.1. Photo of flow through small-scale (1:50) breach.

An 80 foot long tilting flume was used to provide a simulated levee breach and flow for testing of various closure methods discussed above. The flume cross section is 3 feet wide and one foot deep. The facility has pumps that can supply up to 5.5 cfs of flow capacity. In order to maintain a constant water level during the closure tests, a special side-weir-overflow device was constructed to fit within the flume. A simulated levee was constructed separately, but made to fit exactly within the confines of this overflow device. The flume, overflow device and simulated levee are all shown in figure 5.1.

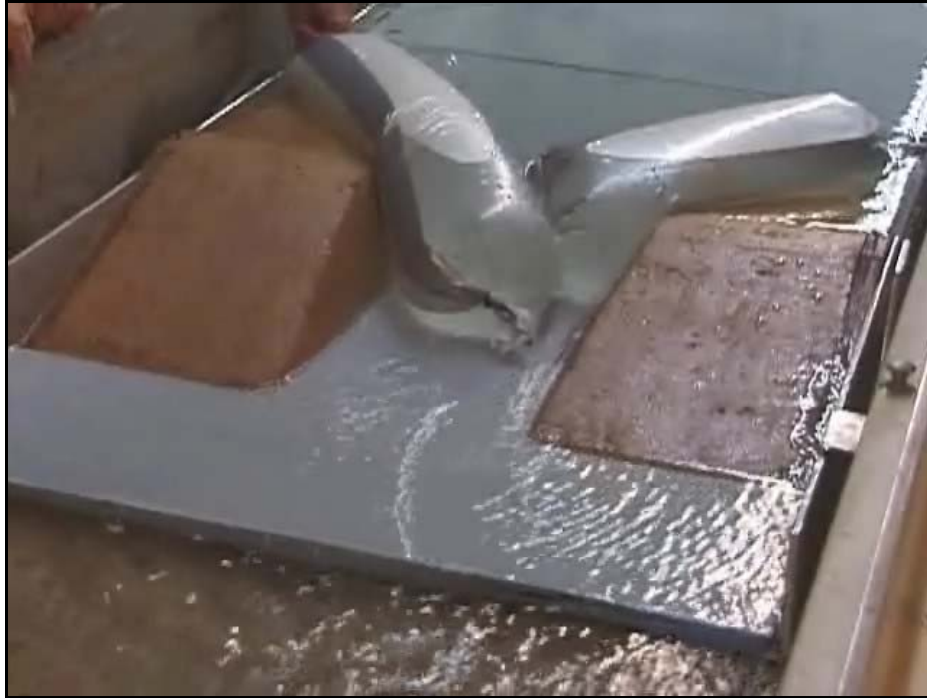
Figure 5.6. *Photo of water-filled tube concept utilizing two tubes anchored to either side of a breach in the 1:50 scale model basin.*

4. Geo-textile fabric bags filled with water. For these tests, water-filled plastic bags were tested in anchored and un-anchored configurations. Bags anchored on each end and filled in place are shown in Figure 5.6.

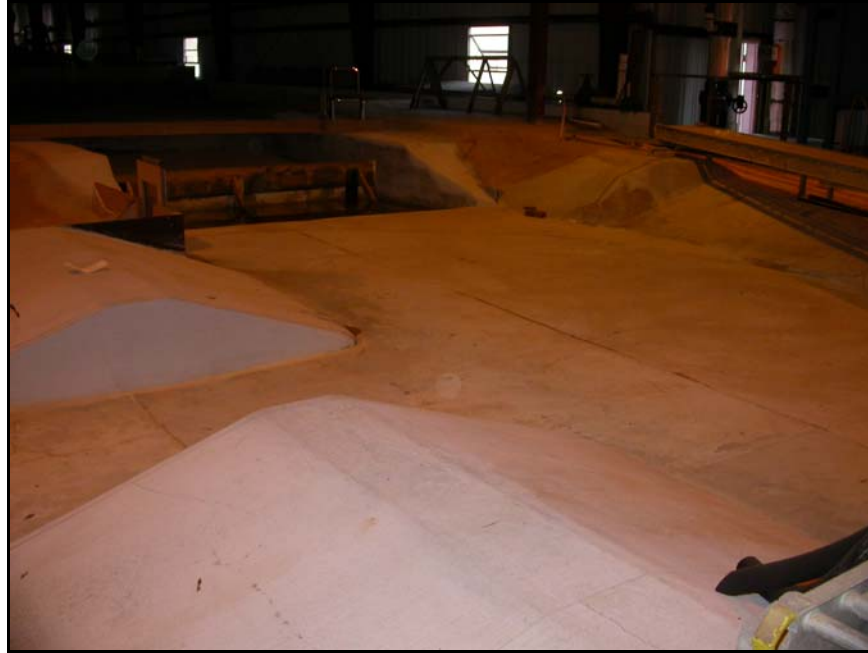
Figure 6.1. *Test basin for 1:16 scale physical model tests.*

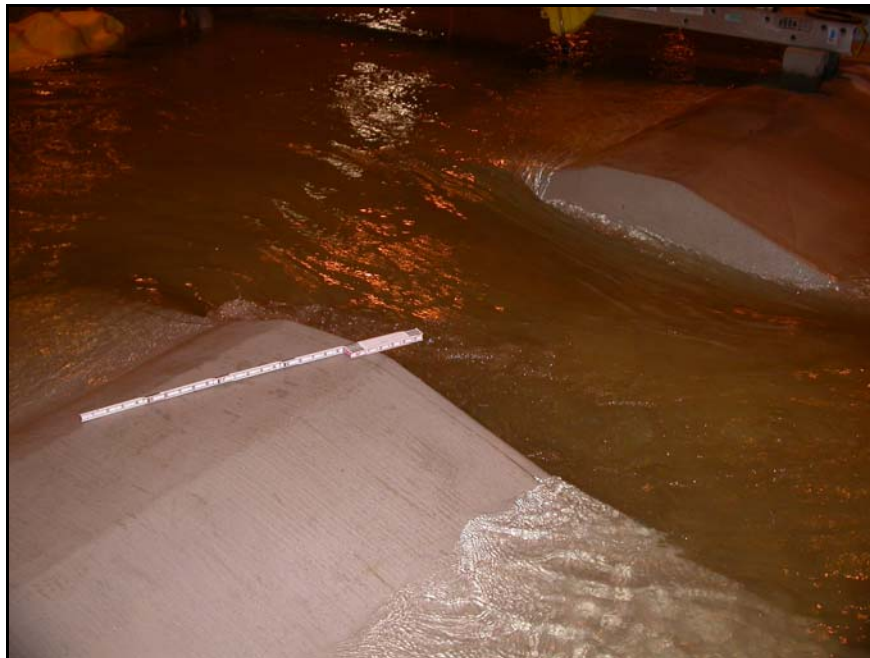
Figure 6.2. *Flow through the breach with upstream depth at 18.7 ft.*

This model represents a fairly extreme test for breach closure, since the breach is 80 ft wide and 20 ft deep, the still water level is 18.7 ft deep, and there is as a significant riverine current flowing along, past, and through the breach (Figure 6.2).

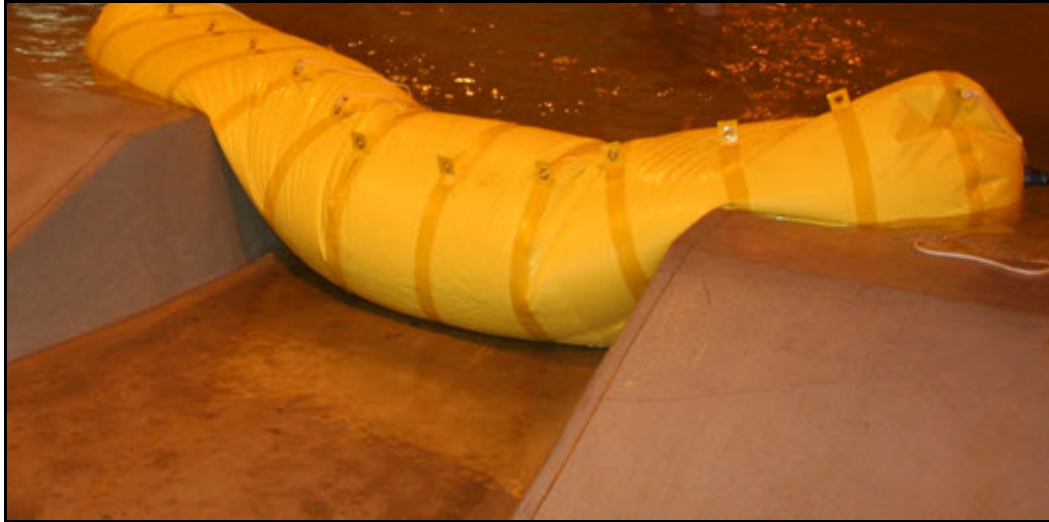
Figure 6.5. Deep-breach closure with large tube filled to 60% fill volume.

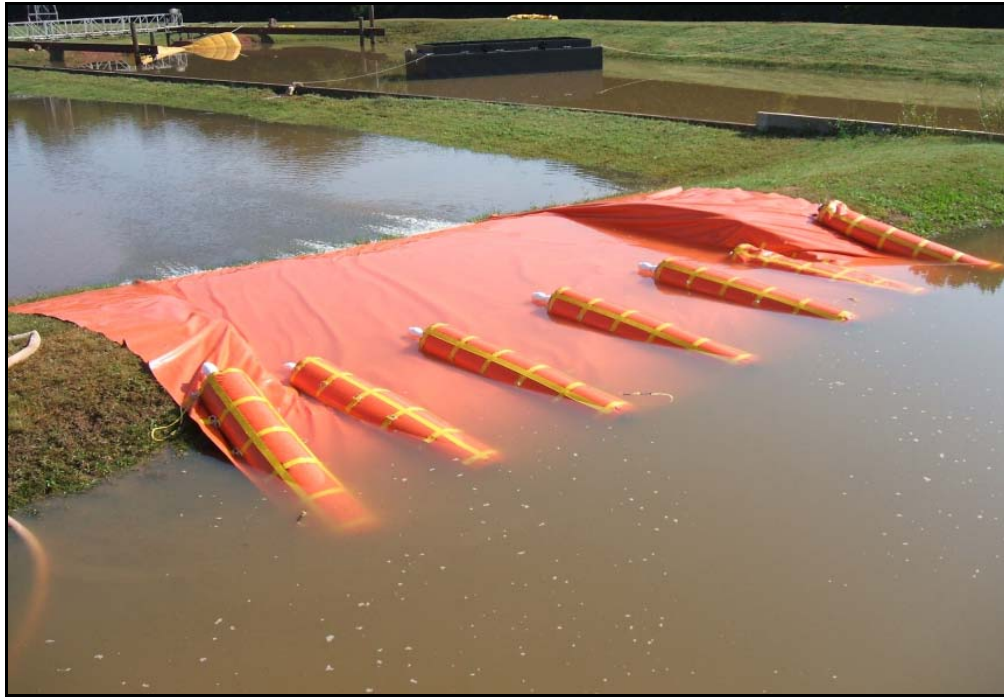
Figure 7.2. Demonstration of REPEL system with 0.5-ft of water passing over the top of the breach.

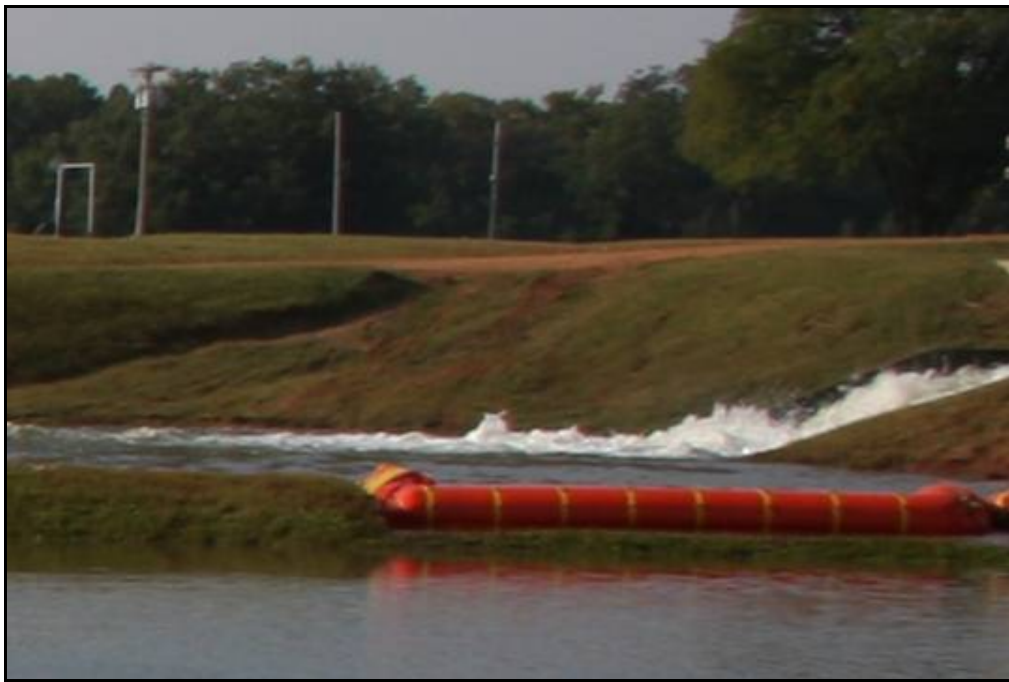
Figure 7.3. *Demonstration of shallow, wide breach closure system at ARS facility in Stillwater.*

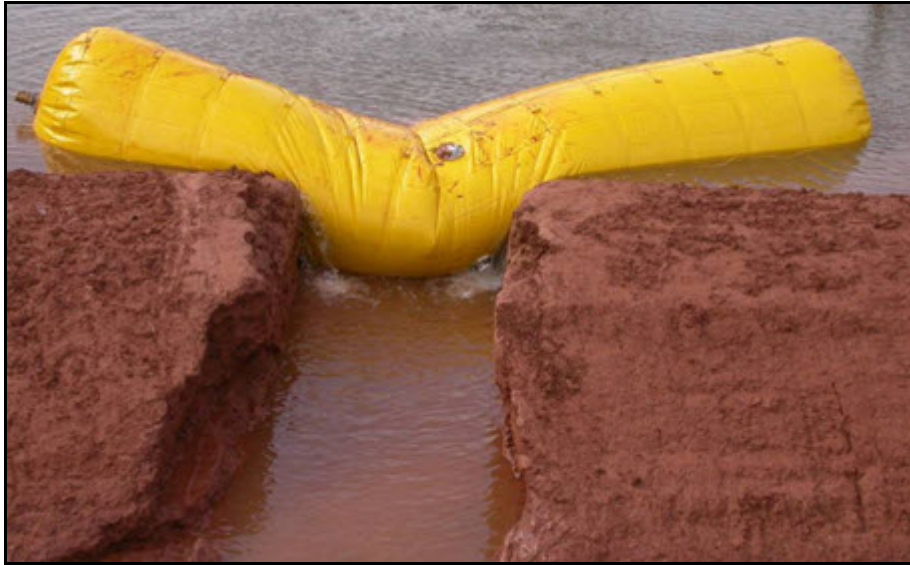
Figure 7.6. Sample deployment of deep-breach closure system, with a small residual flow still persisting along the upper edges of the breach opening.

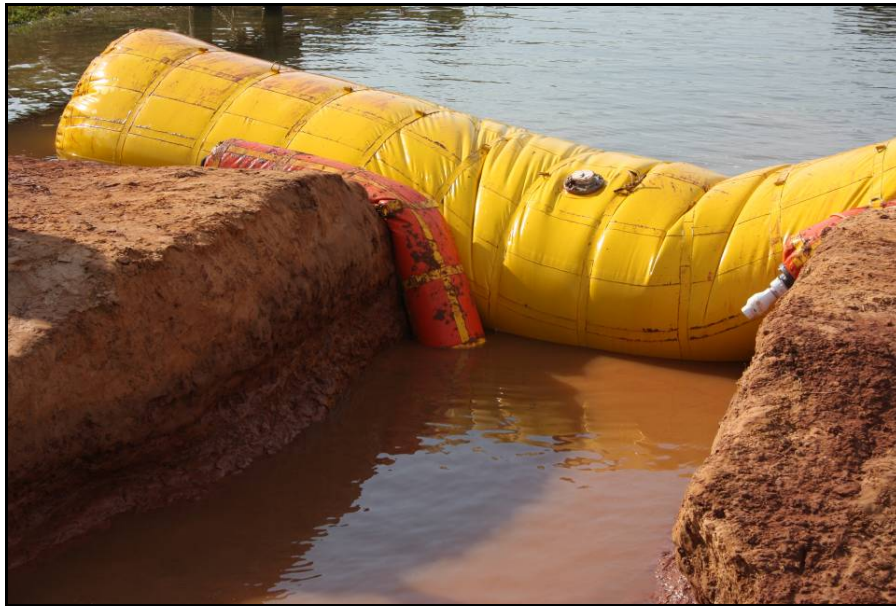
Figure 7.7. Sample deployment of deep-breach closure system including the addition of two small tubes along the upper edges of the breach opening which produced essentially zero-flow conditions through the breach.

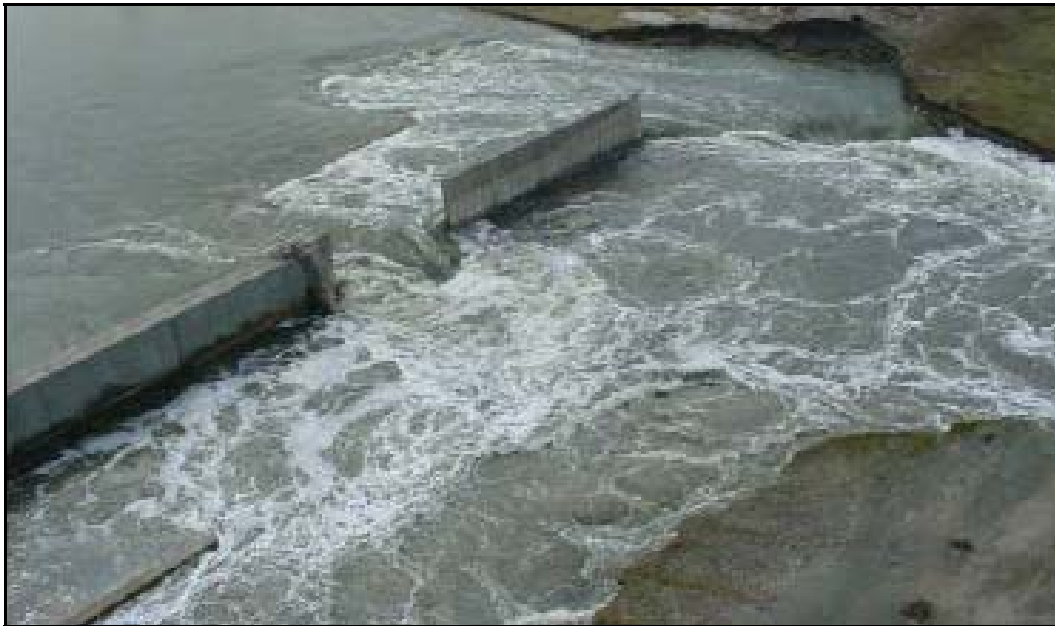
Figure 9.1. Breaches during Katrina.

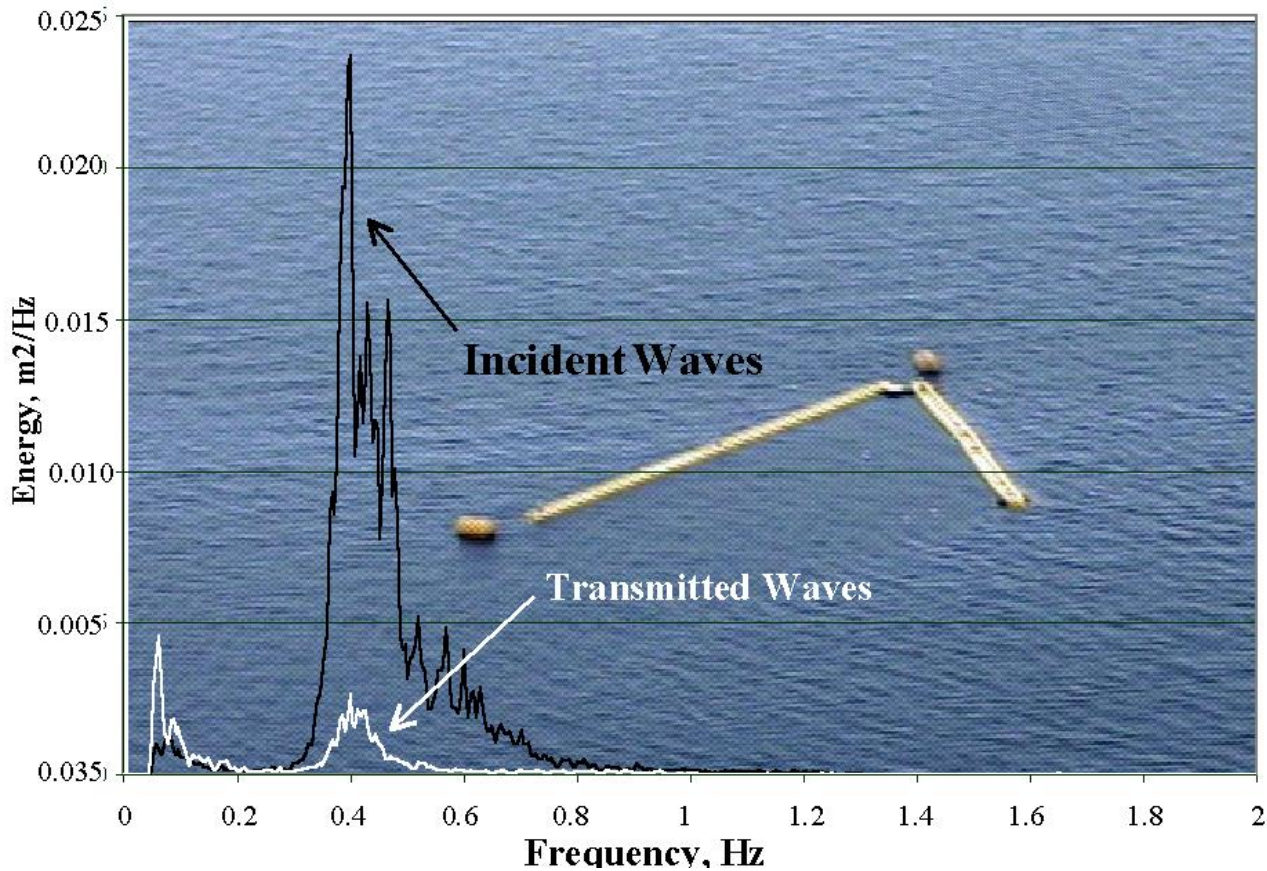
Figure 8. Incident and transmitted wave energy plots superimposed on a photo of the RIB used in the FY 2000 field study.

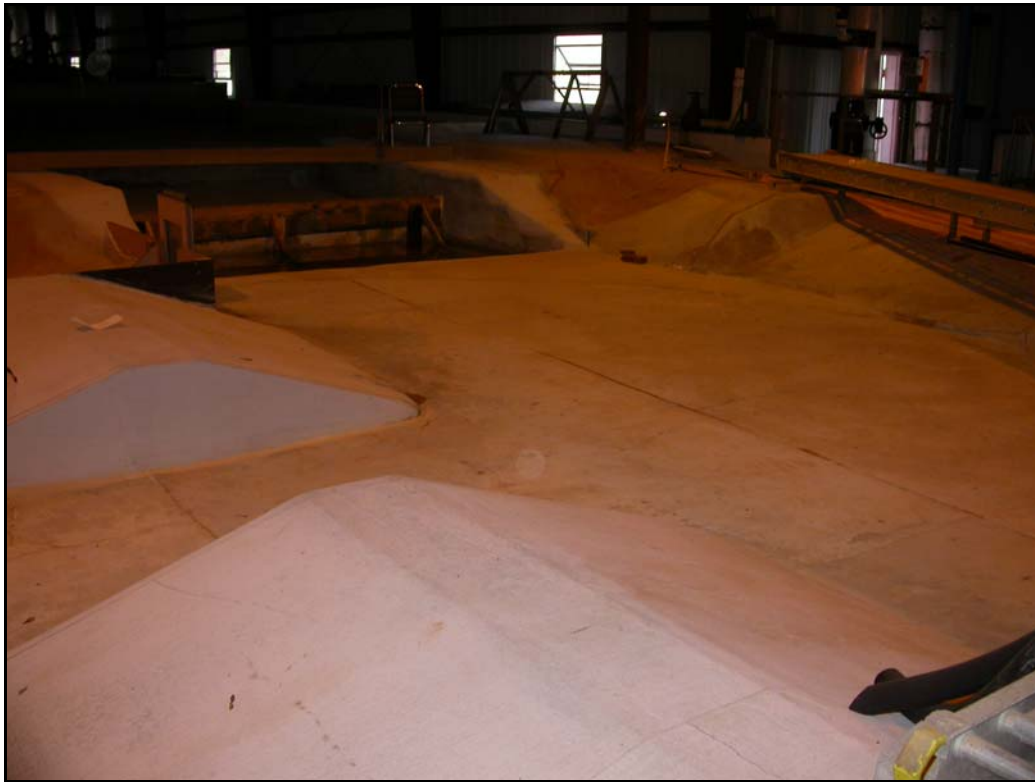
Figure 1. Test basin for 1:16 scale physical model tests.

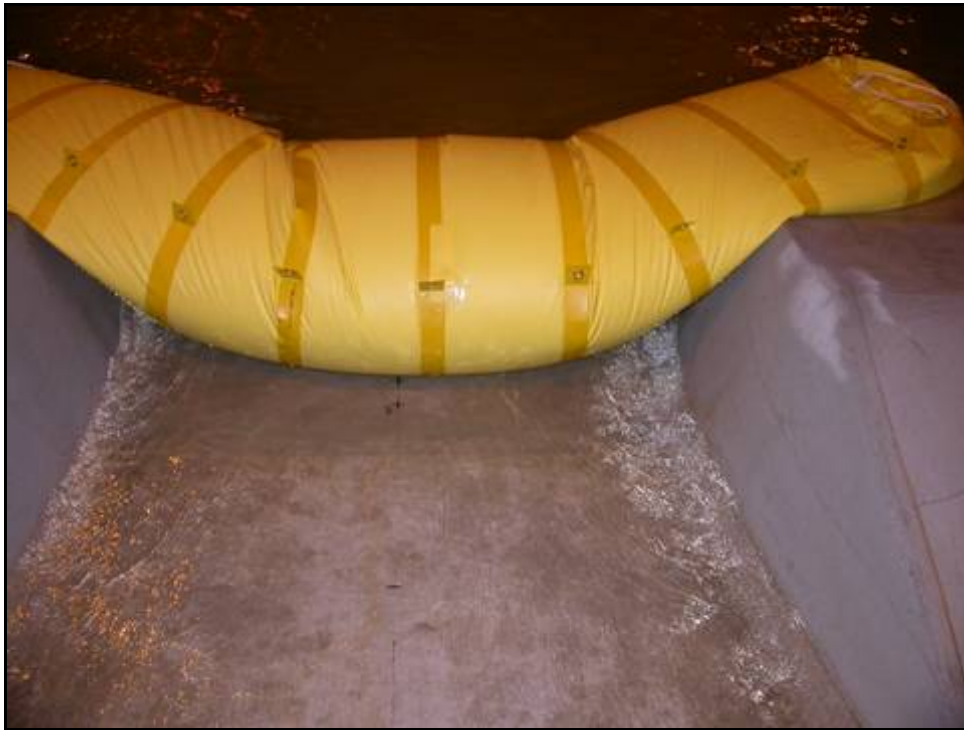
Figure 2. Breach sealed by 195-ft-long bag with 70% fill.

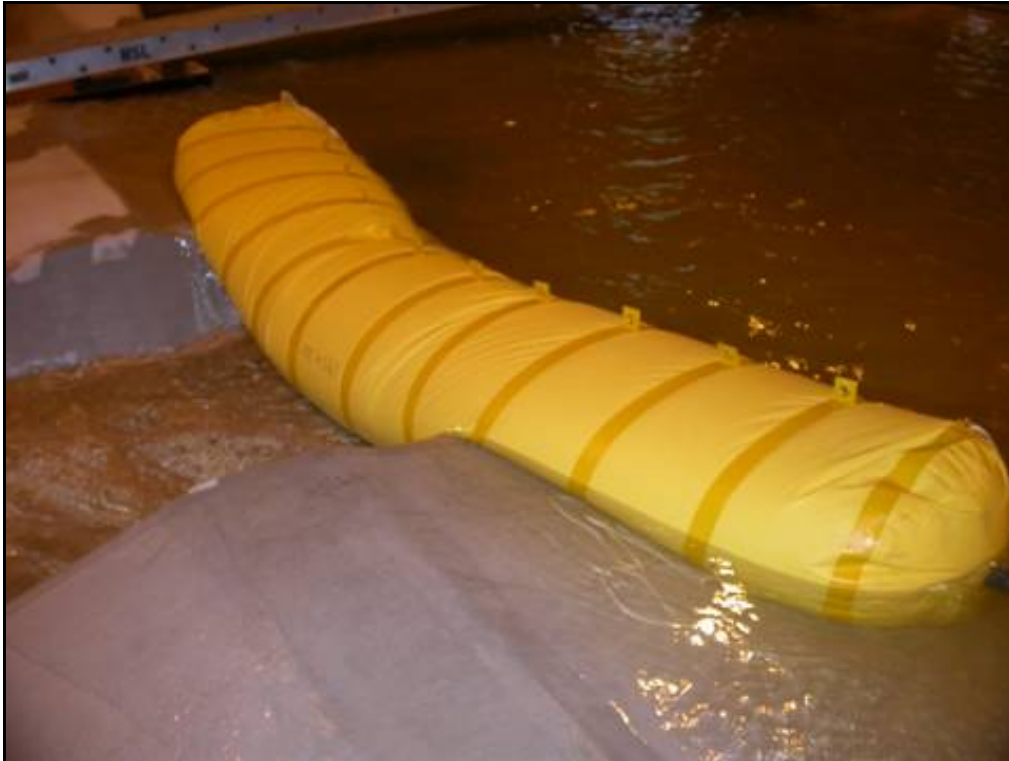
Figure 3. Breach sealed with 195-ft-long bag with 80% fill.

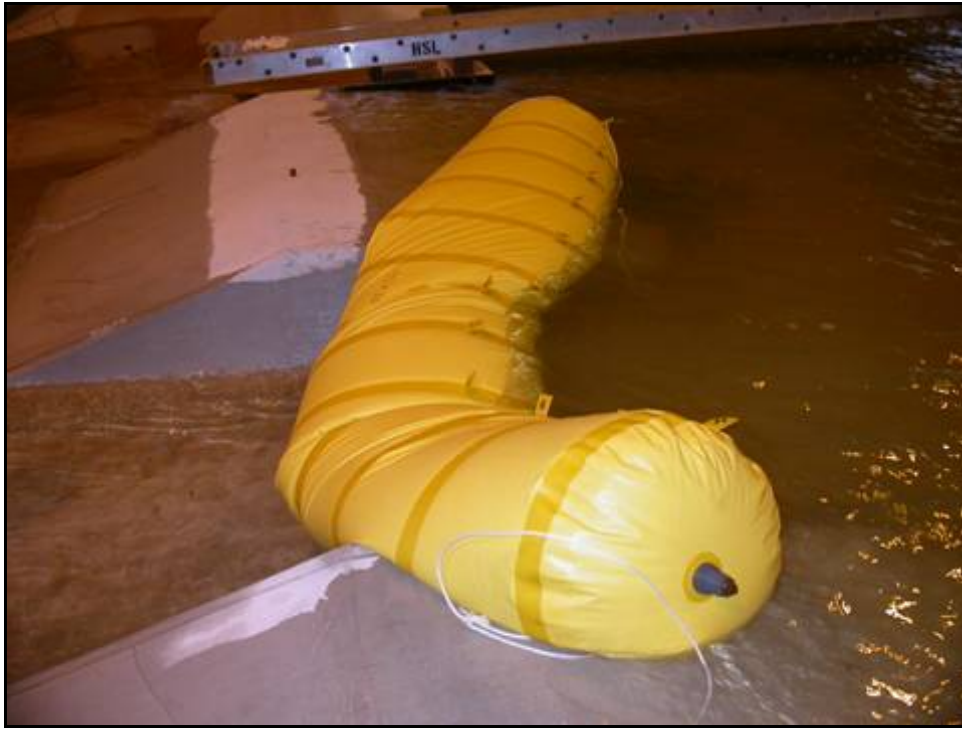
Figure 5. Breach filled with 195-ft-long bag with 65% fill and air left in bag before filling.

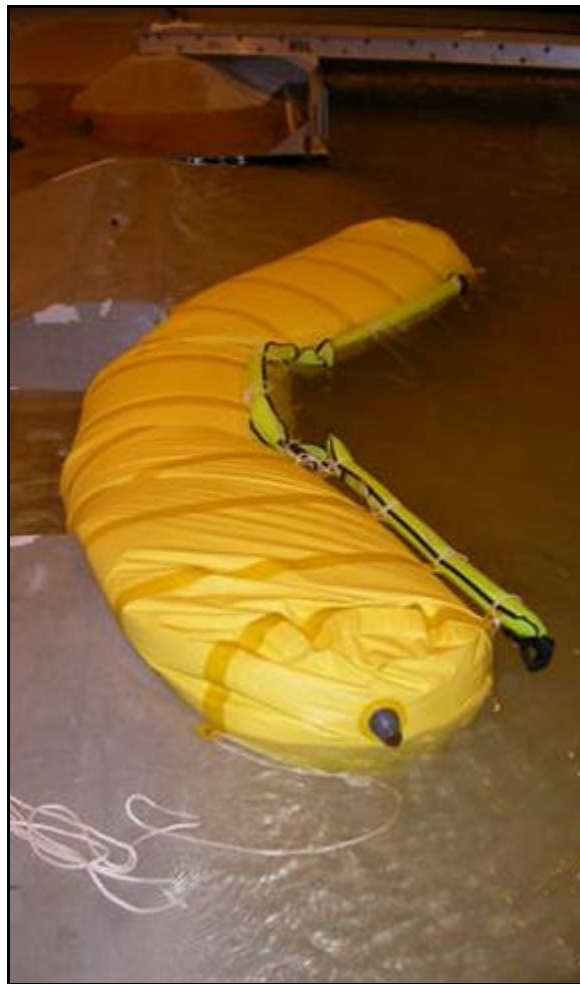
Figure 5. 195-ft-long bag deployed with outside air chamber.

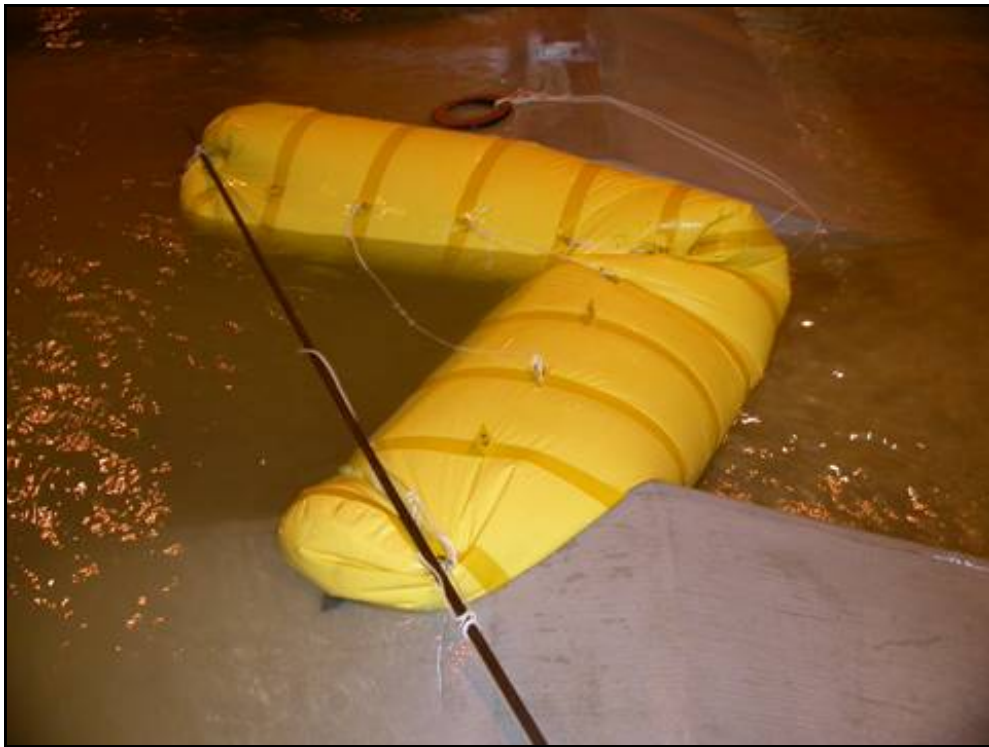
Figure 6. Beam and ties used to force 195-ft-long bag into a wedge shape.

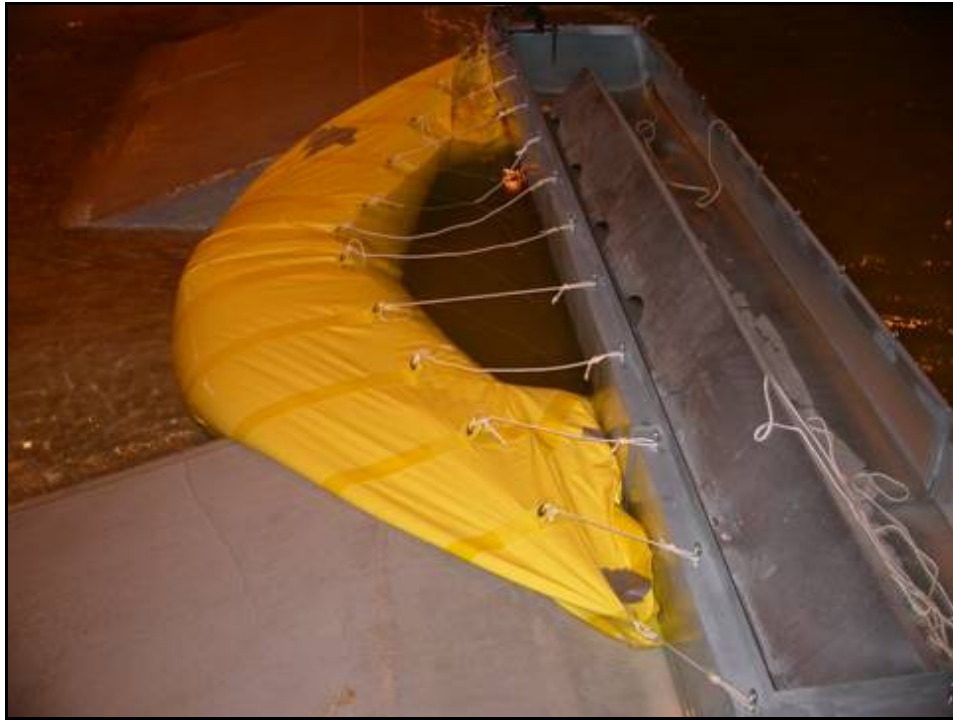
Figure 8. Bag extending into the breach while attached to the barge.
