Development and Demonstration of Rapid Repair of Levee Breaching Technology

Donald Resio¹, Stanley Boc, Stephen Maynard, Donald Ward, and
David Abraham

¹ Coastal & Hydraulics Laboratory, Engr. Res. and Dev. Ctr., Vicksburg, MS 39180-6199

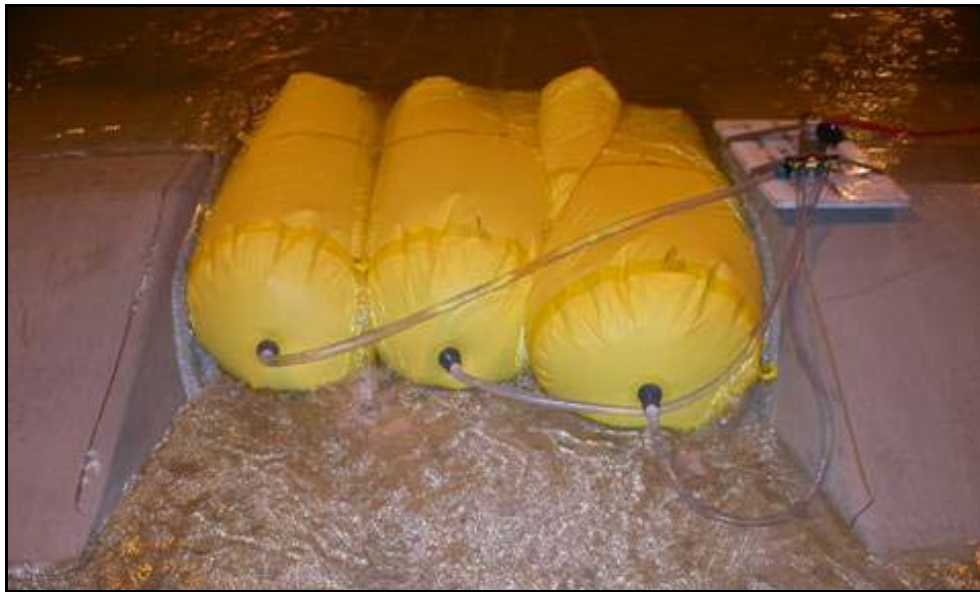
Figure 11. 30-ft-diam bags placed side-by-side to span the breach, looking upstream into the breach

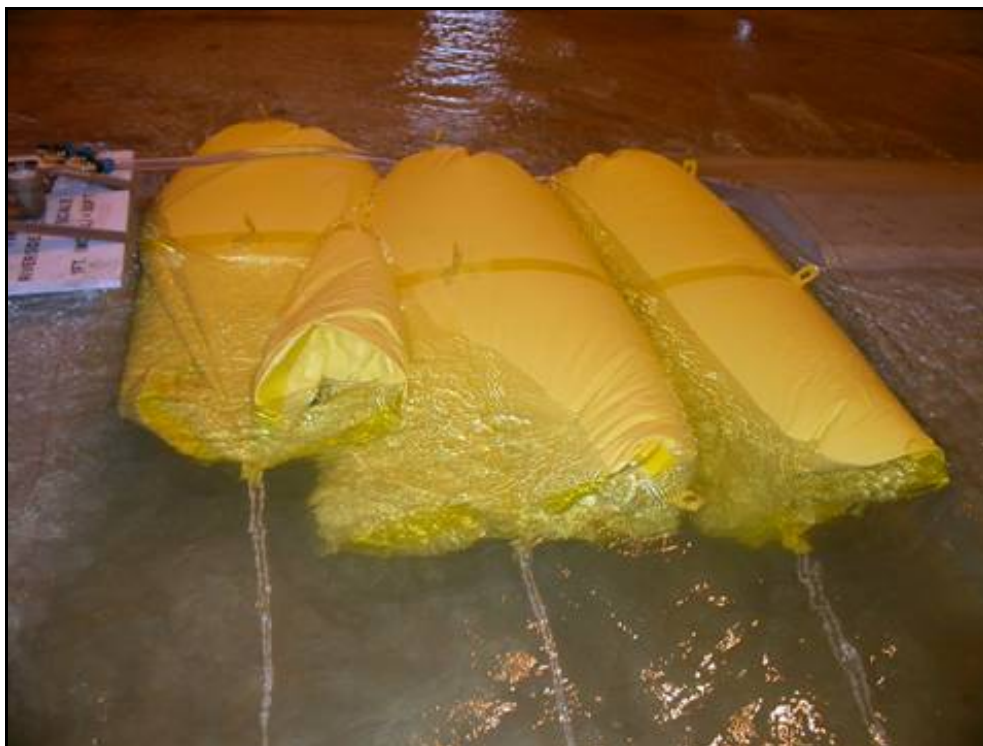
Figure 9. 30-ft-diam bags in breach, looking downstream.

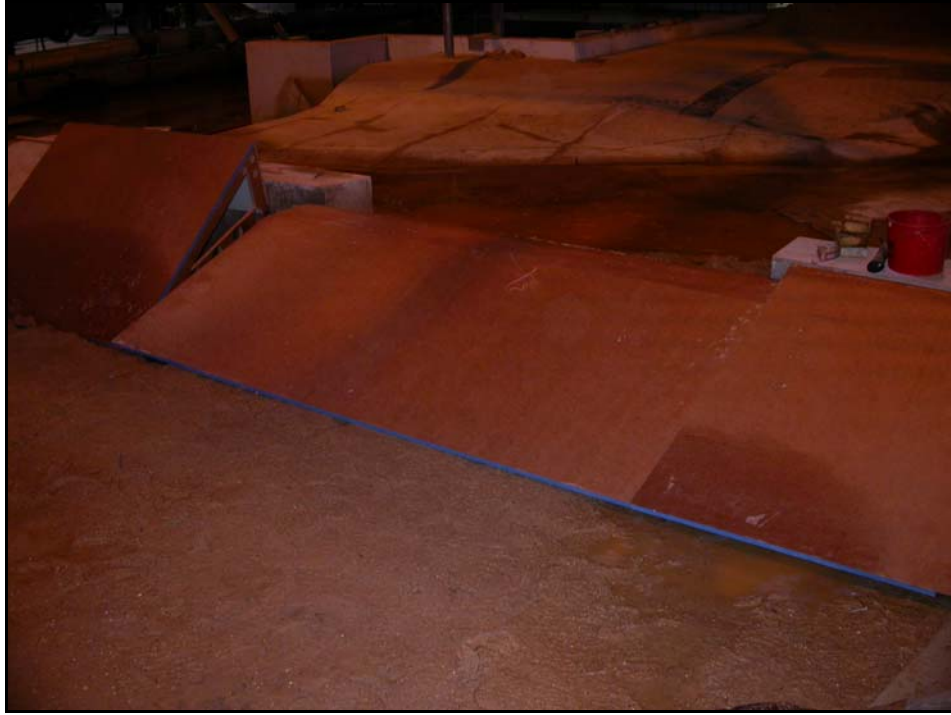
Figure 10. Plywood sections used to construct the shallow-water breach. The section on the left end is elevated only to illustrate the construction.

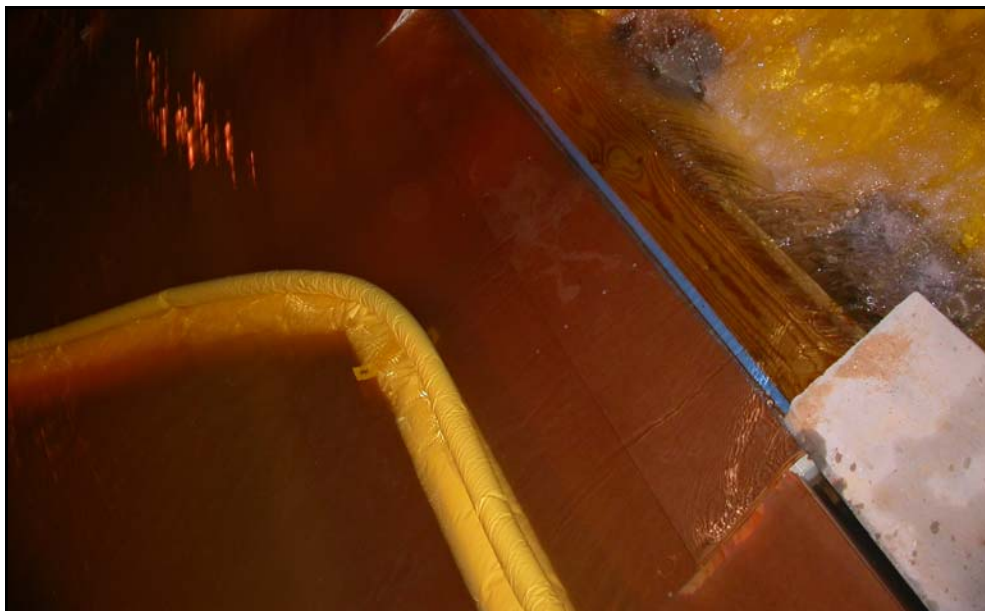
Figure 12. Shallow-water breach bag being carried into place by current.

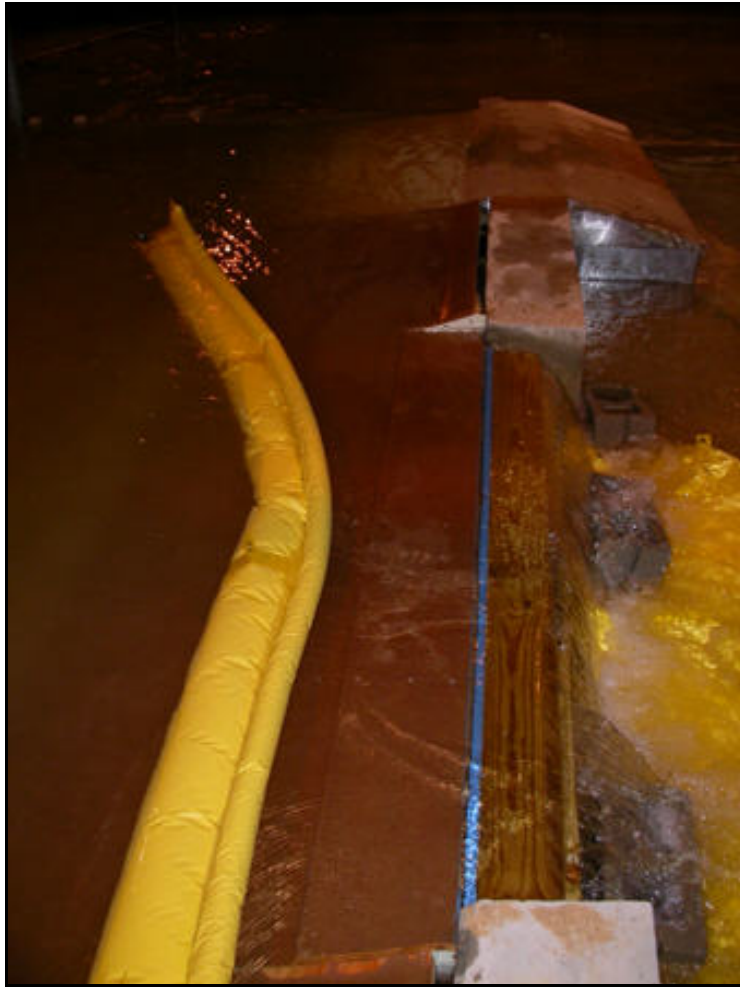
Figure 13. Shallow-water breach bag nearly in place.

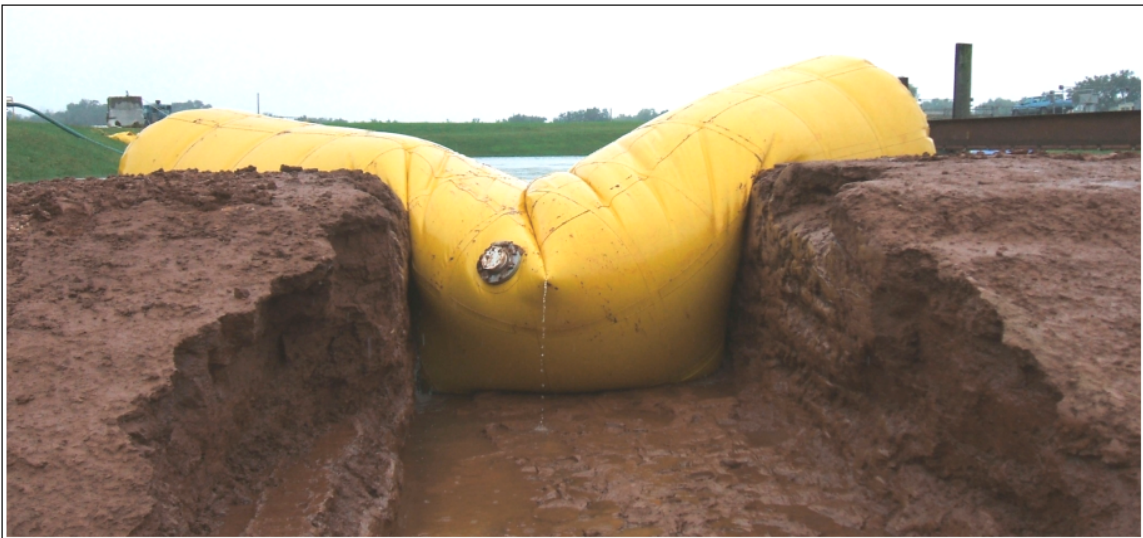
Figure 3.2.1 Cross-Flow, Deep Breach

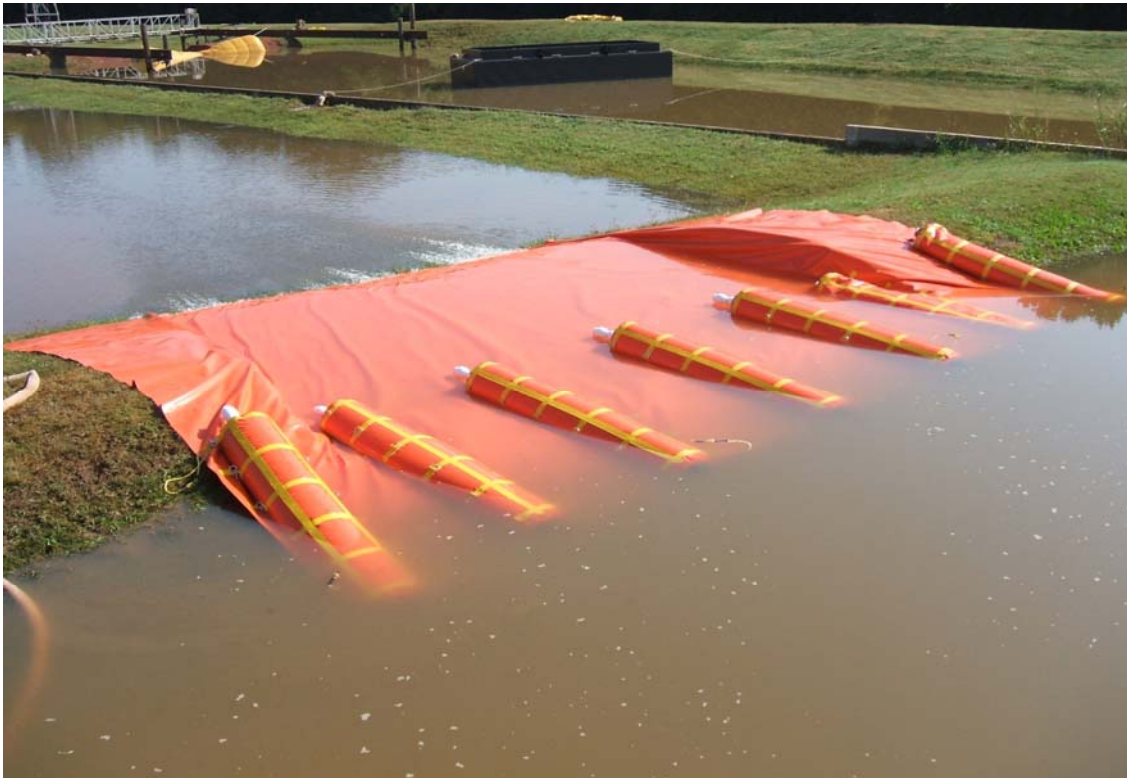
Figure 3.4.1: Shallow Water Spillway

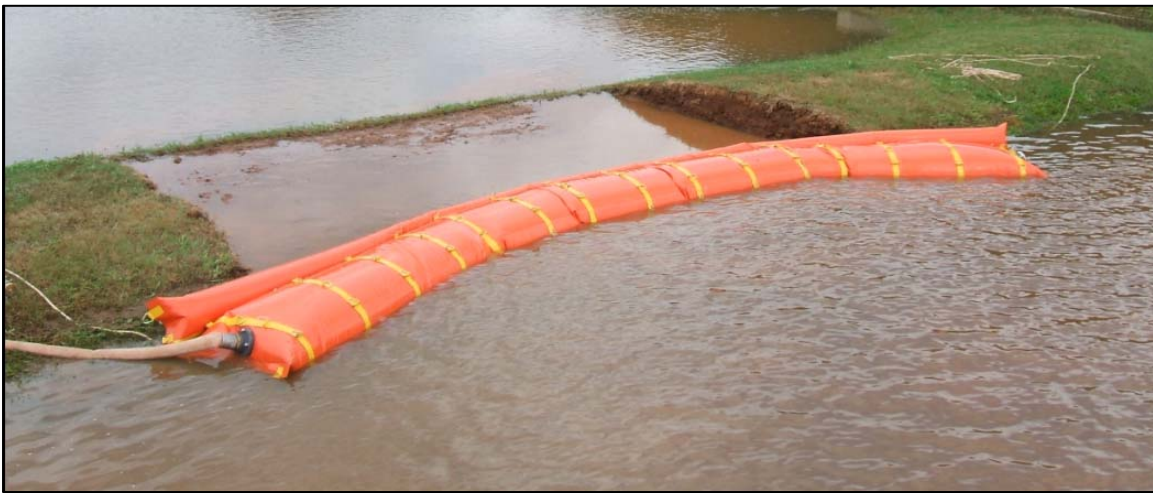
Figure 3.5.1: Shallow Water Blocking Configuration.

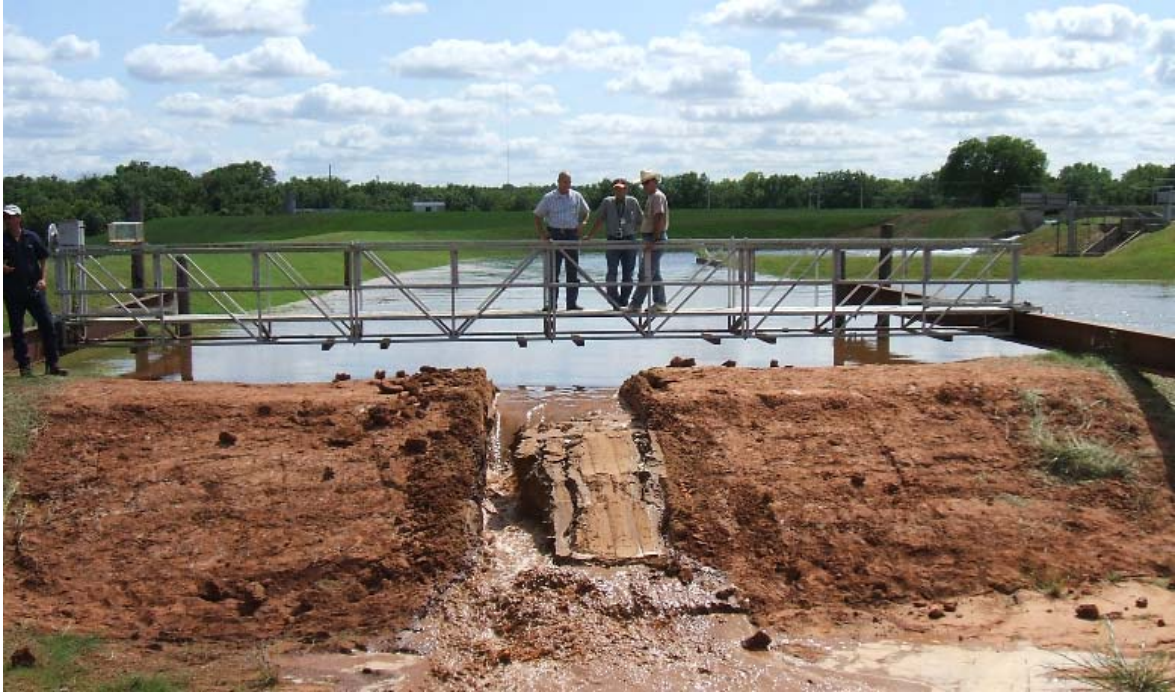
Figure 5.1.3: Deep Breach Levee Section.

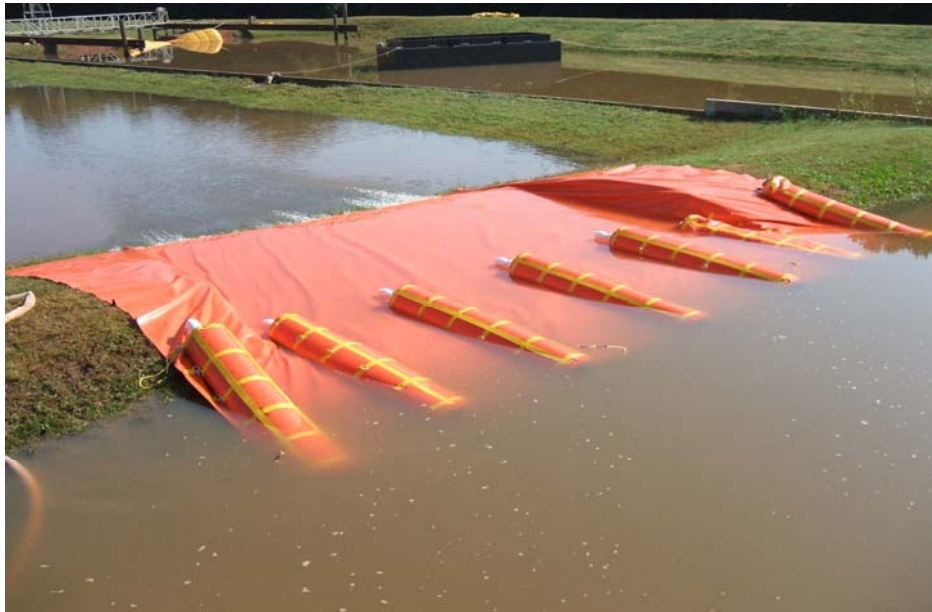
Figure 5.1.5. Shallow Breach with Spillway Concept.

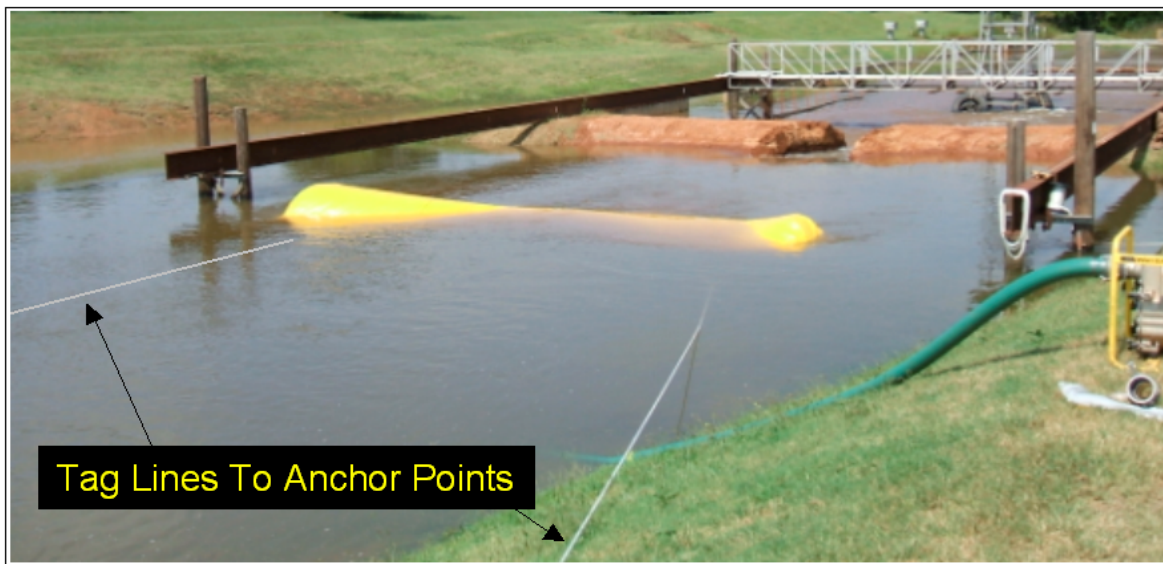
Figure 5.3.1.1 Tube Filled, Staged for Deployment

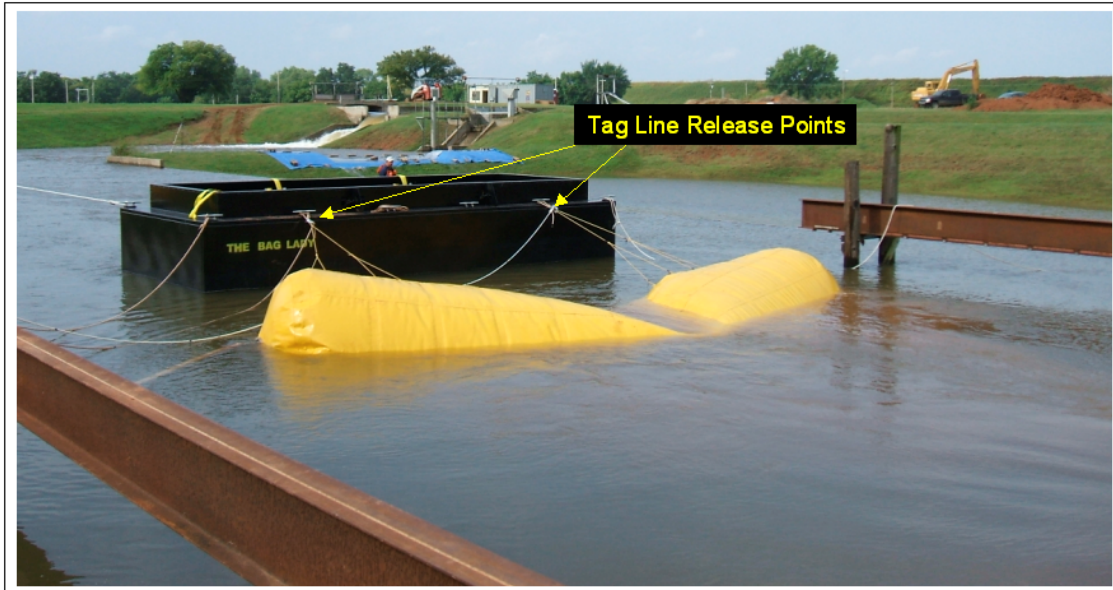
Figure 5.3.2.1: Barge-Deployed Tube Configuration

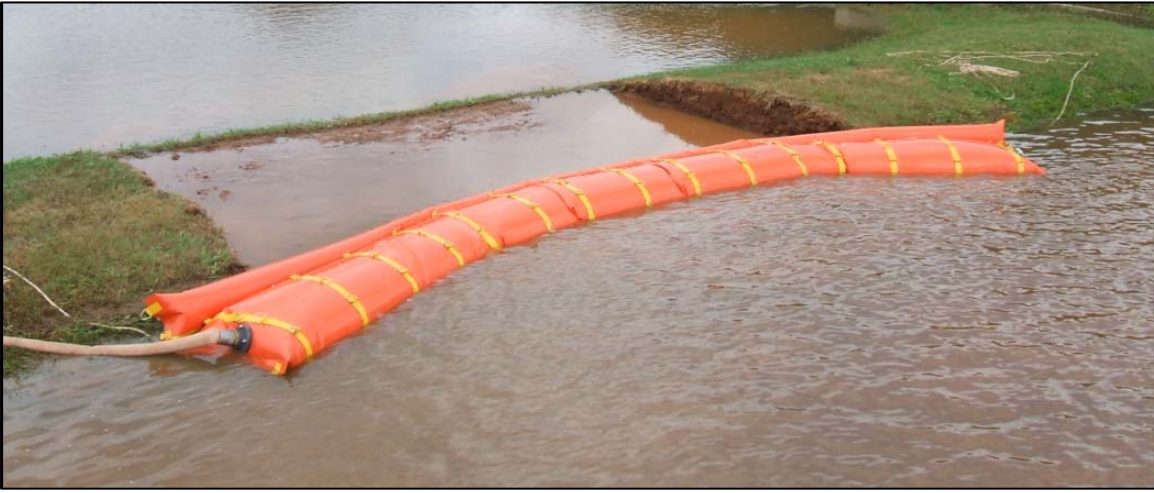
Figure 5.4.3.1: Shallow Water Block Test
