# Floods in Germany (June 2013)

Post-flood field investigation, July 2& 3, 2013

Preliminary Findings

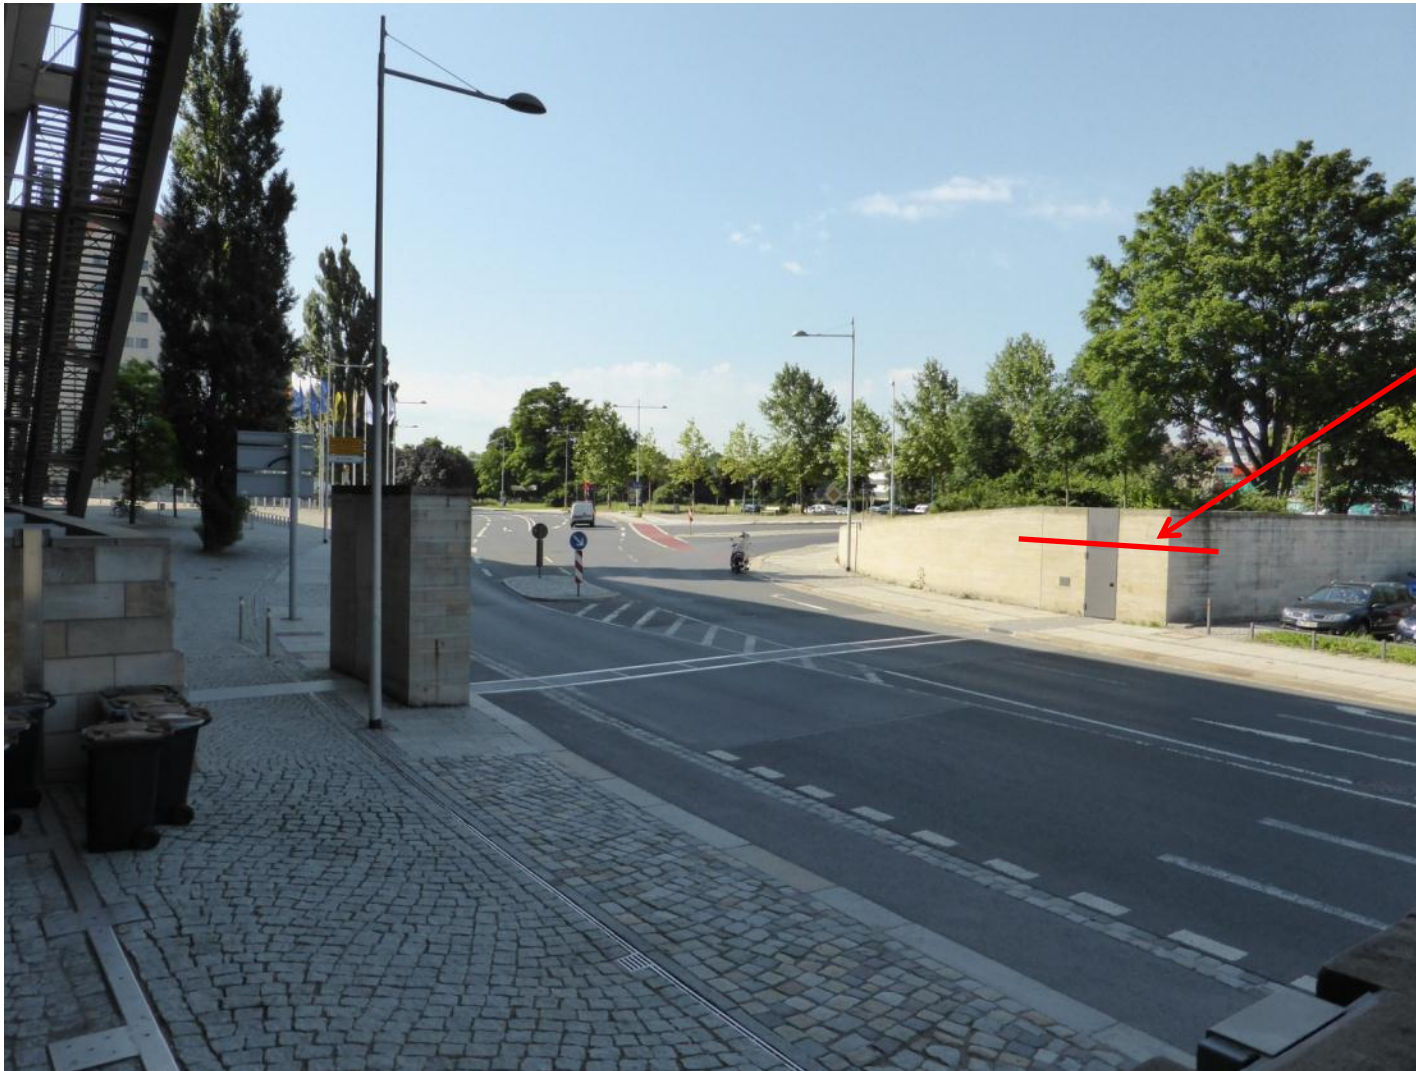
# Dresden – flood gates

Gate lower  
than floodwall  
to allow  
overflow

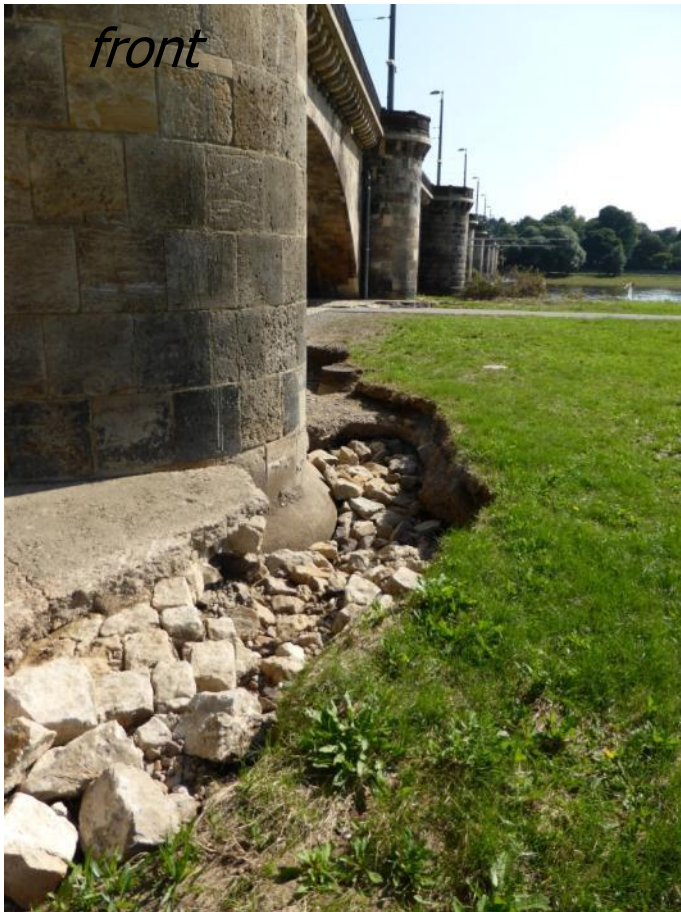
# Dresden – erosion

unexpected erosion next to the Marienbrücke in the bypass (after removing obstacles downstream)

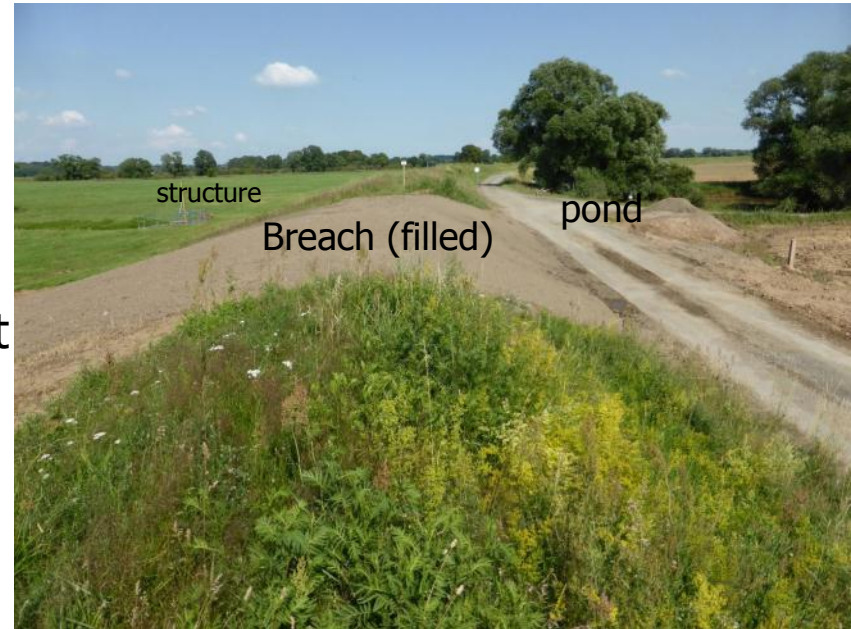
# 1. Bitterfeld – Mulde breach

- Breach on the Mulde river, one of multiple breaches
- 25 m wide breach, relatively high on slope
- Wells on the inside of sandy material, possibility of piping mechanism
- Highest water about 1m (?) below crest

- Next to small dewatering structure and small pond
- In 2002 a breach occurred in the same area, a few hundred meters upstream from the current breach.

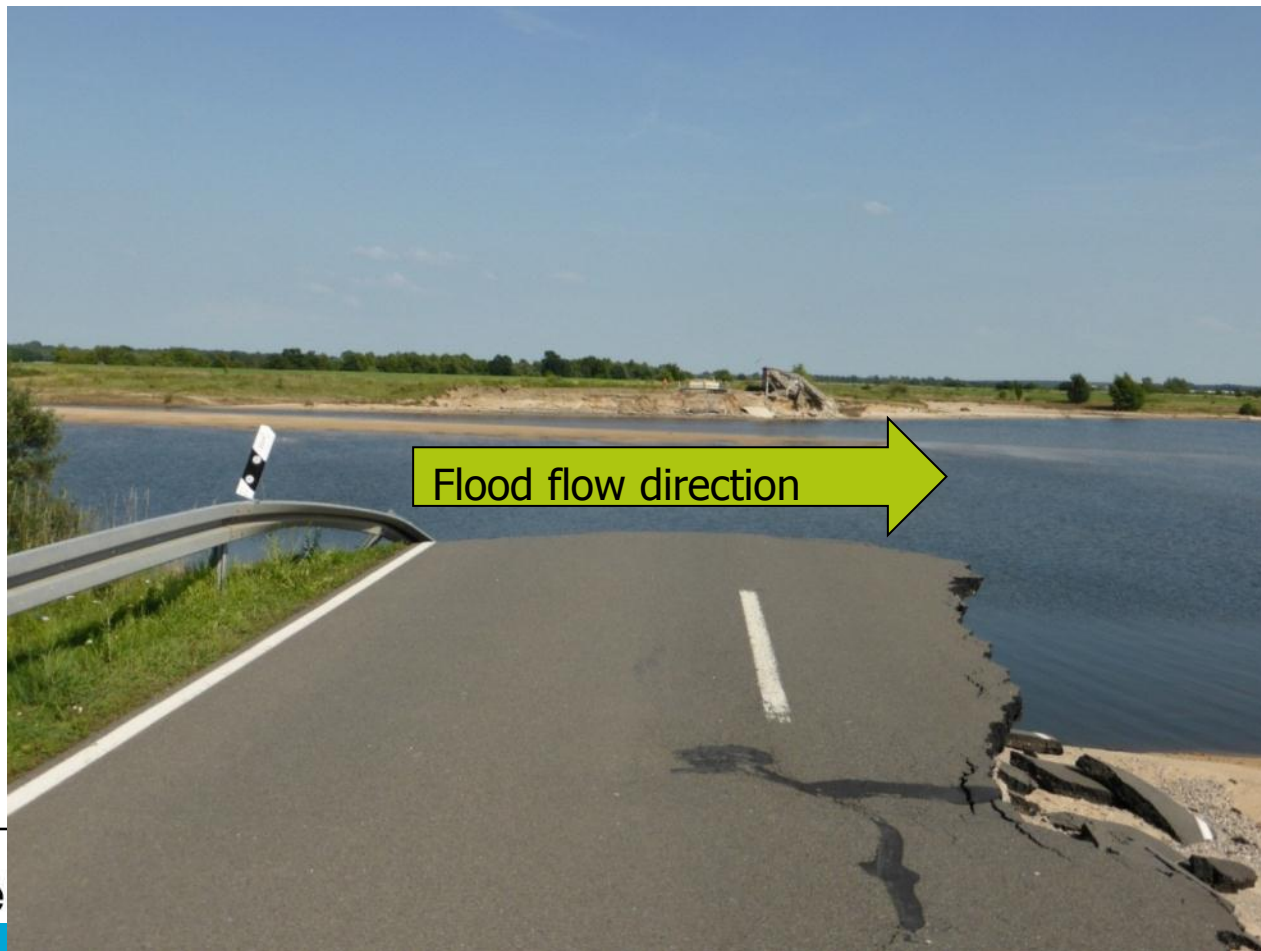
## 2. Bitterfeld - Breaches in Road Nr. S12

- Large breach in road (200m or more)
- Overtopping and erosion of road and bike path

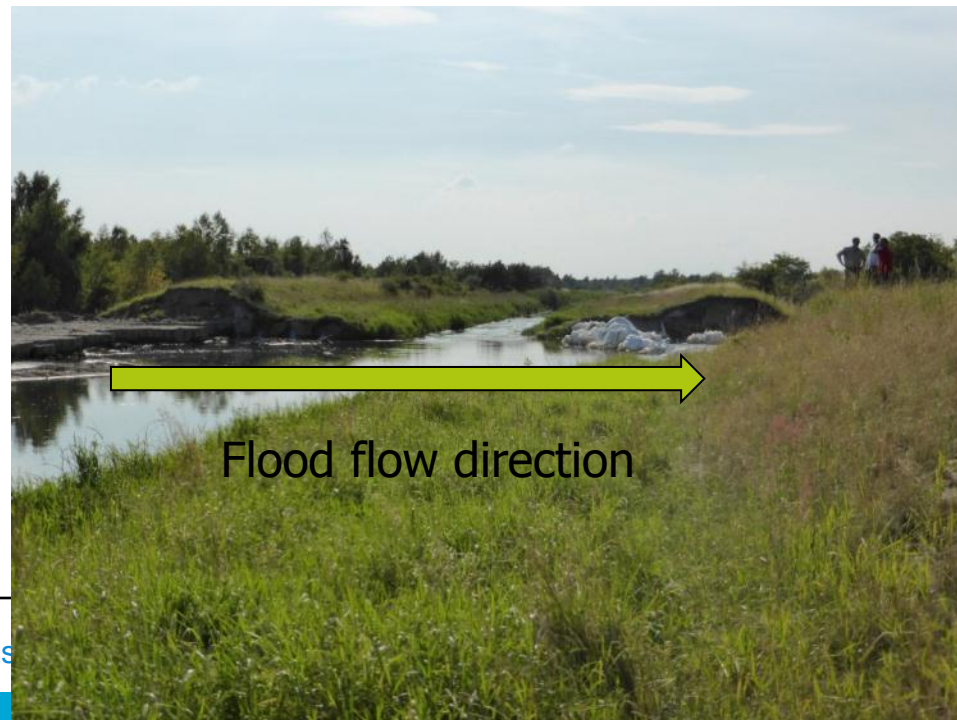
### 3. Bitterfeld, Breaches in Channel embankments between lakes

- Seelhausener Lake fills due to breach (several meters)
- Overflow and breaching of adjacent canal dikes
- Unsuccessful attempt to close breaches with bigbags by helicopters
- Cascading effects to Grosse Goitscherzee, threatening city of Bitterfeld

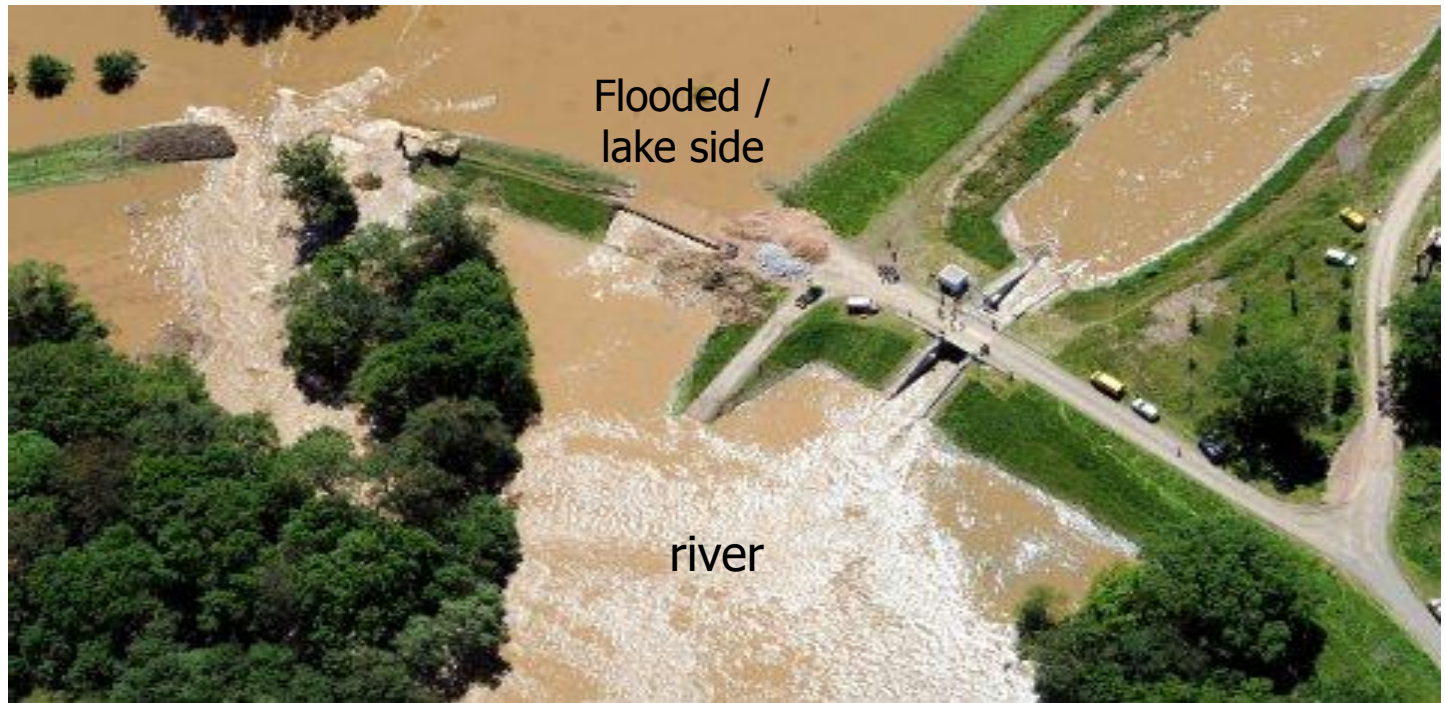
# Bitterfeld – dewatering

- Breaches created with dynamite for dewatering

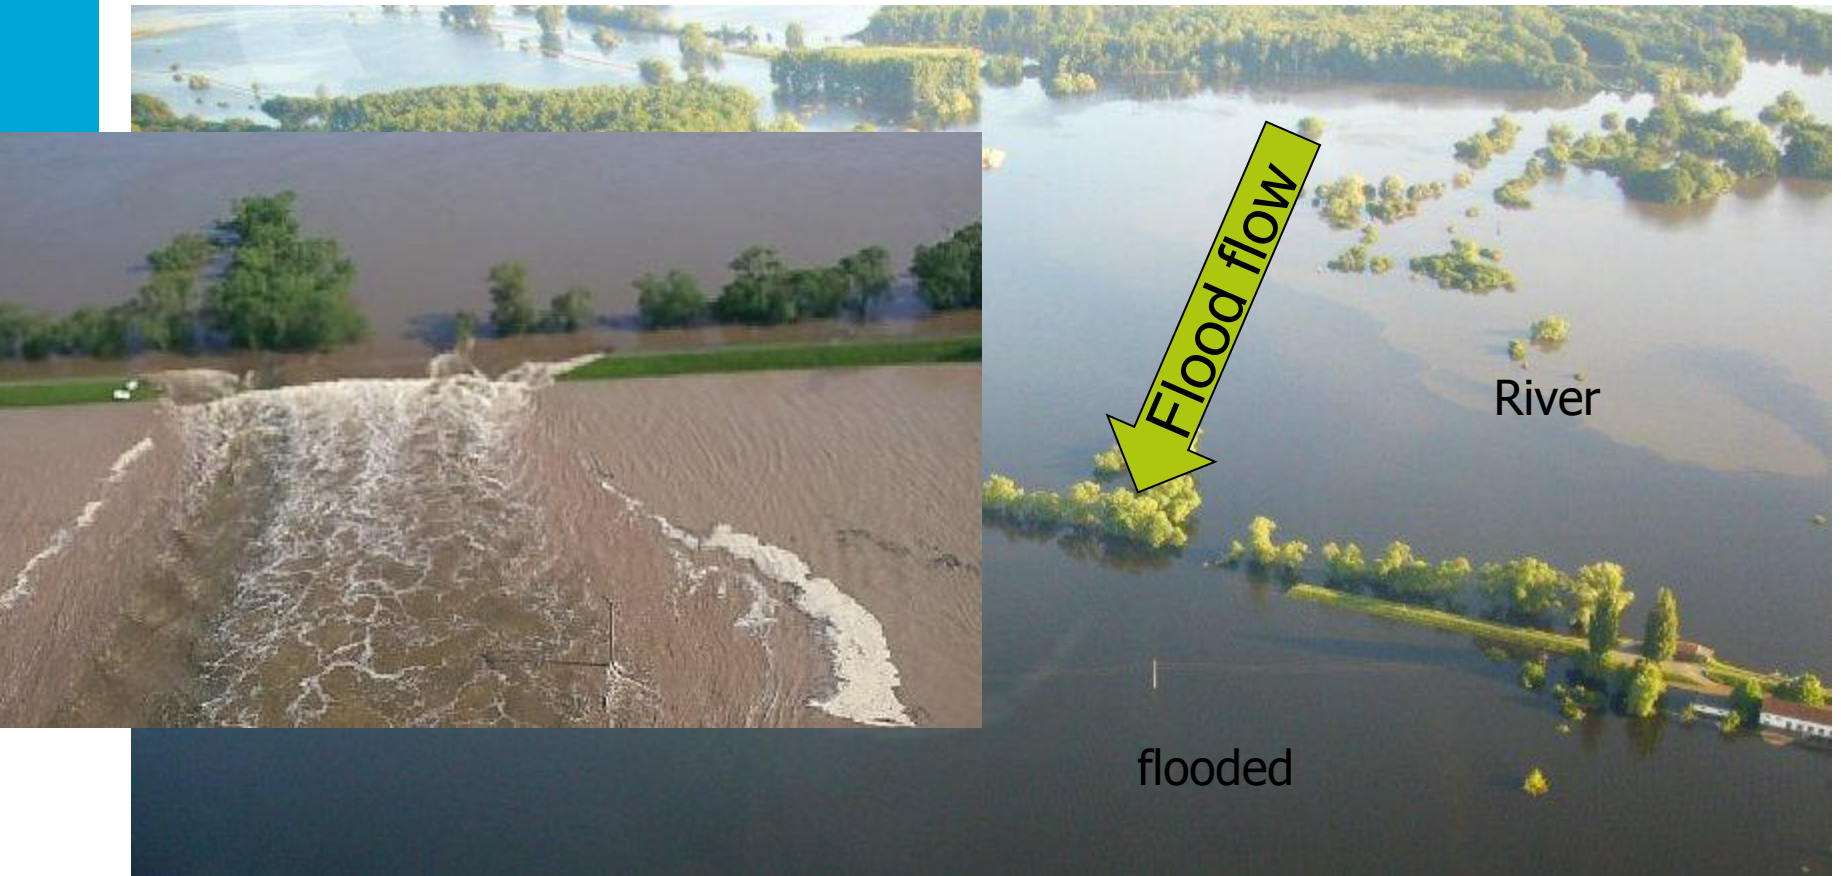
# Breitenhagen - levee breach

- Located on Saale river, water levels about 1~1.5m below crest
- Trees located in front of dike
- Dikes consisted of clay, slope about 1:2.5 to 1:3
- Slip circle occurred on inside, on landside of the road
  - Part of the dike remained for 10 hrs, then breached
  - 150m breach
- Dike reinforcement plan was available, but not yet implemented
- Emergency measures:
  - First round of bigbags delivered by helicopters
  - After that no army assistance available anymore
  - For dewatering:
    - Explosions were not effective to blow up dike
    - Breach opened by equipment for dewatering
    - Pumps installed to dewater the urban area

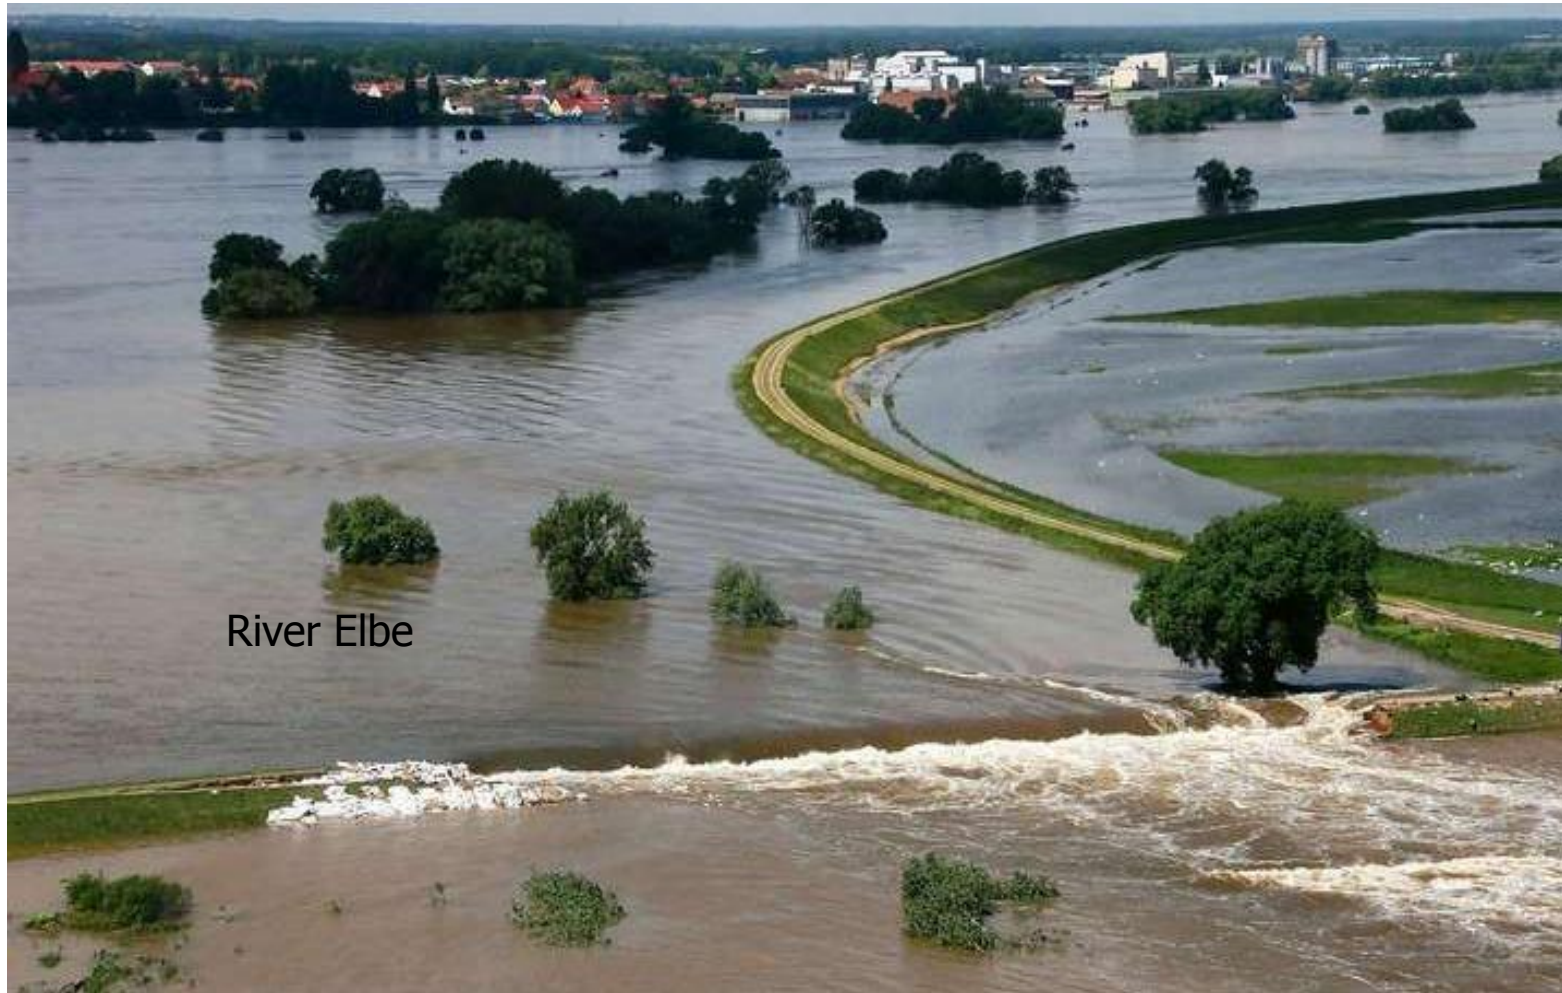
# Fischbeck (levee breach)

- breach location located at “corner”
- Western side of the Elbe,
- water level below crest (0.2m ~ 0.4m)
- dike: about 5m high, moderate/steep slope (about 1:3?), no berm
- dike body: clayey sand (sandy clay in lower part)

- cracks in crown, stage-wise settlement of the inner slope
- heavy flood fighting to prevent breach (sand bags, big packs)
- breach occurred around midnight (Sunday 9 June around 00:01 AM)
- inner slope sliding/breach occurred fast (10 ~ 20s)
- initial width 50m, growth to 100m within hours, 2-3m deep scour hole
- estimated inflow up to 700-1000 m<sup>3</sup>/s (different figures in BfG report)
- Water was within town of Fischbeck (~ 2km) within 5 minutes
- Fischbeck had been evacuated previously
- flooding extended in a wide area (up to the Havel river, tens of km)

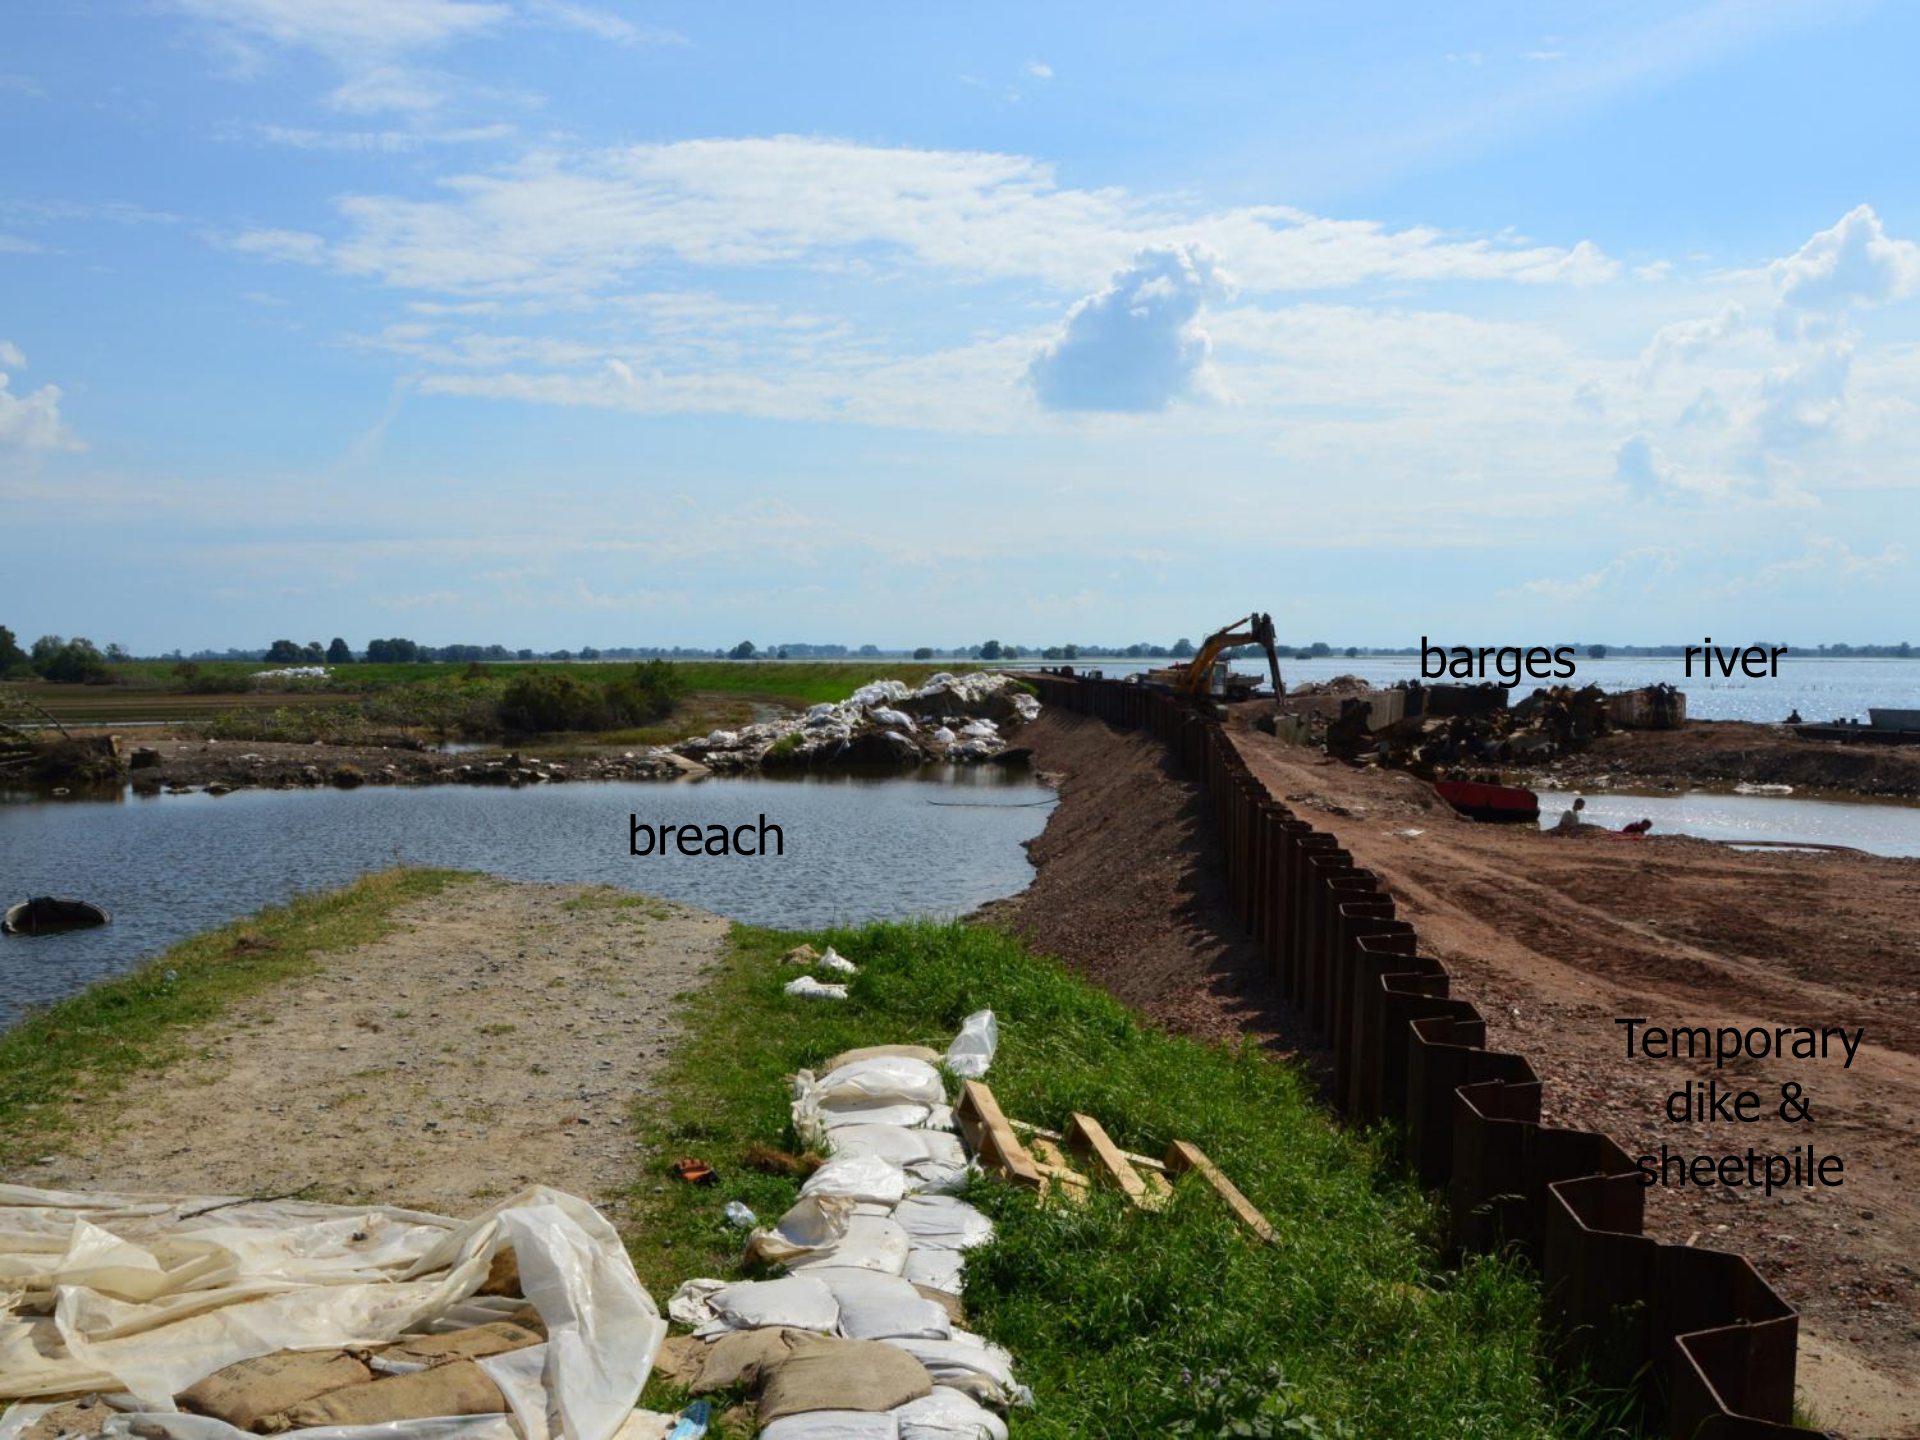
breach

barges

river

Temporary  
dike &  
sheetpile

- Three barges sunk in front of the breach using explosives
- inflow reduced significantly
- breach finally closed when water was levelled out
- Temporary flood defence:
  - Sheet pile in the breach (8 ~ 11m)
  - Earthen dike / roadway in front
  - Ships are being removed, new dike will follow different alignment

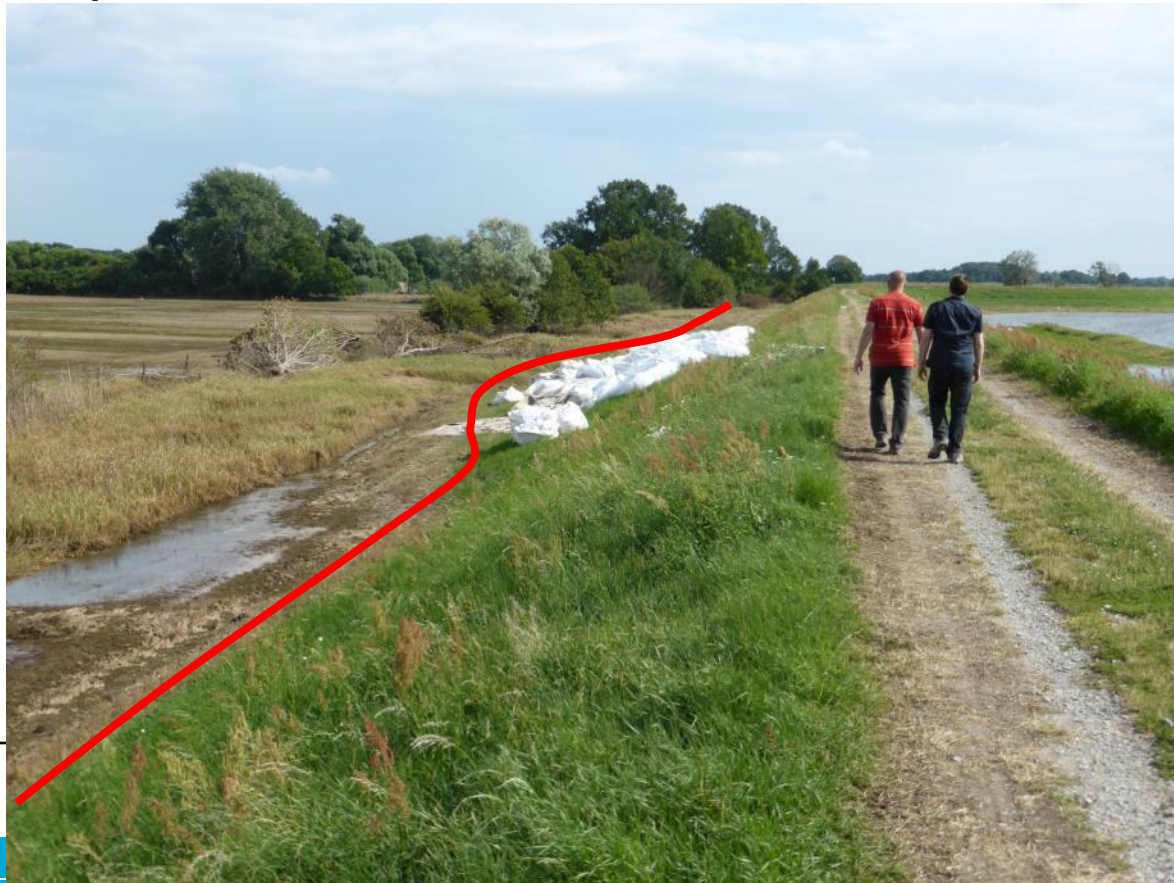
# Fischbeck - local instability

- Few hundred meter from breach site
- Seems initiation of slip circle over about 25 ~ 30m
- Sheet pile in dike and bigbags on slope implemented as emergency measures
