*The paper was published in the proceedings of the 7th International Symposium on Geotechnical Safety and Risk (ISGSR 2019) and was edited by Jianye Ching, Dian-Qing Li and Jie Zhang. The conference was held in Taipei, Taiwan 11-13 December 2019.*

# Burrowing Activity of Muskrats, Nutrias and Beavers on River Levees – Damages, Consequences and Mitigation Measures

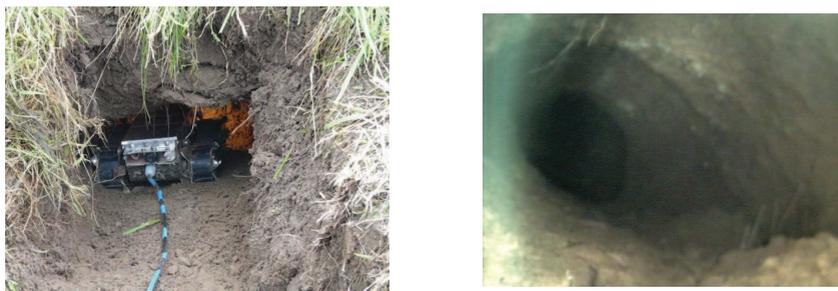
**Figure 4.** Video-camera inspection of a beaver tunnel in levee at River Oder near Neurüdnitz (Germany)

At the Technische Universität Dresden (TU Dresden) first surveys regarding levee intrusion by burrowing animals started in 2012 by means of a video-camera inspection (Fig. 4) of a beaver tunnel in a river levee, which was discovered shortly after a flood event. The tunnel entrance was located about 1 m below the maximum flood water level. Showing a mild upward gradient, the tunnel with a diameter of about 0,3-0,4 m reached about 3m into the levee ending in a den with a diameter of about 1 m. In order to quantify dimensions and shapes of such beaver tunnels in more detail, similar inspections are planned for 2019 using (rotating) laser scanning technology.
