Transient Seepage Through Levees and the Influence of Roots and Animal Burrows

Ph.D., [Civil and Environmental Engineering](#) [UC Berkeley](#)

Transient Seepage Through Levees and the Influence of Roots and
Animal Burrows

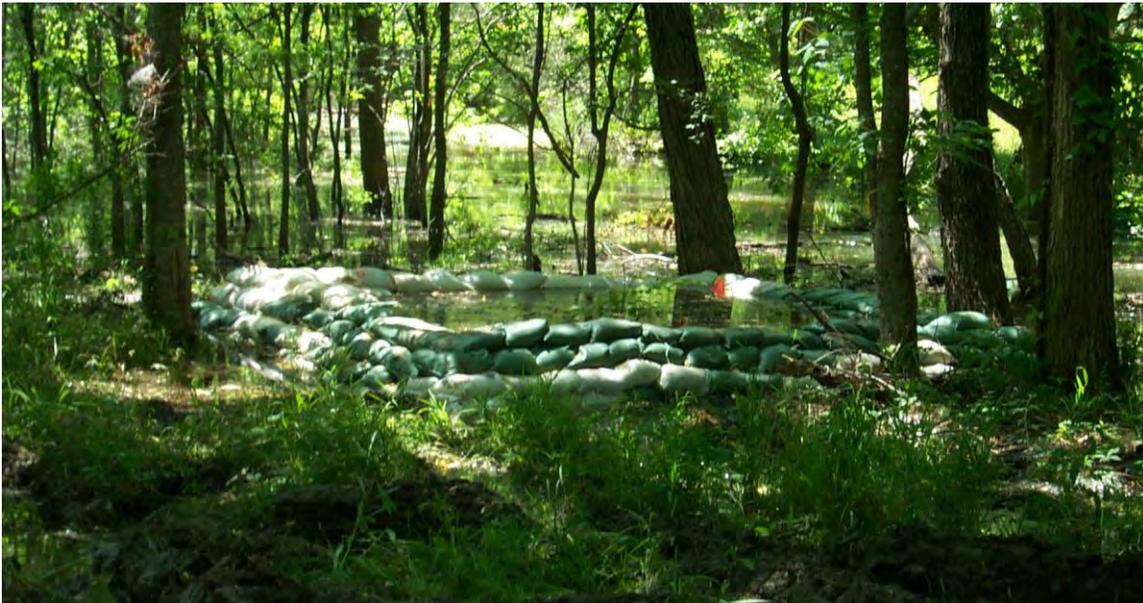
Figure 2-1. Sand boil. Image from USACE (2011a)

formation of volcano-like features, widely known as sand boils (Figure 2-1). This phenomenon occurs when coarse-grained particles are dragged by the water and carried to the surface by the fast flowing water beneath the levee toe and is referred to as piping. Piping ultimately produces voids (or pipes) in the sand under or within the levee, beginning at the mouth of the sand boil downstream of the levee toe and extending upstream a certain distance.

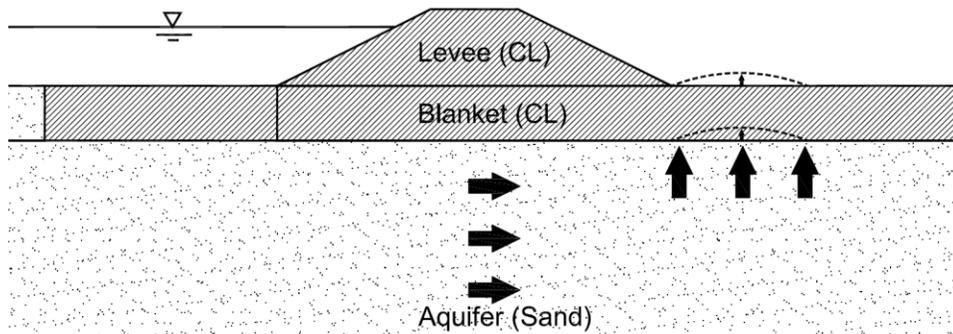
Figure 2- 2. Schematic diagram showing heave mechanism

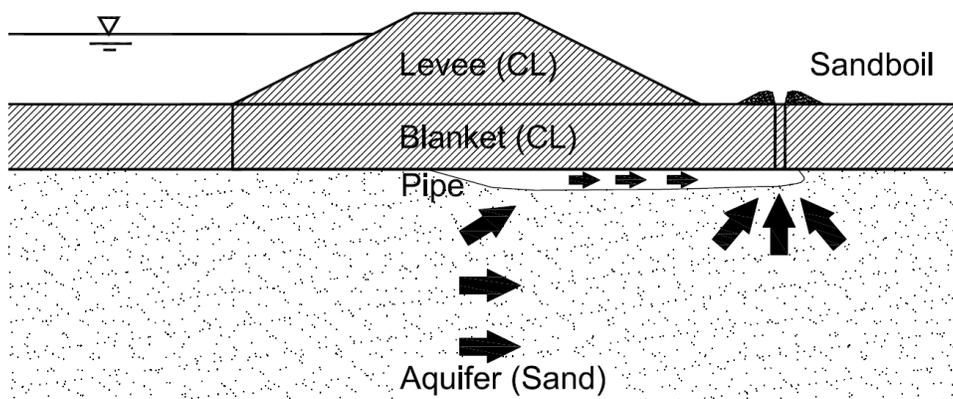
Figure 2-3. Piping mechanism

In addition to established flow regime, piping susceptibility is also a function of geometry of the subsurface layers and material properties. A typical subsurface profile beneath a levee consists of a fine-grained top layer, generally deposited over long periods of time as fines settled after high flows overtopped existing levees and left low energy clay and silt deposits atop coarser alluvial fans. Alternatively, this top layer may have been placed as part of a reclamation or engineering project. If this fine-grained top (blanket) layer is present, heave and cracking of the blanket (Figure 2- 2) is necessary to initiate sand boils and piping (Figure 2-3), unless open paths are present from penetrations, ditches, decomposed roots or animal burrows.

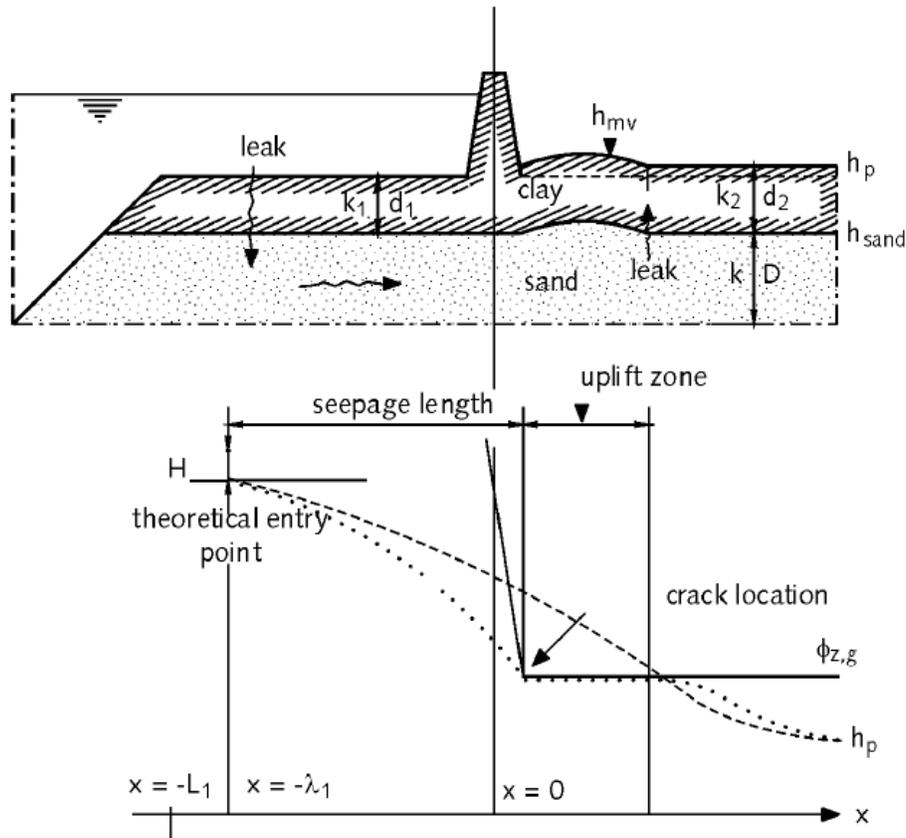
Figure 2-4. Calculation of heave potential (TAW, 1999)

Where i is the heave gradient, h_o is the difference between the hydraulic head at the bottom of the blanket and the elevation of the ground surface near the levee toe (residual head), and z is the thickness of the blanket. A similar estimate is provided by TAW (1998) for Dutch levees (Figure 2-4) and was employed in the WATEX software (Deltares, 1999) developed for the computation of the flow field beneath the blanket.

Along the h_{sand} surface on Figure 2-4 the weight of the blanket layer works vertically down, and is counteracted by the water pressure from the aquifer layer. Equilibrium is reached when:

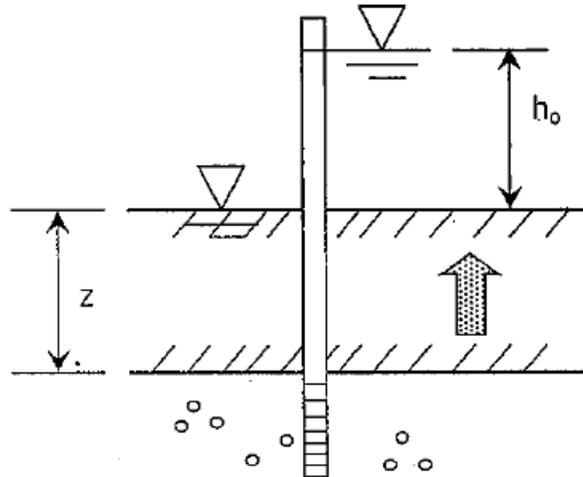
Figure 2-5. Estimation of heave gradient (USACE, 2003)

Where d is the thickness of the blanket layer. Similarly, the USACE defines heave potential in terms of a heave gradient (Figure 2-5), as the ratio between the residual head (h_o) and the thickness of the blanket (z). Heave occurs when the heave gradient exceeds a critical value, often defined as:

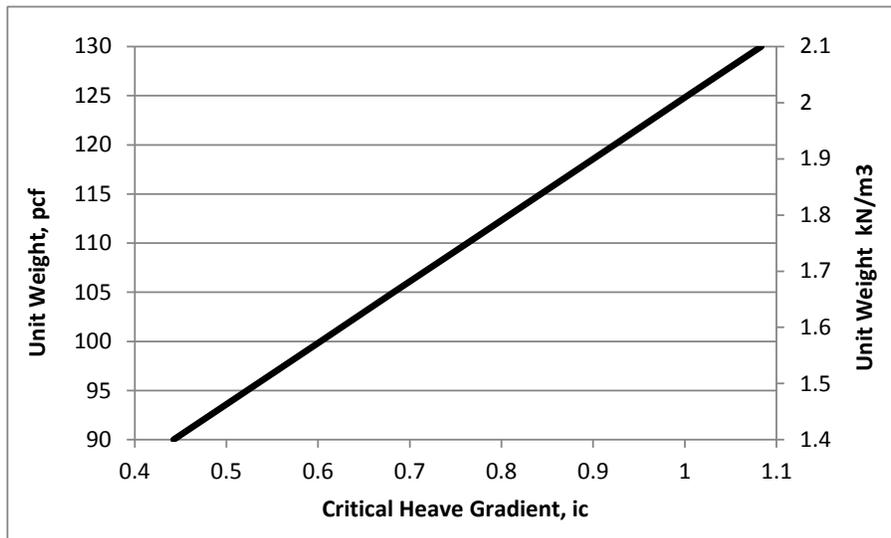
Figure 2-6. Critical gradient i_c in relation to unit weight

The critical gradient is given by the right hand side of Equation 2.10, and is a function of the saturated unit weight of the layer, assuming the density of the water is constant (Figure 2-6).

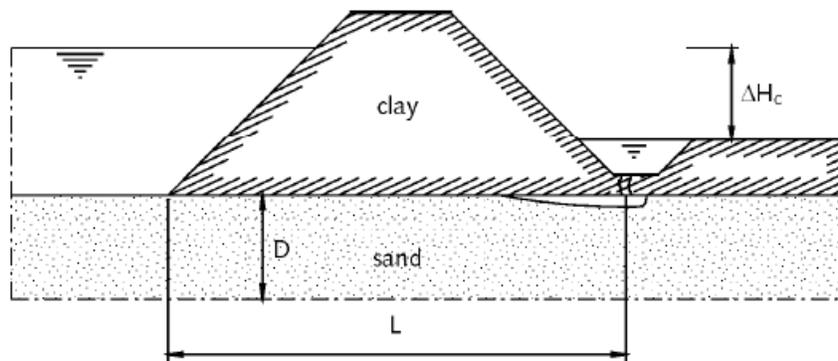
**Figure 2-7. Sellmeijer (1989) piping model (TAW, 1999)**

More recently, Sellmeijer (1989, 1993) developed a mathematical model for piping calculations based on three governing principles: (1) the groundwater (Darcy) flow through the soil, (2) water flow through the eroding pipe, and (3) a state of limit equilibrium of the particles along the bottom and sides of the pipe (Sellmeijer, 2006). With this model, a maximum head on the waterside can be estimated at which point the sand grains within the aquifer are still in equilibrium. This value of head is a function of the pipe length to levee footprint length ratio (l/L) in Figure 2-7, the hydraulic conductivity of the aquifer, the coefficient of drag of the sand particles.

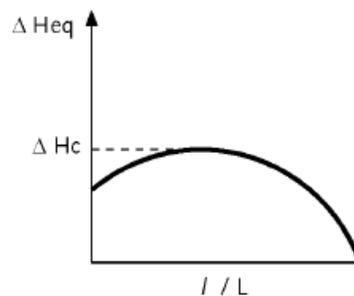
Figure 2-8. Equilibrium hydraulic head in Sellmeijer's model (TAW, 1999)

Sellmeijer's method assumes that for a head below the critical value, an erosional fissure will develop and stabilize at a certain point. The corresponding gradients decrease as the fissure or pipe lengthens, and the sand grains along the fissure offer no further resistance to drag forces. If the head increases the fissure will grow again until a new state of equilibrium is reached (Figure 2-8). Following this assumption, Sellmeijer's model was developed:

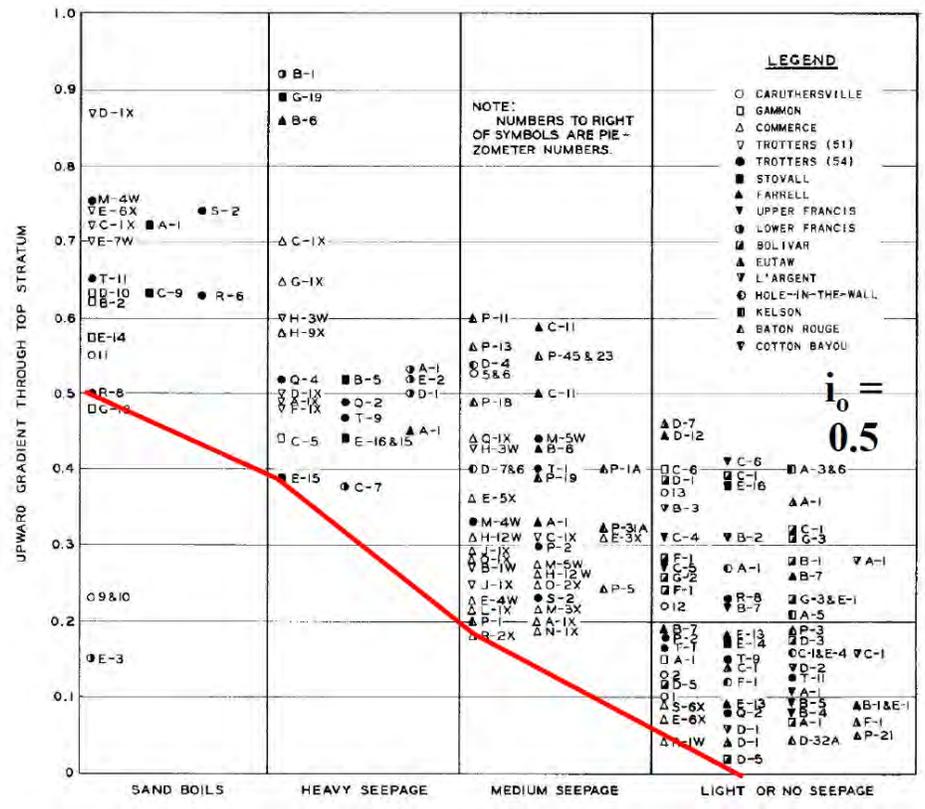
Figure 2-9. Historical review of underseepage history, USACE (1956)

Technical Letter 1110-2-569 (USACE, 2005) provides a summary of current levee design and analysis underseepage guidance, including the rationale for selection of critical gradients. Derived from the work by Turnbull and Mansur (1956) and reproduced in TM 3-424 (USACE, 1956), Figure 2-9 presents a relationship between gradient and severity of seepage for 16 sites along the Lower Mississippi River during the 1950 flood. From this figure trends have been adopted for the triggering and/or reactivation of sand boils, as follows: (a) for gradients between 0 and 0.5, 'light to no seepage' is expected; (b) for gradients between 0.2 and 0.6 'medium seepage' can result; (c) gradients between 0.4 and 0.7 'heavy seepage' can result, and (d) gradients 0.5 to 0.8 likely will result in 'sand boils'. The ranges specified in TL 1110-2-569 indicate that there is a large variation in the value of gradient that may cause sand boils to form, but the letter indicates that occurrence of sand boils under gradients of 0.5 or lower may be due to reactivation of existing boils rather than genesis of new ones. Gradients specified in this technical letter, TM 3-424 and other USACE publications are computed using the ratio of residual hydraulic head and blanket thickness in Equation 2.5, and hydraulic heads beneath the blanket are computed using *blanket theory* (USACE, 2000). Blanket theory is an analytical

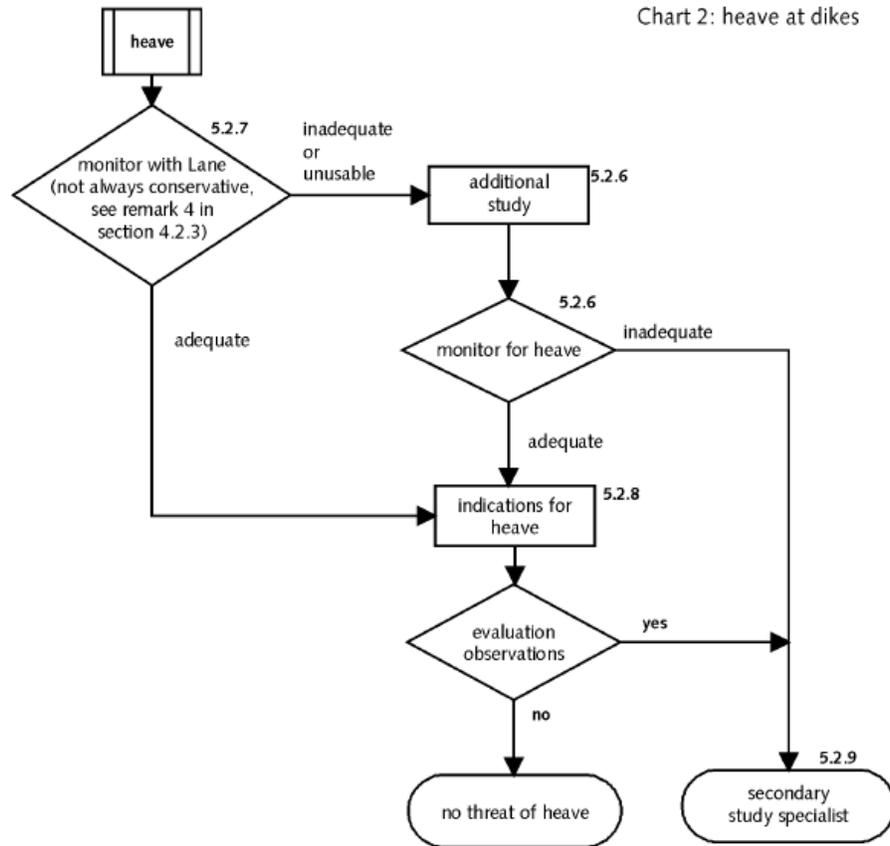
Figure 2-10. Flow chart for heave susceptibility on Dutch levees (TAW, 1999)

Common practice in the Netherlands includes the determination of piping potential using common empirical formulas developed by Bligh (1910), Lane (1934), Sellmeijer (1989), and the fragment method contained in TAW (1999), which recommends simple flow charts to decide whether a given levee is in need of heave (Figure 2-10) or piping (Figure 2-11) remediation, by applying the methodologies by Lane, Bligh and Sellmeijer in conjunction with secondary studies if needed. Similar to United States practice, the Dutch standards also require gradients be kept below 0.5.

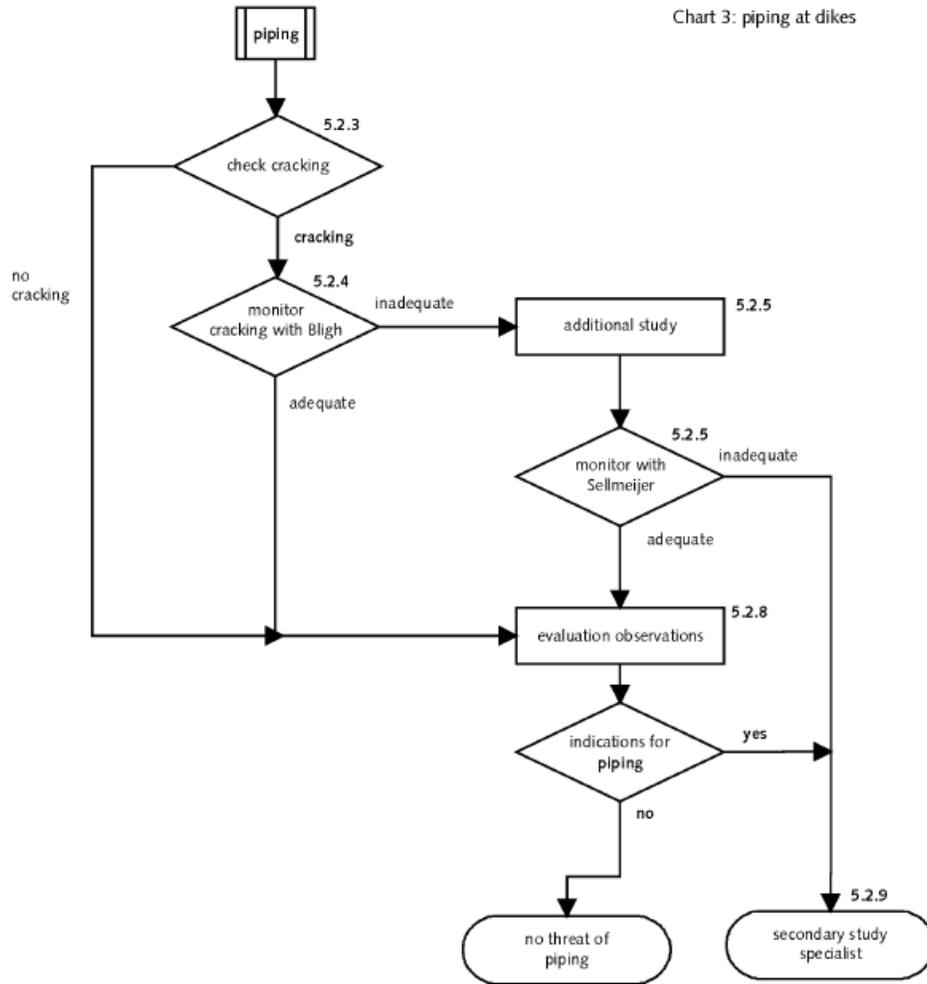
Figure 2-11. Flowchart for piping susceptibility on Dutch levees (TAW, 1999)

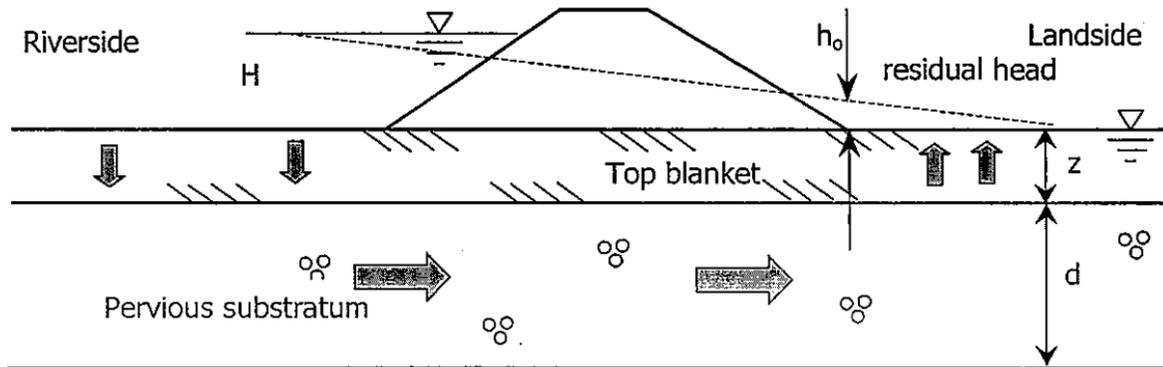
Figure 3-1. Definition of residual head used in underseepage analyses (USACE, 2003)

The relationship in Equation 3.1 yields the heave or uplift gradient acting vertically up against the resisting downward pressure exerted by the submerged unit weight of the blanket (Figure 3-1). As described in Chapter 2, these heave gradients are considered critical when above 0.7 to 0.8 (USACE, 2003), but depending on the properties of the surficial clay layer this critical value can be significantly lower.

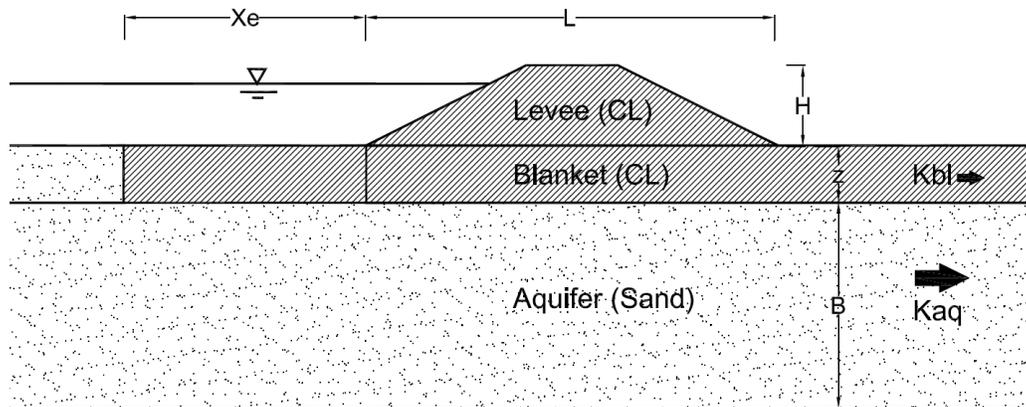
Figure 3-2. Cross section used for transient models

A typical river levee cross section was used for the analyses (Figure 3-2), consisting on three main layers: (1) a compacted clay embankment, (2) a thin clay layer beneath the embankment, and (3) a thick sandy aquifer extending to the bottom of the model. The aquitard was modeled as a 'no flow' boundary beneath the sand layer. The following variables were used in the models:

The analyzed cross section (Figure 3-2) consists of a 7-meter high clayey levee embankment with landside and waterside slopes of 2:1 (Horizontal to Vertical) resting atop a clay blanket. The model extends 100 meters towards the waterside, and 500 meters towards the landside to minimize the effects of lateral boundary conditions. Element size was set to 1 meter to achieve the desired level of accuracy and to satisfy convergence and error tolerances.

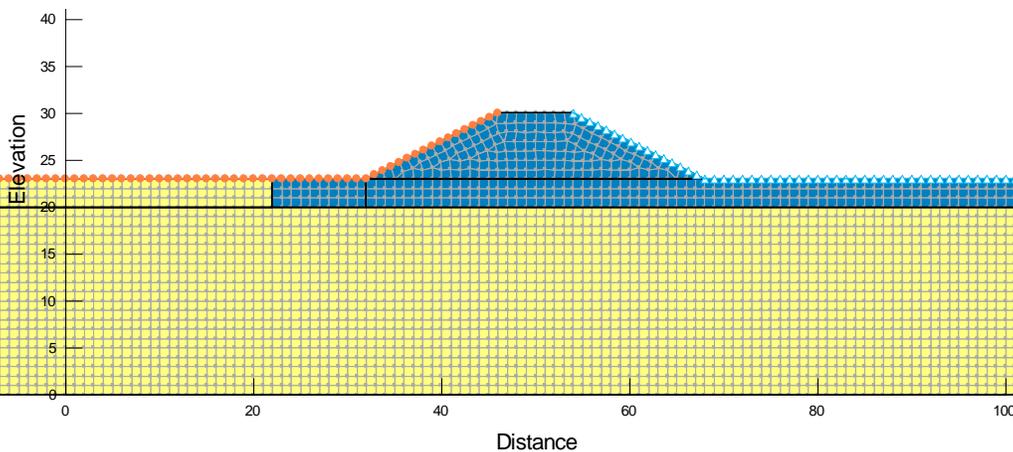
Figure 3-3. SEEP/W input section. All dimensions in meters

The distance from the waterside toe to the aquifer entrance (X_e) was varied by horizontally moving the nodes left of the blanket (blue region in Figure 3-3) to distances of 0, 10, 30, 50, 80 and 100 meters, yet for the generation of the resulting isochrones, this value was normalized by the footprint length of the levee (L) with the intent of eliminating units. Blanket thickness (z) was set at three meters and aquifer thickness (B) was set at 20 meters. An arbitrary vertical datum was set so that the bottom of the model was located at elevation 0 m. Initial conditions were created by performing a steady state calculation assuming an established phreatic surface corresponding to the elevation of the bottom of the blanket ($H=20$ m), meaning that the blanket and levee soils were unsaturated prior to the flood.

Waterside boundary conditions (orange nodes on Figure 3-3) were applied along surface nodes and the waterside (left) vertical edge to represent a sudden increase on river stage from the initial steady state conditions to a total head corresponding to one meter below the levee crest ($H=29$ m), which is a typical design freeboard. The idealized hydrograph is shown on Figure 3-4. The peak duration of the modeled flood was one of the key parameters in the increase in transient gradients; therefore a wide range of values was modeled.

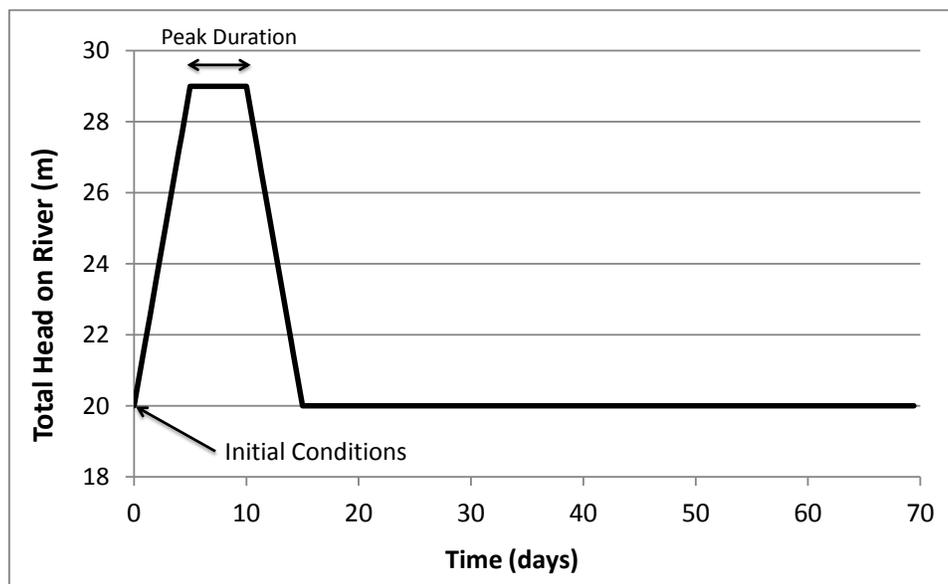
Figure 3-4. Base hydrograph used in transient analyses

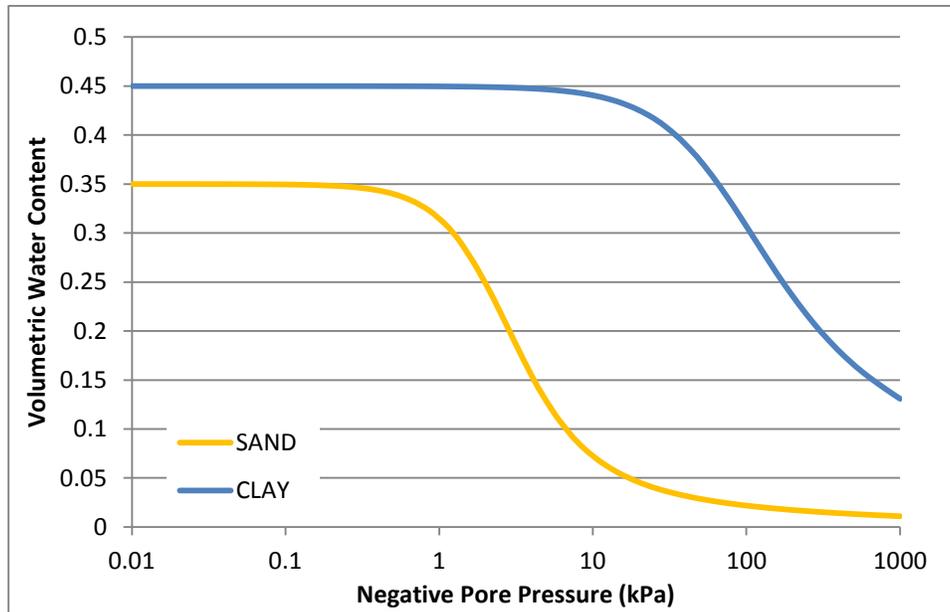
Figure 3-5. Soil Water Characteristic Curves for clayey and sandy materials in transient models

Figure 3-5 shows the resulting soil-water characteristic curves using the Van Genuchten (1980) method for the main soil types considered on the transient models. The sandy materials have a low air entry value of about 1 kPa, which allows for the rapid saturation of unsaturated portion of these materials under relatively small changes in pore pressure. Conversely, the fine grained materials have an air entry value close to 60 kPa, consistent with higher suction values and the longer time to saturate these materials.

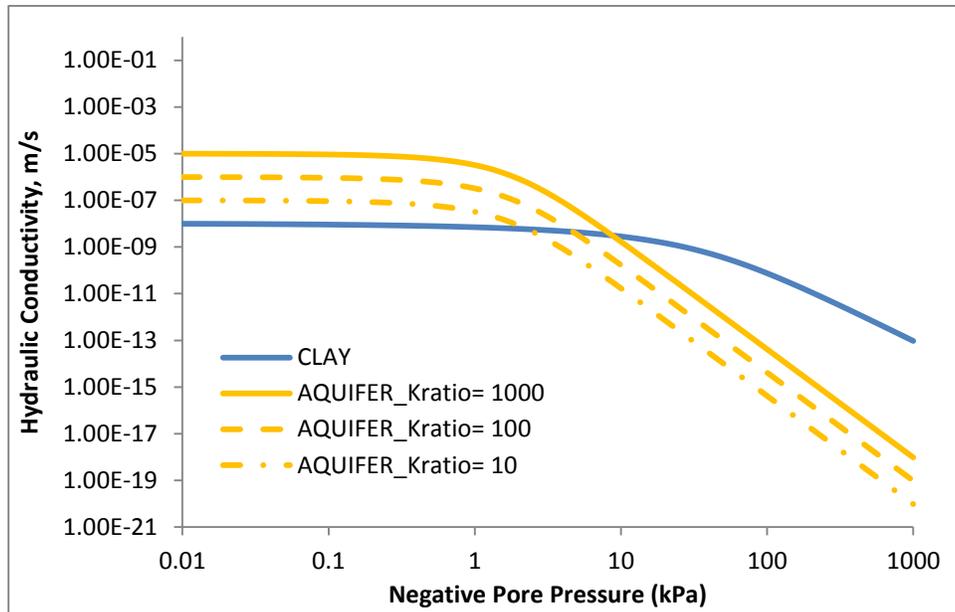
Figure 3-6. Hydraulic conductivity functions used in the transient models

The conductivity functions shown on Figure 3-6 contain values for the clay blanket and levee (blue series), and a changing function for the aquifer (orange series), to accommodate saturated hydraulic conductivity ratios (K_{aq}/K_{bl}) of 1,000, 100 and 10. A set of isochrones was developed using each one of these conductivity ratios.

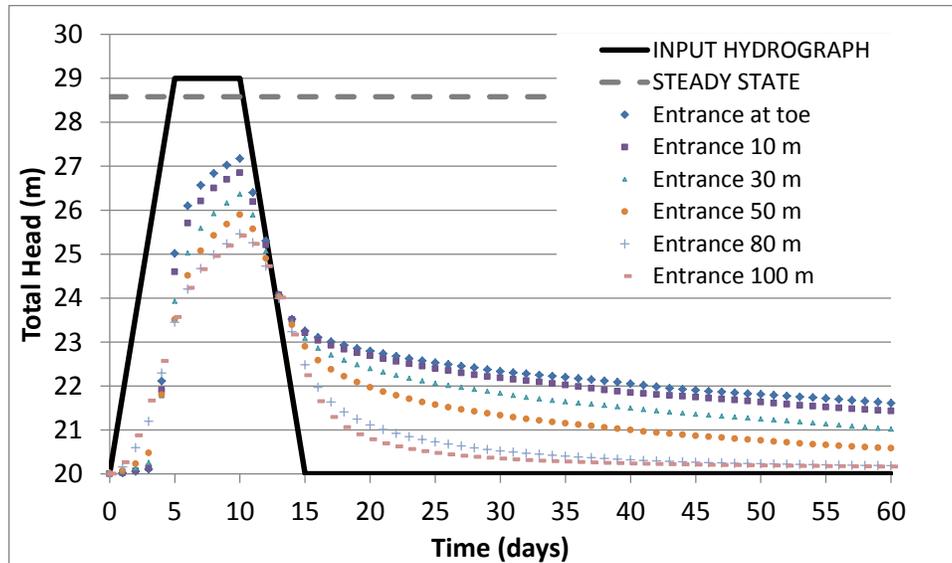
Figure 3-7. Example of evolution of total heads beneath clay blanket, $X_e/L=0$, $K_{aq}/K_{bl}=1,000$, peak duration= 5 days

The analyses were used to obtain a time series of total heads at a node beneath the base of the blanket, aligned vertically with the landside levee toe. This value was then compared the pore pressure obtained by performing a steady state calculation using the peak value from the input hydrograph. Figure 3-7 shows the evolution of heads for the case of a five day peak storm and a conductivity ratio of 1,000 and varying length of waterside blanket. For this case, computed total heads range between 95% and 88% of the steady state values for the cases of 'entrance at toe' ($X_e/L=0$) and 'entrance 100 m' ($X_e/L>3$), respectively. Figure 3-8 shows steady-state total head contours for the case of $X_e/L=0$ and $K_{aq}/K_{bl}=1,000$, showing essentially no head drop across the aquifer and a significant head differential across the fine-grained blanket, indicative of very high steady-state heave or uplift gradients. Using Equation 3.1 results in a steady state heave gradient of 1.84.

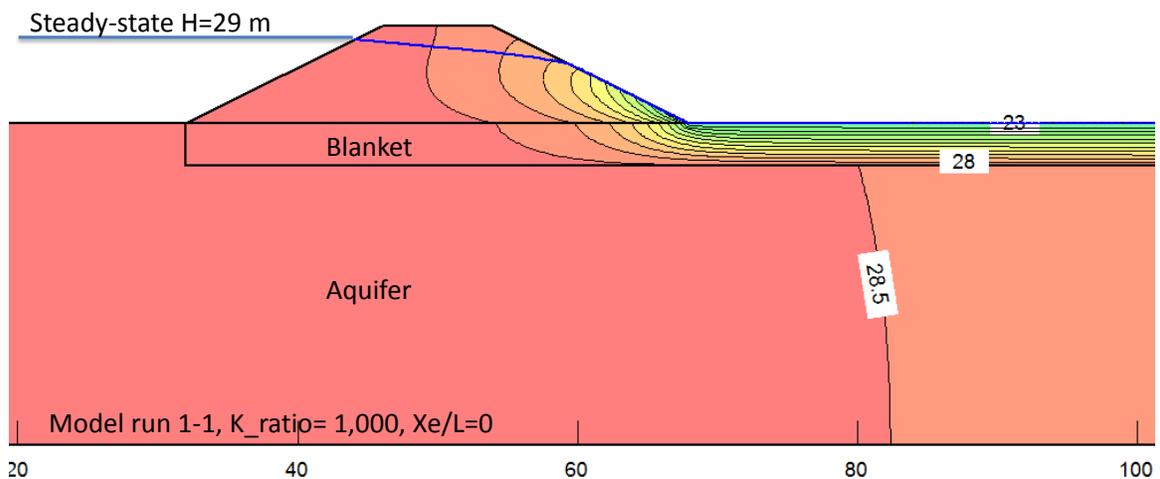
Figure 3-8. Steady-state base case $X_e/L=0$, $K_{aq}/K_{bl}=1,000$

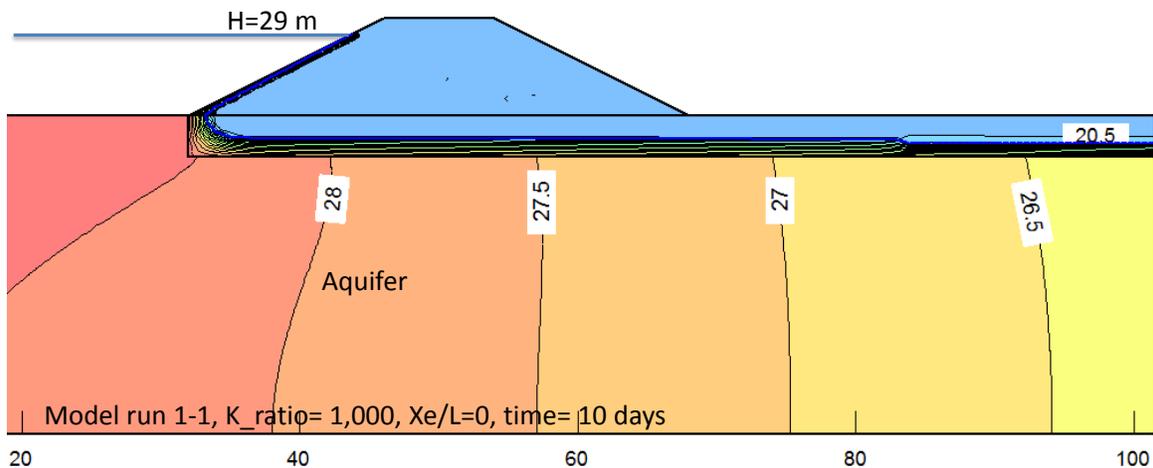
Figure 3-9. Transient head contours, $X_e/L=0$, $K_aq/K_{bl}=0$, $time=10$ days

The results of the transient analysis yield slightly smaller total heads beneath the blanket, approximately 1 meter less than the steady state condition near the landside toe (Figure 3-9), and while the heads are smaller than the steady-state case, they are approximately 95% of the steady state value, which is equivalent to a heave gradient of 1.77, still significantly larger than the critical gradient for heave. The head contours shown on Figure 3-9 indicate that the levee and blanket layers have not reached saturation during the duration of the peak, as evidenced by the tightly arranged head contours near the bottom of the blanket and waterside slope, yet the aquifer is pervious enough to allow the development of critical gradients and heave potential.

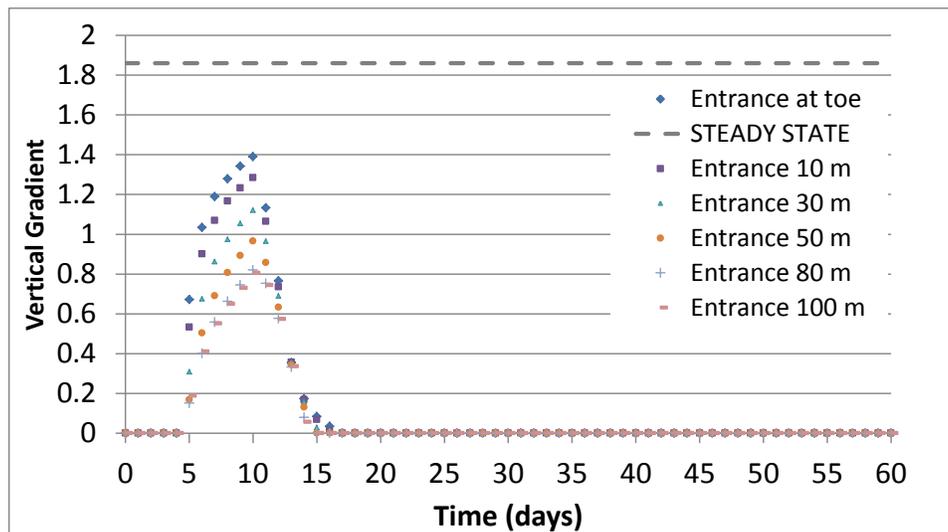
Figure 3-10 shows the time histories of gradients for the case mentioned before. Using the maximum value of total head reported in the time history for each analysis case, a normalized heave gradient was computed by dividing the transient gradient by the corresponding steady-state value.

Figure 3-10. Example of time series of heave gradients, $X_e/L=0$, $K_aq/K_{bl}=1,000$, peak duration= 5 days

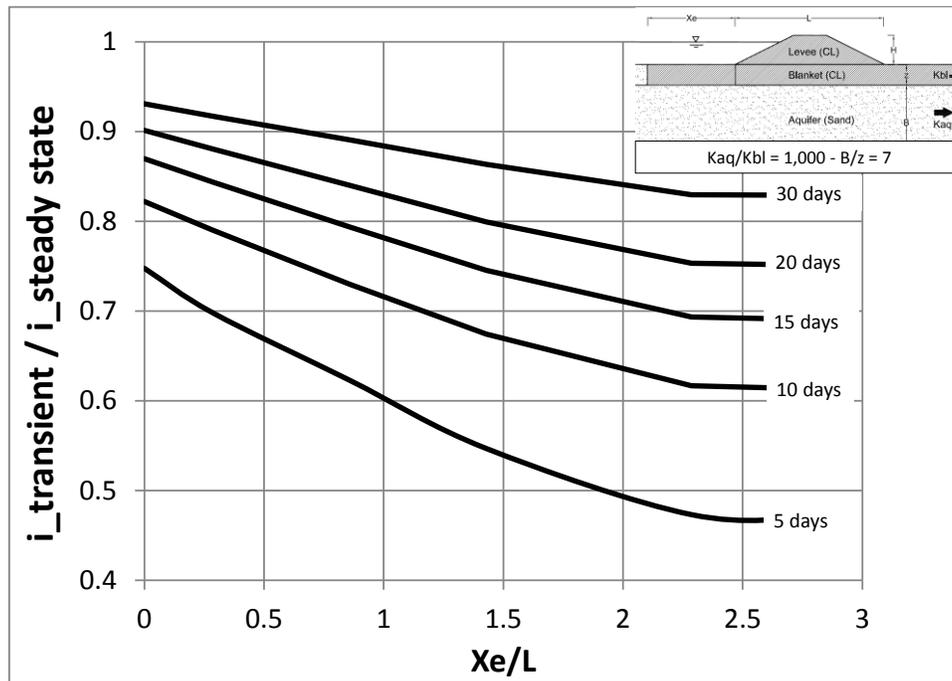
Figure 3-11 shows the isochrones for the case of a hydraulic conductivity ratio of 1,000. The plot indicates that after a X_e/L value larger than 2.5 to 3.0, the ratio of transient to steady-state

heave gradient stabilizes, and decreases as a function of increasing X_e/L and decreasing storm duration.

Figure 3-11. Isochrones for $K_{aq}/K_{bl}=1,000$

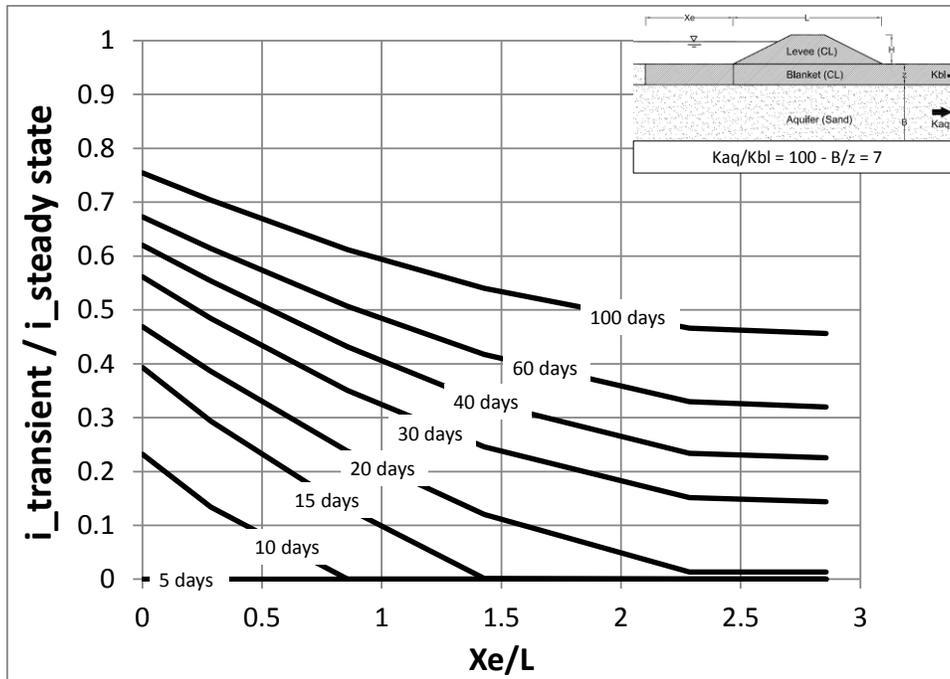
Isochrones for a hydraulic conductivity ratio of 100, obtained by decreasing the conductivity of the permeable layer by a factor of 10, are shown on Figure 3-12. The 10-fold decrease in hydraulic conductivity of the aquifer layer yields a slower response of the aquifer layer and higher total head losses.

Figure 3-12. Isochrones for $K_{aq}/K_{bl}=100$

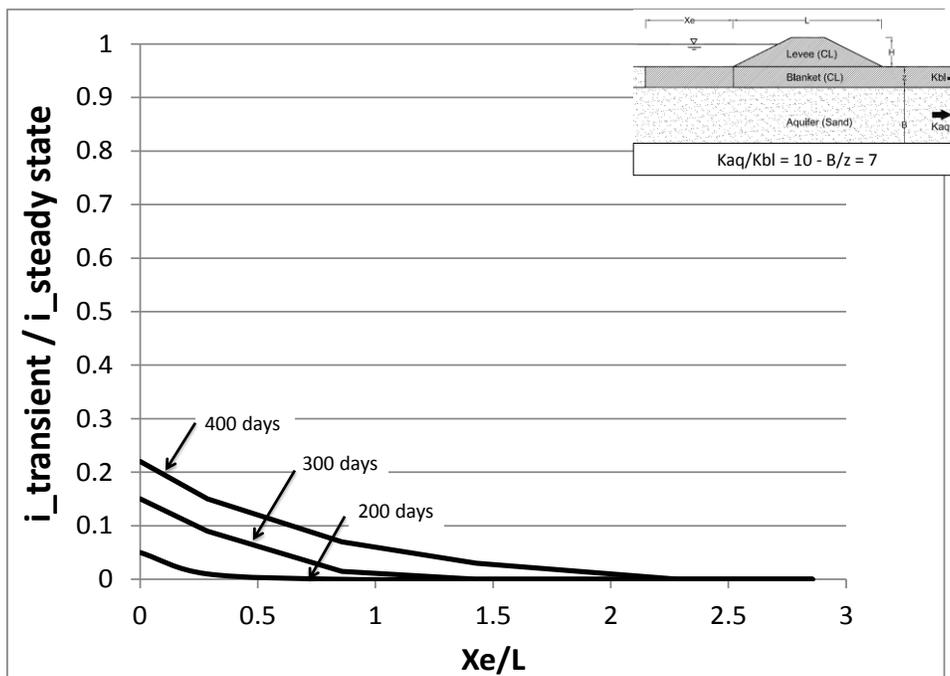
Isochrones for a hydraulic conductivity ratio of 10 are shown on Figure 3-13. This case with this low ratio barely starts to yield any type of gradient after a flood duration larger than 100 days.

Figure 3-13. Isochrones for $K_{aq}/K_{bl}=10$

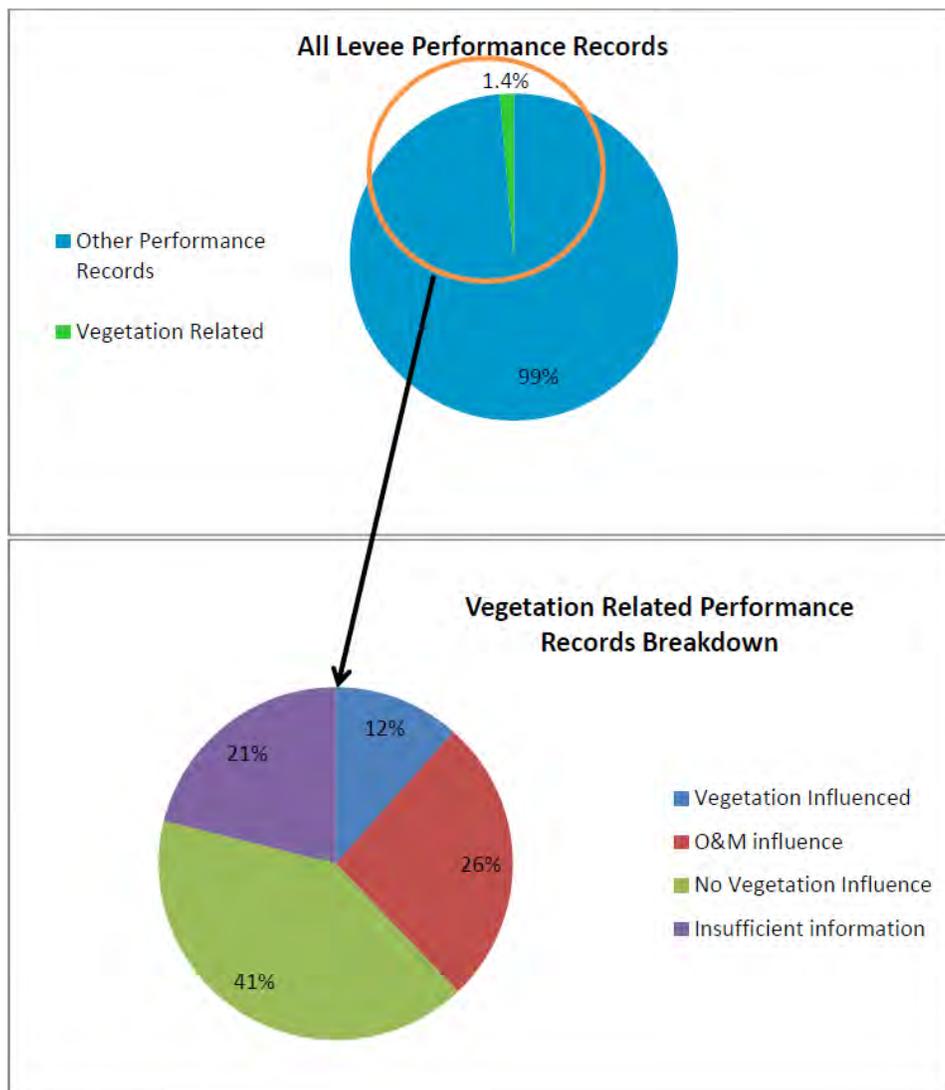
Figure 4-1. Performance records related to vegetation in California levees (URS, 2011)

The results of the URS analysis of over 10,000 records showed that 6,970 performance records contained some observations with respect to vegetation. Of these, 348 were levee breaches resulting in water flooding the protected side, but none of the records identified vegetation as an influence on the reported breaches. The remaining 6,622 records contained 95 performance reports that indicated the presence of vegetation in the vicinity of an identified performance issue (Figure 4-1). From these 95 records, 11 identified vegetation as a factor influencing performance, 25 indicated vegetation had an influence on O&M (Operation and Management),

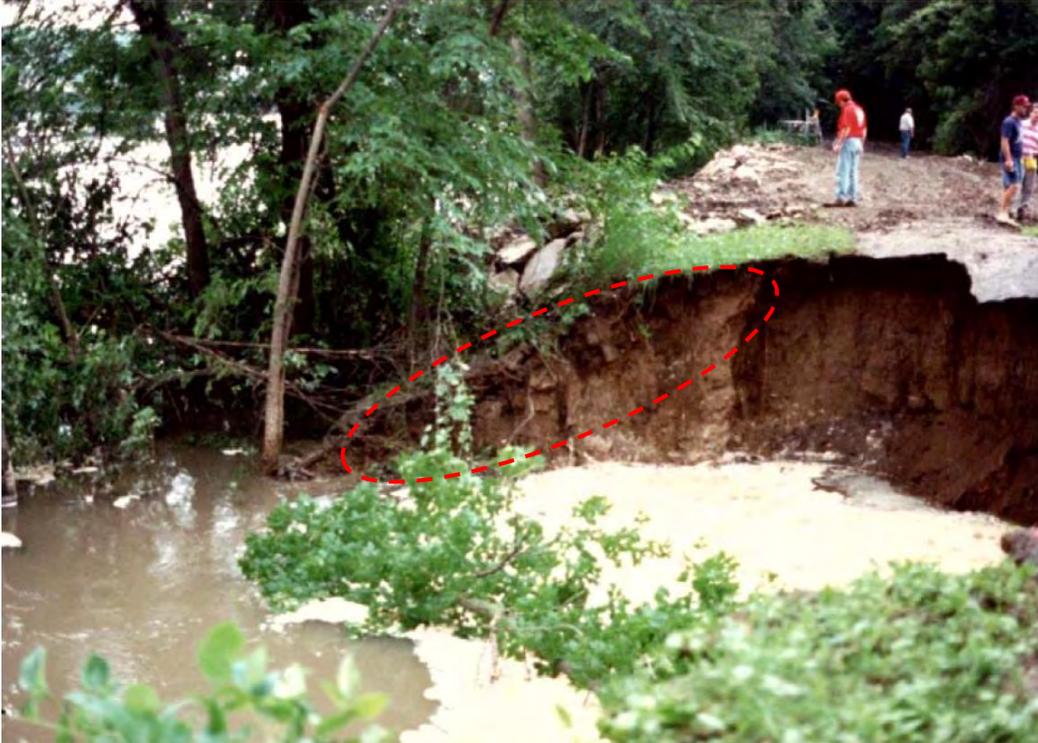
Figure 4-2. 1993 Des Moines River breach (USACE, 1993). Red oval highlights root system

The event in 1993 was reported to have crested one to two days before the breach occurred, and the breached levee was known for having been constructed with poor compaction, having no under or through seepage measures, steep slopes under constant erosion from the river and heavy tree growth (Figure 4-2 and Figure 4-3). Once the waters began to recede, the engineer in charge of the report states that *“saturated levee embankments in this reach began a catastrophic failure, with large segments of the levee material slumping into the river. Several massive root balls were observed in the area where the levee failed. Ultimately the levee slumping passed through the levee crown and into the landside of the levee...the heavy tree growth hindered levee inspections and monitoring during the flood fight as well as the remedial constructive measures that were undertaken on the landside of the levee”*. The inspection report goes on to state that *“the large trees located on these saturated slopes added to the non-stability of the levee with dead and wind loads contributing to the failure of the levee. While original construction standards on material compaction were inadequate, the failed areas of the levee revealed significant root growth throughout the levee, which likely further facilitated the saturation of the levee embankment when record river stages were occurring”*.

This last statement suggests the possibility of saturation of the levee prism enhanced by seepage paths along the roots, but no direct or specific evidence was provided. The fact that the failure occurred while the waters were receding and progressed from the waterside slope to the landside indicates that these failures may have been related to a rapid drawdown slope instability condition rather than root-driven seepage forces.

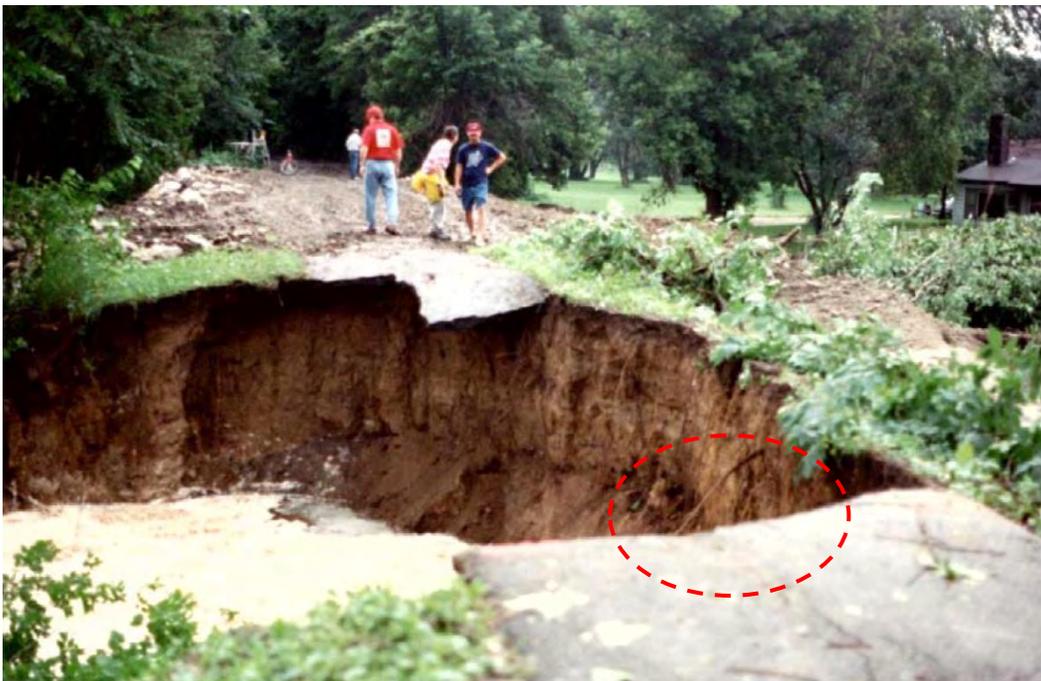
Figure 4-3. Downstream view of Des Moines River levee break (USACE, 1993). Red oval highlights root system

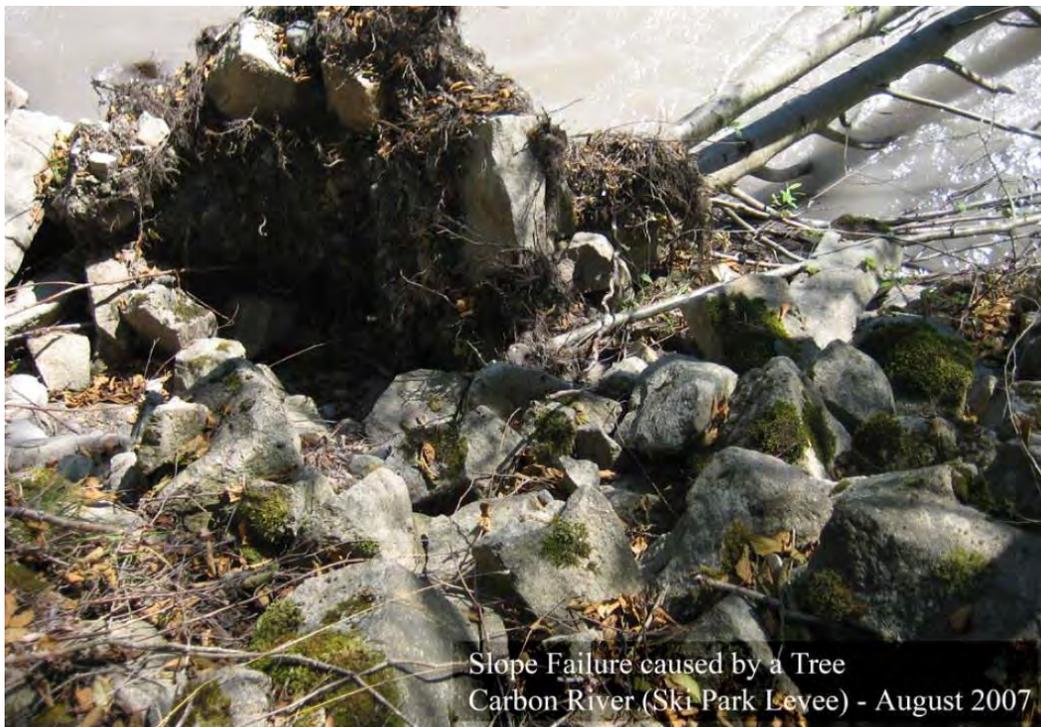
An August 2007 USACE report describes localized waterside levee slope damage near Orting, WA, after an alder tree was toppled in a windstorm and removed surficial soil and erosion armoring from the surface. No measurements of the hole left by the root system were provided, but it appears that the tree lifted a very shallow 'slab' of soil (Figure 4-4). No levee failure or distress was reported at this site.

Figure 4-4. Erosion on waterside slope after tree toppling (USACE, 2007)

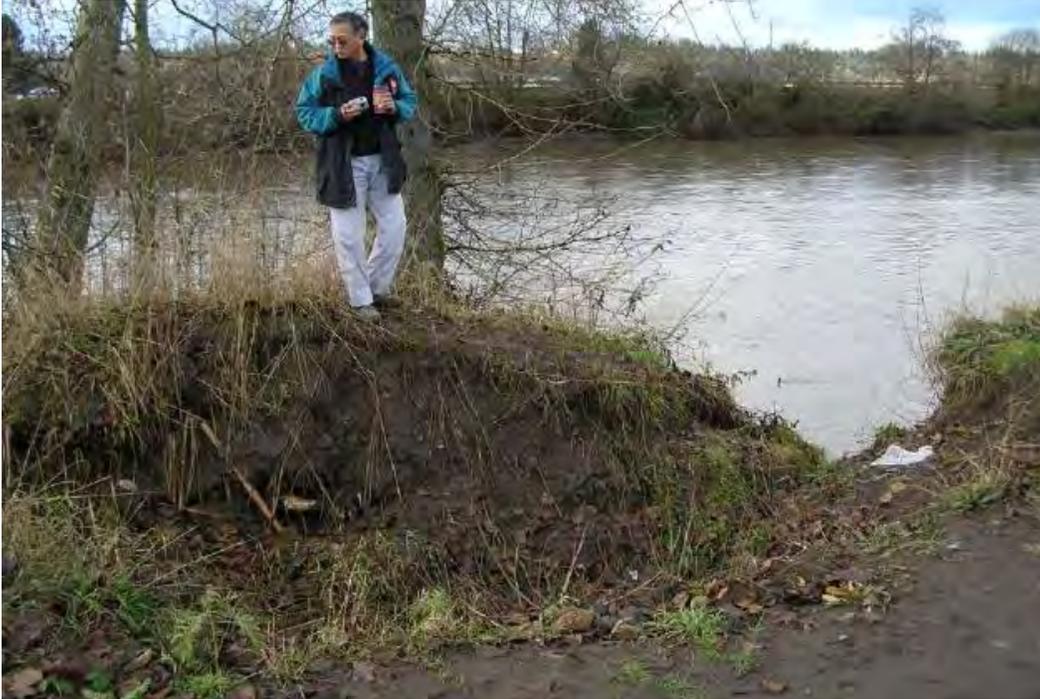
Vegetation-induced levee damage in December 2005 was reported by the USACE on the levee along the Puyallup River near Tacoma, WA. This incident report indicates that soft soil conditions, along with wind loads and river incision contributed to a cottonwood tree toppling over and removing soil from the waterside slope (Figure 4-5). No further indication of damage or reconstruction is provided in the incident report, but the report indicates that this type of occurrence is common in the area and toppled trees pull out material adjacent to the levee prism. In this case, the root ball pulled a mass of soil near the waterside toe the levee.

Figure 4-5. Cottonwood toppled on Puyallup River (WA). Image courtesy USACE

Similar to the case on the Puyallup River (Figure 4-5), in 2008 high wind caused several trees to topple and remove soil and erosion protective riprap from the waterside slope (USACE, 2008). The levee appeared to have had very little maintenance and trees and shrubs grew uncontrolled on the waterside slope (Figure 4-6). The report does not give an indication as to how deep the hole left by the root system was as the tree toppled, nor how many of these incidents occurred along the Touchet River. A failure or breach of the levee did not occur.

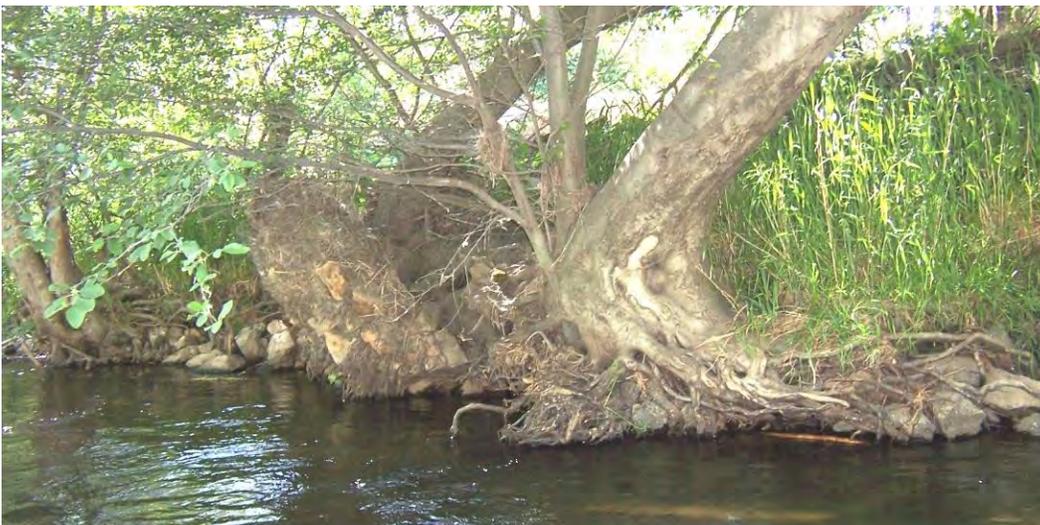
Figure 4-6. Damage on waterside toe, Touchet River (USACE, 2008)
