Transient Seepage Through Levees and the Influence of Roots and Animal Burrows

Ph.D., [Civil and Environmental Engineering](#) [UC Berkeley](#)

Transient Seepage Through Levees and the Influence of Roots and
Animal Burrows

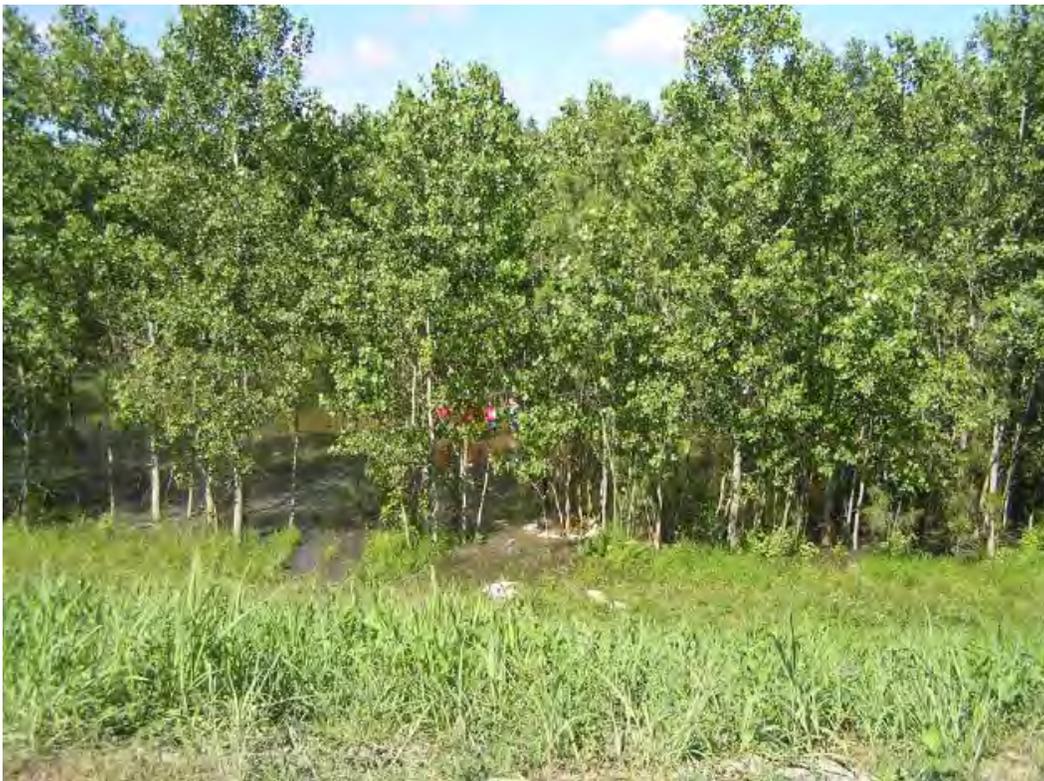
The St. Genevieve #2 levee along the Mississippi River was subjected to severe water loading during June 2008. USACE post incident inspection report provides a description of the levee distress that seems to have been related to presence of woody vegetation near the landside toe. On 28 June, 2008, several active sand boils were reported in a heavily vegetated area (Figure 4-7) which were observed to be flowing water and soil. Flood fighting activities lasted over five days, local authorities built sand bag rings around the active boils (Figure 4-8) and allowed the toe area to flood several feet to reduce the hydraulic head differential and stop the flow of material through the sand boils.

According to the incident report, the largest boil was approximately 1 meter (3 ft) in diameter and most of the boils were encountered in a low spot with a dense line of trees. After the fifth day of flood fighting some boils were still active and a 200 m (600 ft) long rock berm was placed to increase the stability of the toe area, but new sandboils developed upstream of the berm.

Figure 4-7. View of landside toe area, St. Genevieve levee distress (USACE, 2008)

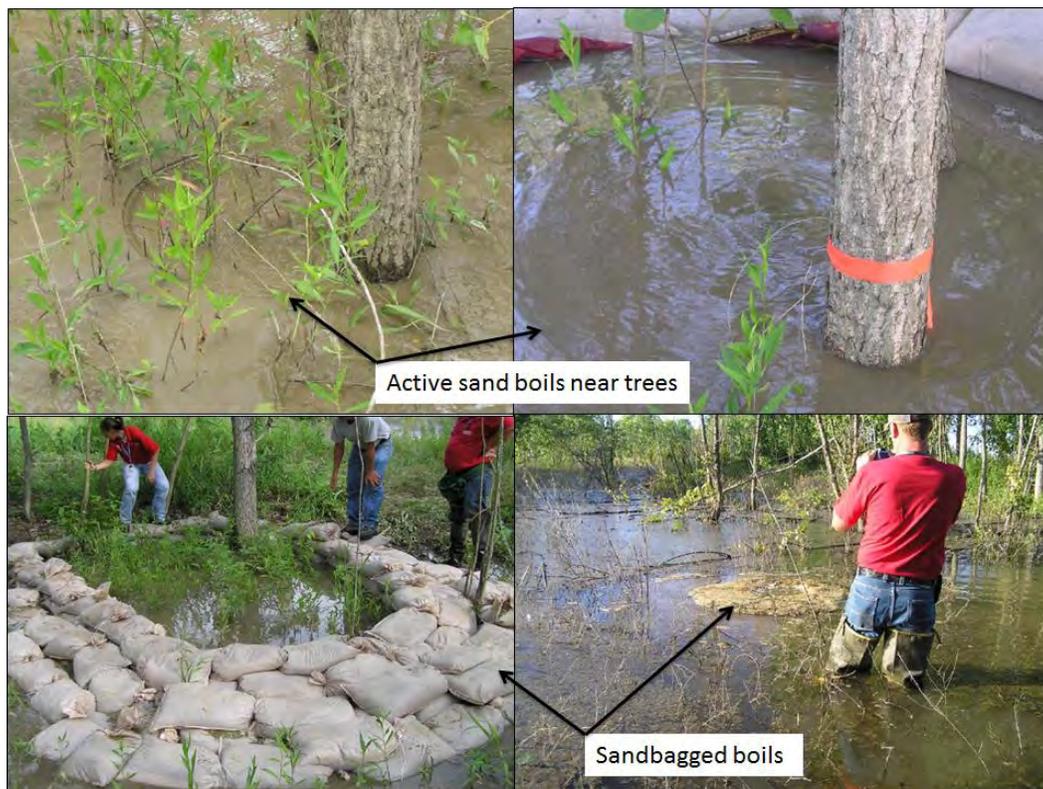
Figure 4-8. Active sand boils around trees, St. Genevieve levee distress (USACE, 2008)

No information on the levee and foundation conditions are given in the incident report, but the levees in the area along the Mississippi River in Missouri are known for their underseepage susceptibility because of relatively thin landside blankets (fine-grained soil layers). Several other sand boils were reported during the same flood event in other areas as described by Harder et al., (2009). The incident report concludes that tree roots and associated animal activity (the animal activity was not reported) likely attributed to the intensity of the seepage, and that

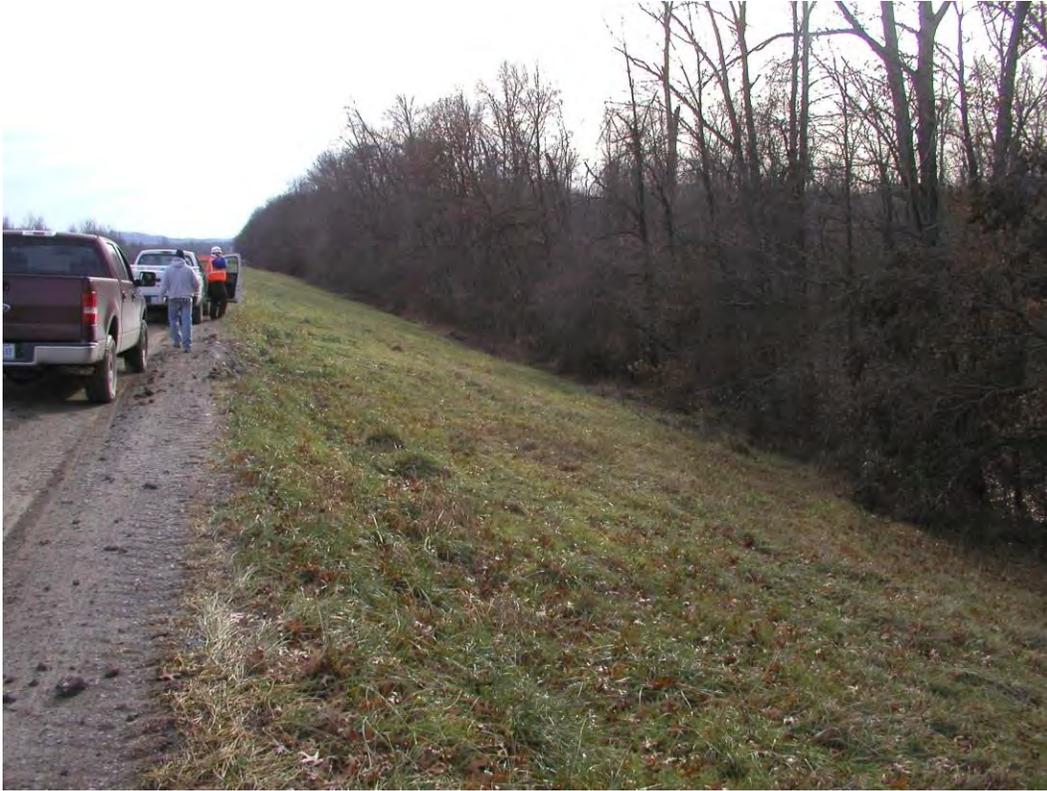
Several shallow landslides along the protected-side toe of the Grand Tower and Degognia levee in Southern Illinois occurred in 2008. At this location, trees were present along long stretches of the landside toe (Figure 4-9). Landslides appear to be a common occurrence in the area and are associated with high-plasticity clays used for embankment material and not necessarily associated with the presence of woody vegetation near the toe of the levee. The report indicates that the trees inhibited maintenance and did not allow for staging materials and equipment for repairs to be performed, but no direct relation to the observed failure was given.

Figure 4-9. Trees along landside toe. Grand Tower Levee (USACE, 2008)

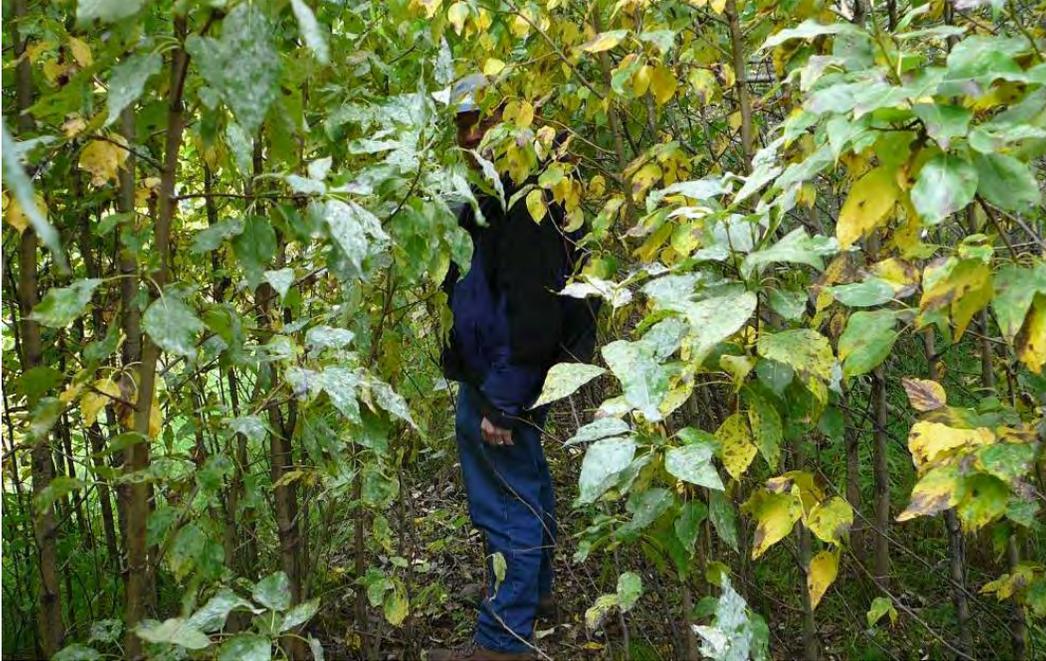
Well documented potential detrimental impact that dense woody vegetation has on levee performance is the interference with regular maintenance and inspection activities. A levee along the Kuskokwim River in Alaska was reported to be so densely vegetated that visual inspection was impossible during routine inspection in 2008 (Figure 4-10).

Figure 4-10. Dense vegetation inhibiting visual inspection along Aniak levee in Alaska (USACE, 2008)

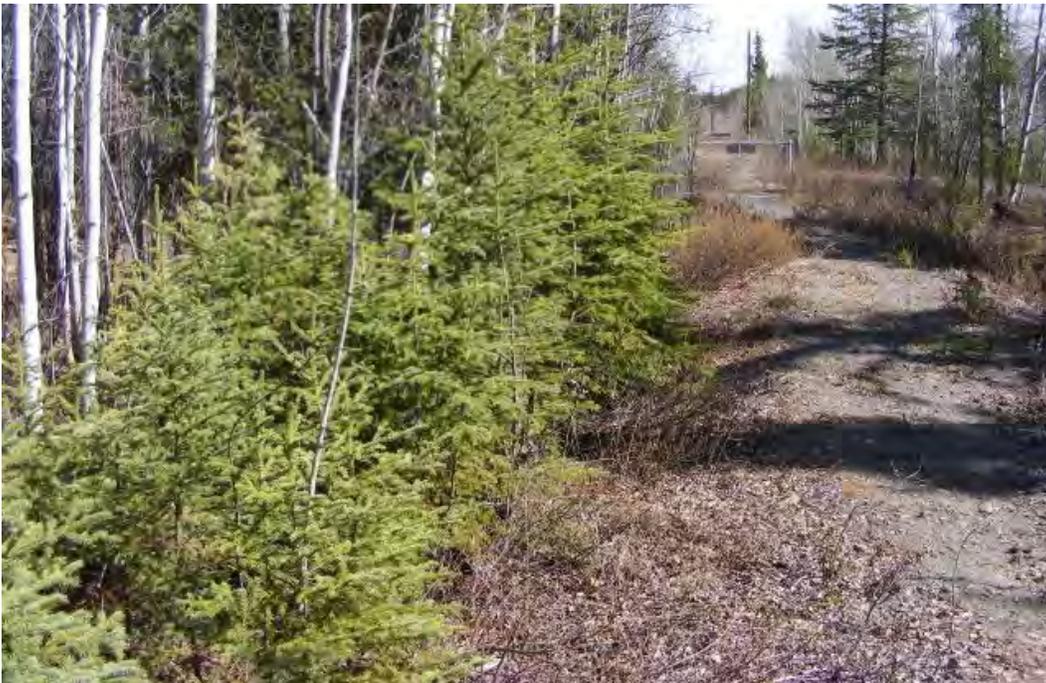
Figure 4-11. Vegetation covered slopes, Klutina River levee, Alaska (USACE, 2008)

Similar cases were reported in May and September 2008 on the Klutina River (Figure 4-11) and Tanana River in Alaska (Figure 4-12). The slopes of the levees were covered with large and small diameter trees and brush, and the levee owner was directed to maintain the levee in accordance to USACE guidelines. However, no indication of poor performance or negative influence from the trees was reported.

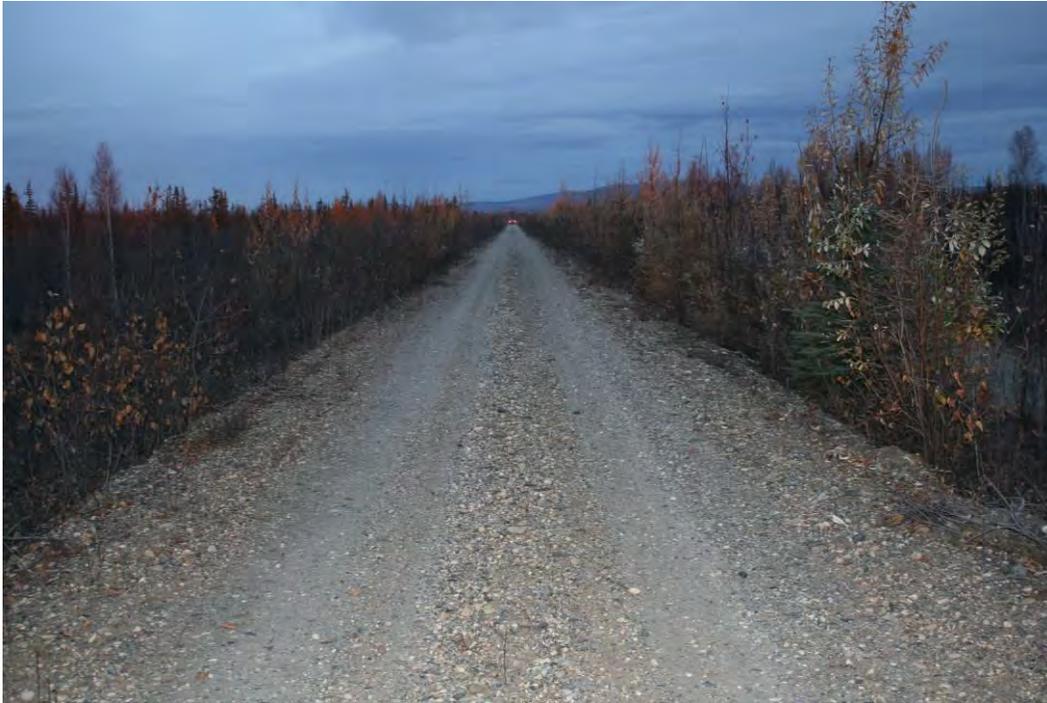
Figure 4-12. Vegetation covered slopes, Tanana River levee, Alaska (USACE, 2008)

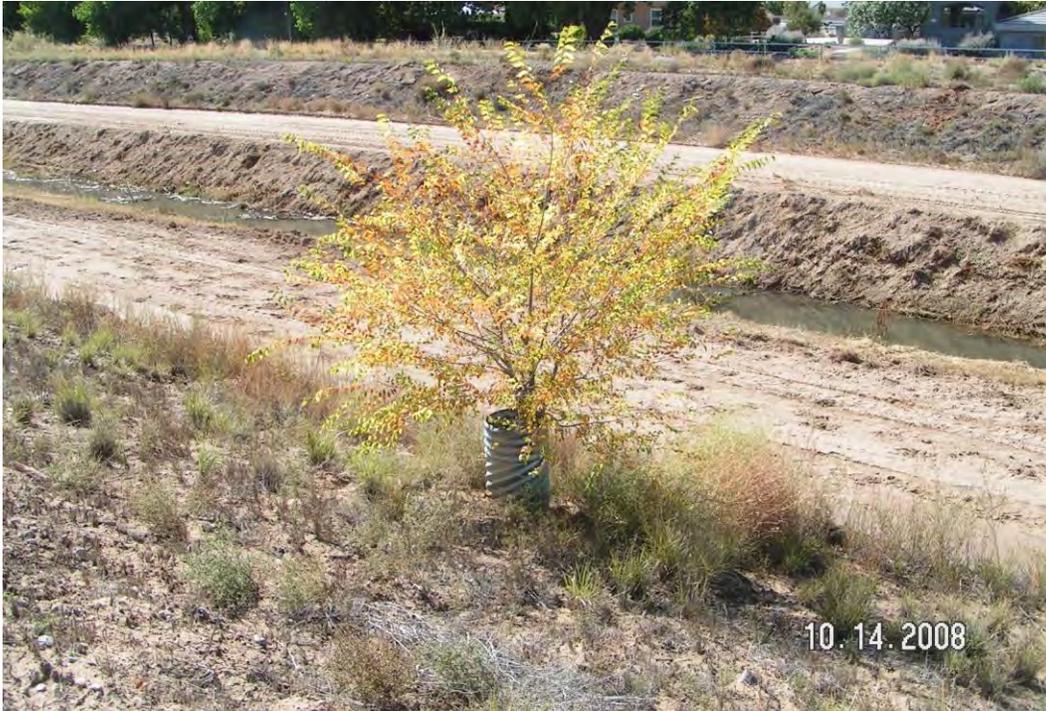
Figure 4-13. Tree growing inside landside subdrain system. Rio Grande, New Mexico (USACE, 2008)

The landside drainage system of the Corrales levee unit along the Rio Grande in New Mexico is protected from underseepage by a system of subdrains comprised of a PVC pipe parallel to the levee toe and risers every 1/10th of a mile. An inspection in October, 2008, found several trees, including Siberian elms, cottonwoods, Russian olive and salt cedar growing next to or inside the risers (Figure 4-13). In some cases the roots of these trees damaged the risers and most likely penetrated the slotted PVC pipe near the toe of the levee. The inspection team deemed that the subdrain system would not function as designed and recommended removing all trees and roots from the toe subdrain system and an investigation of the extent of intrusion by the woody vegetation.

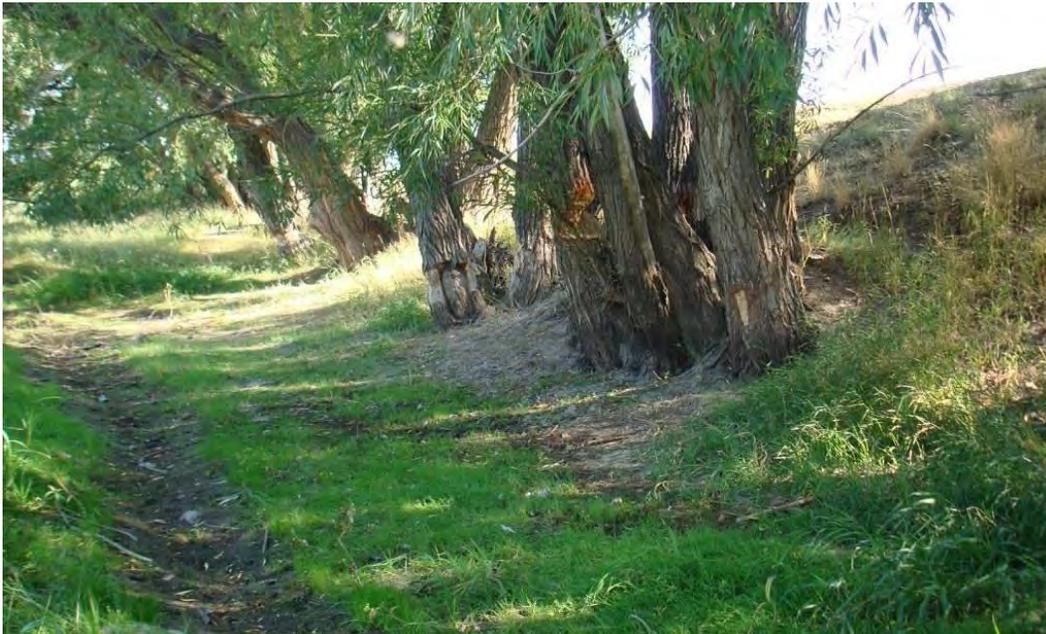
A USACE incident report for the Alamosa levee along the Rio Grande in Colorado from September 2008, describes the waterside toe area to be populated by numerous large trees within 5 meters (15 feet) of the toe (Figure 4-14). The inspector reported that the trees were of different size and health, as some of them had been damaged by recurrent beaver activity in the area.

Figure 4-14. Trees at waterside toe and channel dug by beaver, Alamosa levee, Colorado (USACE, 2008)

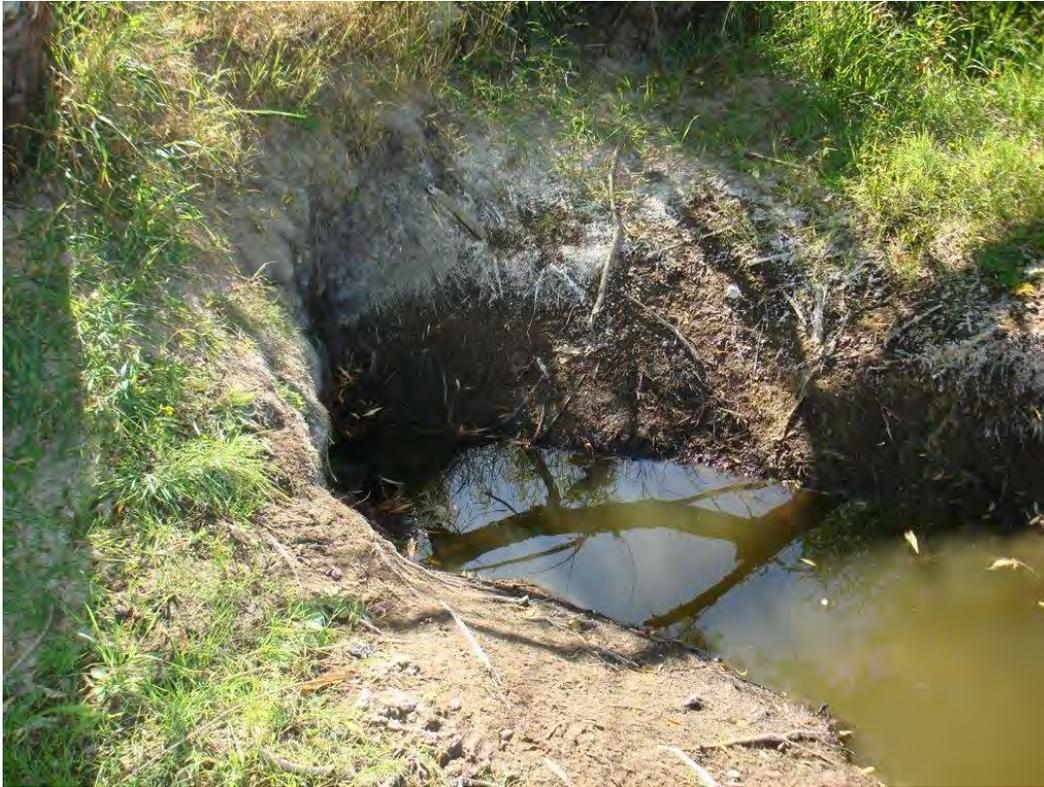
A channel had been dug by the animals from the river to the waterside toe (apparently there is a waterside berm separating the levee from the river) and two large beaver den entrances were encountered, as well as several smaller holes along the waterside slope (Figure 4-15).

Figure 4-15. Beaver tunnel on waterside slope, just below tree line. Alamosa levee, Colorado (USACE, 2008)

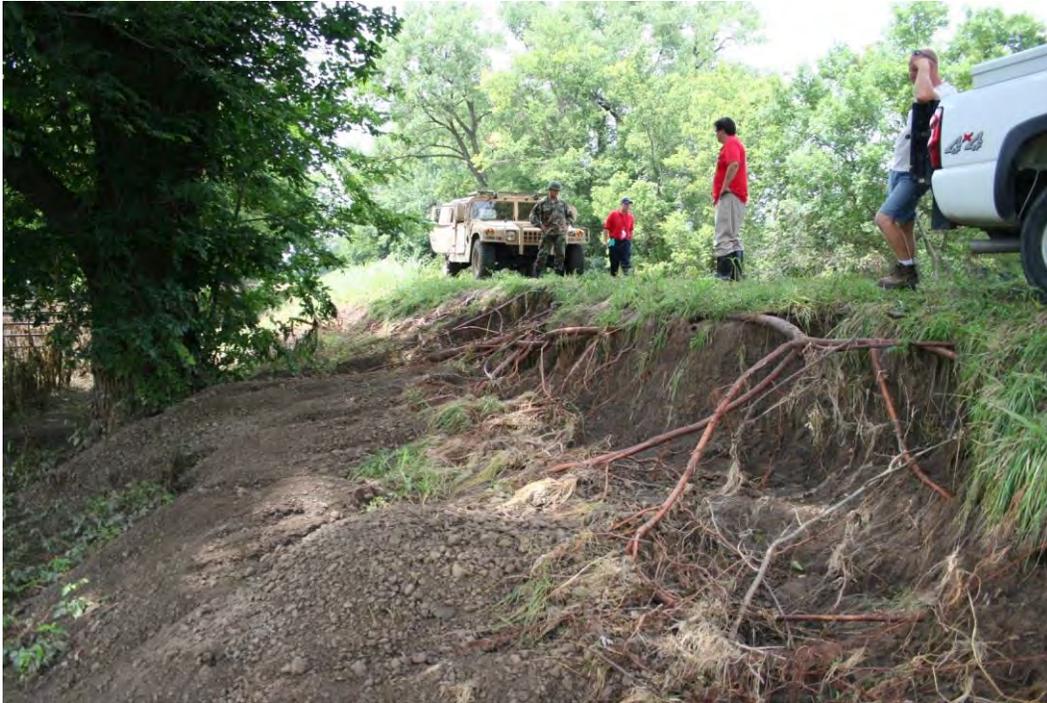
The USACE (2007) reported a small erosional feature on the landside slope of the Coffeyville levee in central Kansas following the storms of May and June of 2007. According to the incident report, the compacted clay levee was overtopped by approximately 1.2 m (four feet) of water and no breaches were reported, but an erosional feature was discovered during post flood inspections (Figure 4-16). The erosion exposed roots from a large tree near the landside toe extending upslope and reaching the crown of the levee. However, it is not clear how the roots might have contributed to the removal of approximately 1 to 1.5 meters (3 to 5.5 feet) from the area near the landside hinge point of the embankment.

Figure 4-16. Levee distress, Coffeyville levee, Kansas (USACE, 2007)

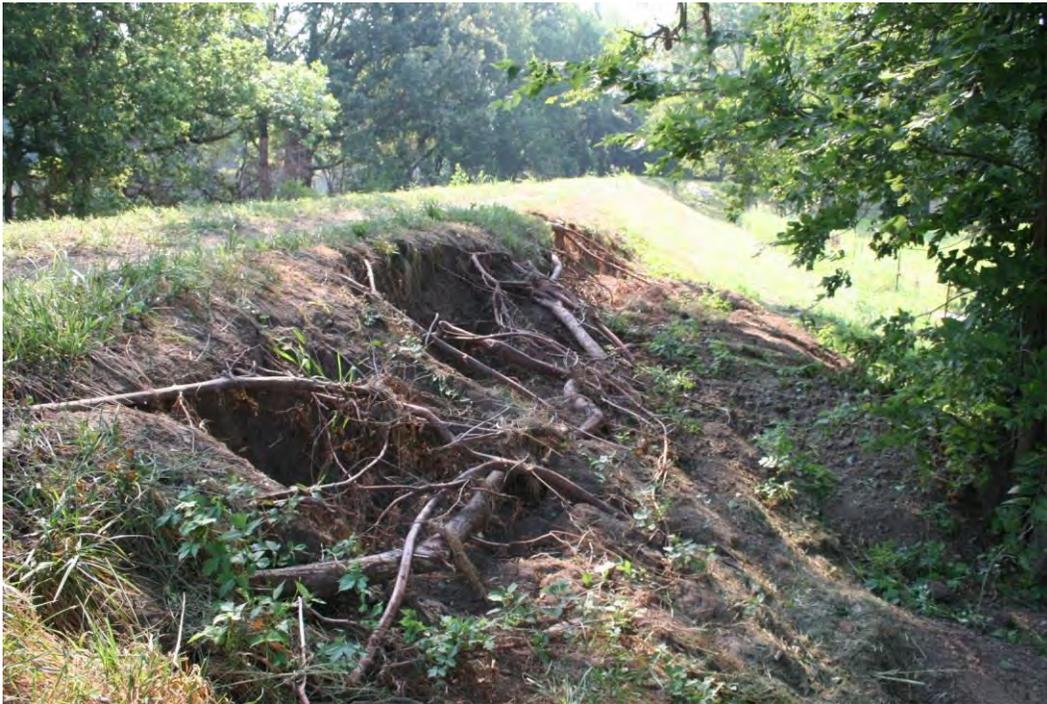
Figure 4-17. View of exposed roots on Coffeyville levee distress, Kansas (USACE, 2007)

The images show that the erosional feature roughly coincides with the zone of densest roots (Figure 4-17). However, there is no information on soil properties and their variability along the levee.

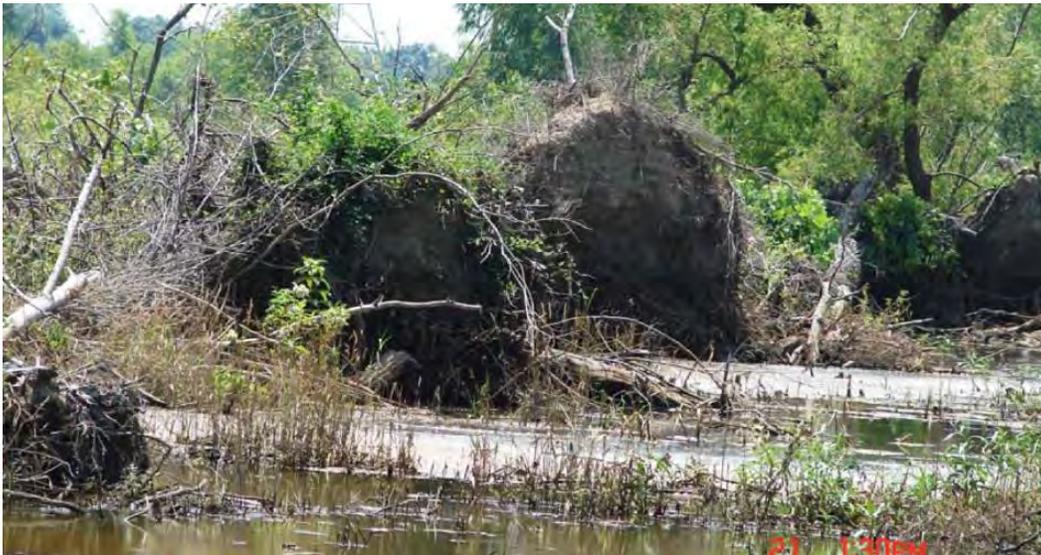
Animal burrows were observed near the crest and on the lower part of the landside slope, and several trees that were apparently uprooted some time before the 2008 floods were also observed. The root balls (Figure 4-18) were still in evidence showing that there was apparently disturbed ground near the landside toe and most likely including roots in the soil.

Figure 4-18. Uprooted trees and root balls at the East St. Louis site. (Harder et al., 2009)

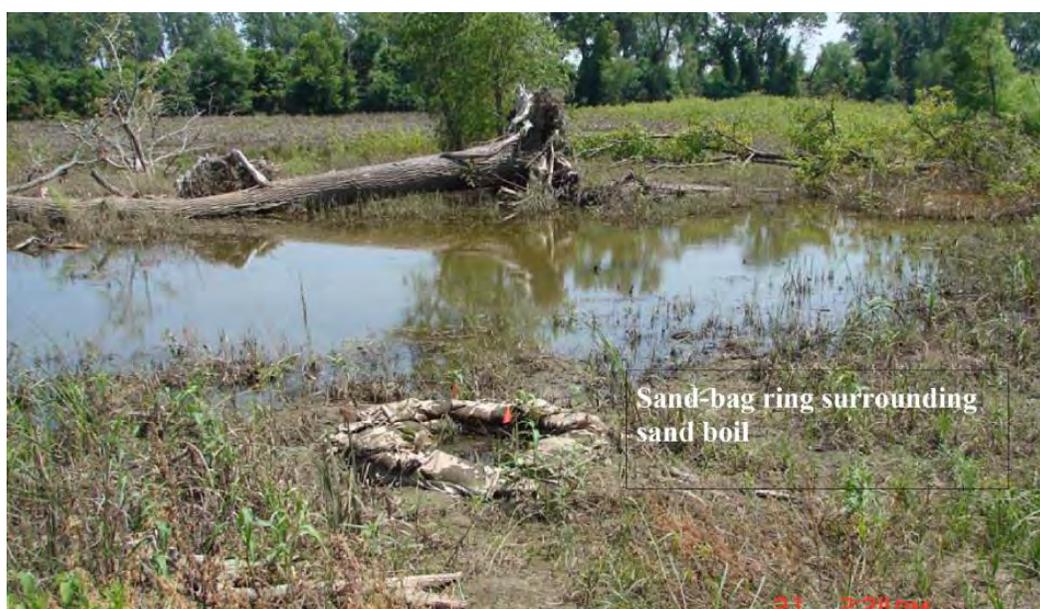
Sand boils (Figure 4-19) were observed between the relief wells, in some instances as close as 20 ft from a well, and the occurrence of the boils appeared to coincide with the ground disturbance produced by the uprooted trees. A previous flood event in 1993 did not produce any sand boils, despite the fact that recorded river levels were about 11 ft higher than the 2008 flood. The report by Harder et al. (2009) indicates that improper tree removal might have

Figure 4-19. Sand boil at East St. Louis site (Harder et al., 2009)

The reported levee distress at this site seems to have been exacerbated by anthropogenic activities rather than by the presence of woody vegetation detrimental to the performance of the levee. The fact that during previous flood events with significantly higher hydraulic loading the existing remediation measures performed adequately (relief wells, stability and seepage berms) indicates that the problems presented on this site were likely a direct consequence of the ground disturbance generated by the removal of the tree and root balls near the landside toe. The report does not provide information on the presence or absence of a landside fine-grained blanket, but it is likely that the removal of root balls had damaged the blanket or created discontinuities that allowed the formation of sand boils.

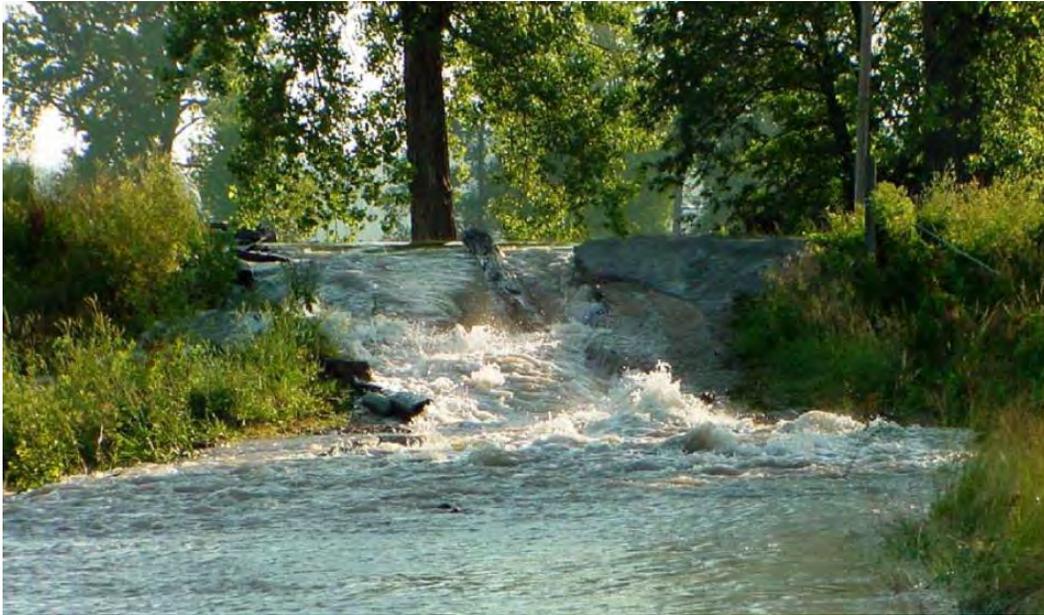
Figure 4-20. Cap Au Gris - Site 1 (Harder et al., 2009)

Post failure reconnaissance of the eroded embankments indicated the presence of several large (5 to 7 inches in diameter) live roots, extending across most of the embankment width. The first breach (Cap Au Gris – Site 1 in Harder et al. 2009) of a relatively low levee (9 feet high) with slopes between 3:1 and 4:1 (Figure 4-20) developed as water overtopped and concentrated on a low spot where a road access joined the levee crown. A witness account described no (through or under) seepage shortly before the failure, therefore the failure was likely due to

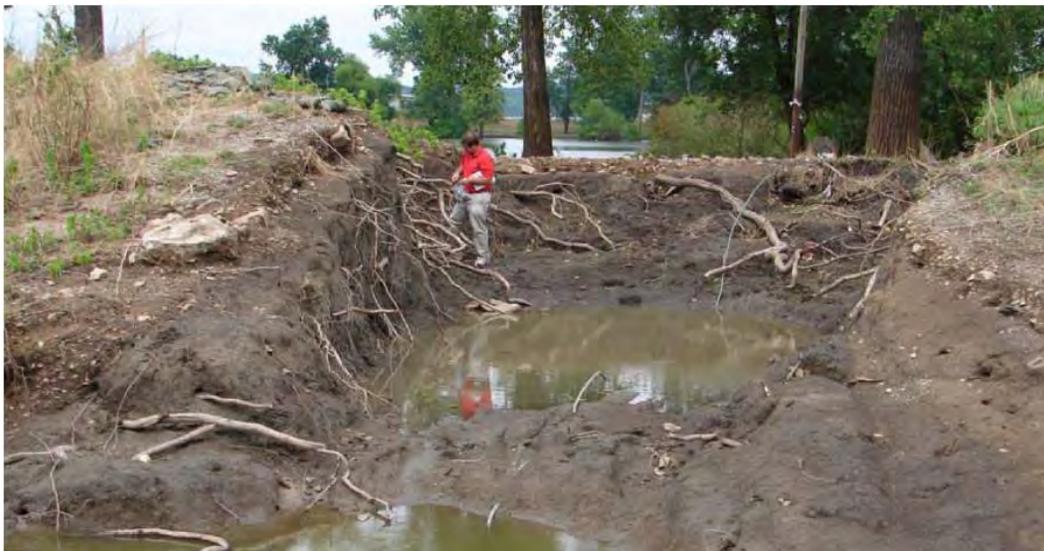
Figure 4-21. View of eroded levee at Cap Au Gris - Site 1 (Harder et al., 2009)

The roots encountered in the eroded area ranged from less than 1 inch to about 5 inches in diameter (Figure 4-21), and seemed to originate from two stumps encountered near the waterside toe of the eroded levee with diameters of 3 and 4 feet. The larger roots appear to have reached distances greater than 50 ft from the stump towards the embankment. A smaller stump and a live cottonwood were also present in the vicinity of the breach.

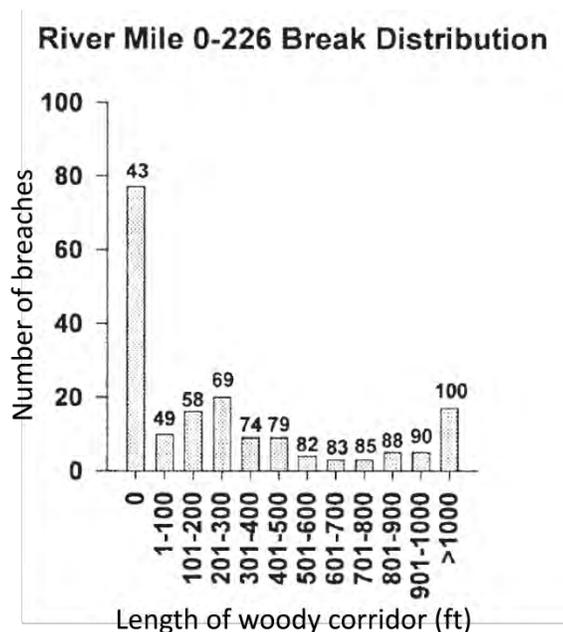
Figure 4-22. Number of breaches as a function of woody corridor length (modified from Allen et al., 2003) [1 ft: 0.3048 m]

Allen et al (2003) investigated a series of levee breaches along the Missouri River after the 1993 floods, and concluded that vegetation played a significant role in the reduction or prevention of damage of levees. Their study of a 353 mile long segment along the Missouri River concluded that areas where vegetation corridors were present exhibited a smaller number of levee failures, and that the length of the failures or breaches was almost halved when a vegetated corridor existed (Figure 4-22). Moreover, they concluded that discontinuities within these corridors can be weak links for initiation of failures. The figure shows number of levee failures based on incremental increases in the width of woody corridors for levee mile 0-226. The numbers above each bar correspond to the cumulative percentage of levee failures occurring with the addition of each increase in woody corridor width.

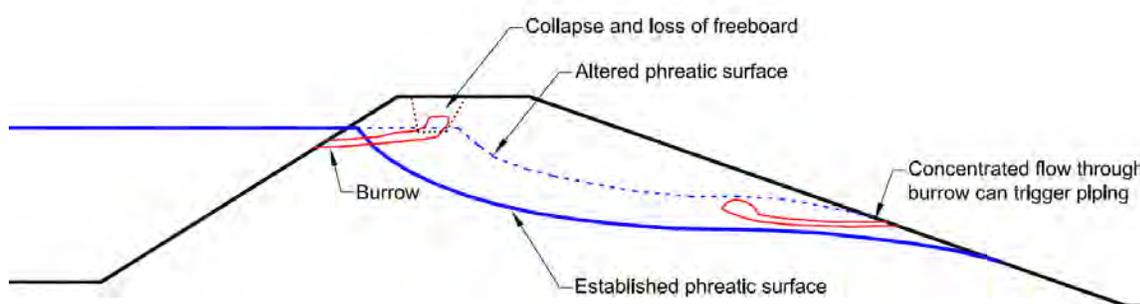
Figure 4-23. Effects of animal burrows in embankments

erosion. Hydraulic alteration (Figure 4-23) is a distortion of the phreatic surface established through the embankment, as burrow dens and complexes located on the waterside can allow water from the waterside to enter inner portions of the embankment with no loss of hydraulic potential. If the burrows are on the protected side (landside), burrows that extend below the phreatic surface can concentrate the flow lines and potentially lead to piping. This phenomenon is most often cited as the greatest concern because it is progressive and can rapidly lead to failure (FEMA, 2005). Structural integrity losses occur when a large number of burrows or dens collapse, generating a localized loss of freeboard or flood protection elevation (Figure 4-23) or slope instability in the vicinity of the collapse. Finally, surface erosion by the downslope biogenic movement of soil ejected from the animal burrows eliminates vegetal cover that provides erosion protection.

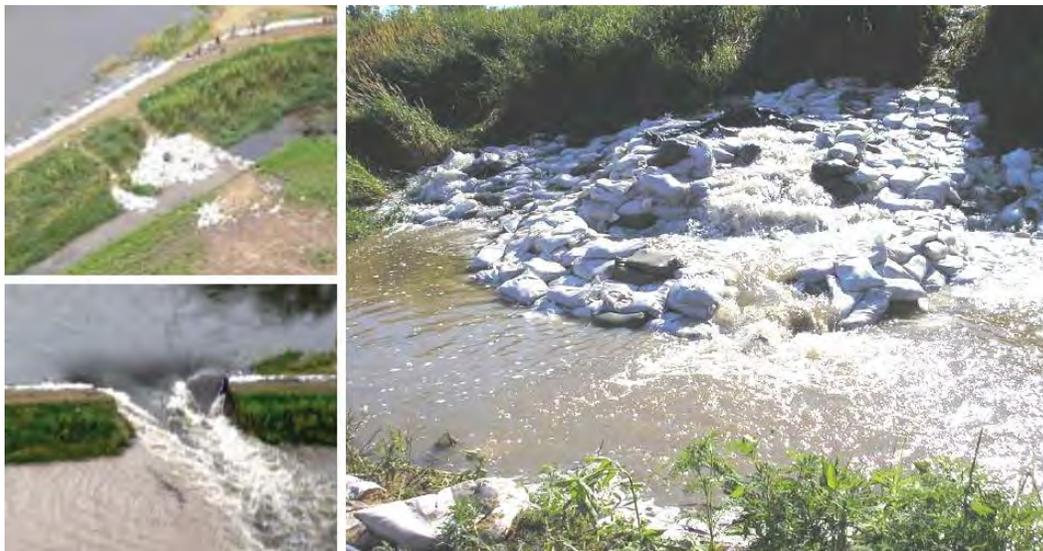
Figure 4-24. Pin Oak Levee breach (Harder et al., 2009)

During the 2008 flood several landside slope failures were observed, as well as through-seepage (flow of water through the levee embankment exiting on the landside slope) at two locations. A breach occurred at one of the through-seepage sites on 27 June, 2008 (Figure 4-24). The heaviest seepage was observed near the landside toe where a landside ditch parallels the toe. Sandbags were placed around the heavy seepage area (Figure 4-25) in an attempt to minimize the seepage quantities but the through seepage 'broke through' the levee material above the top of the sandbags. Subsequent emergency response included the construction of a larger sandbag ring and placement of a tarp on the waterside slope; all to no avail as this levee breached several hours later.

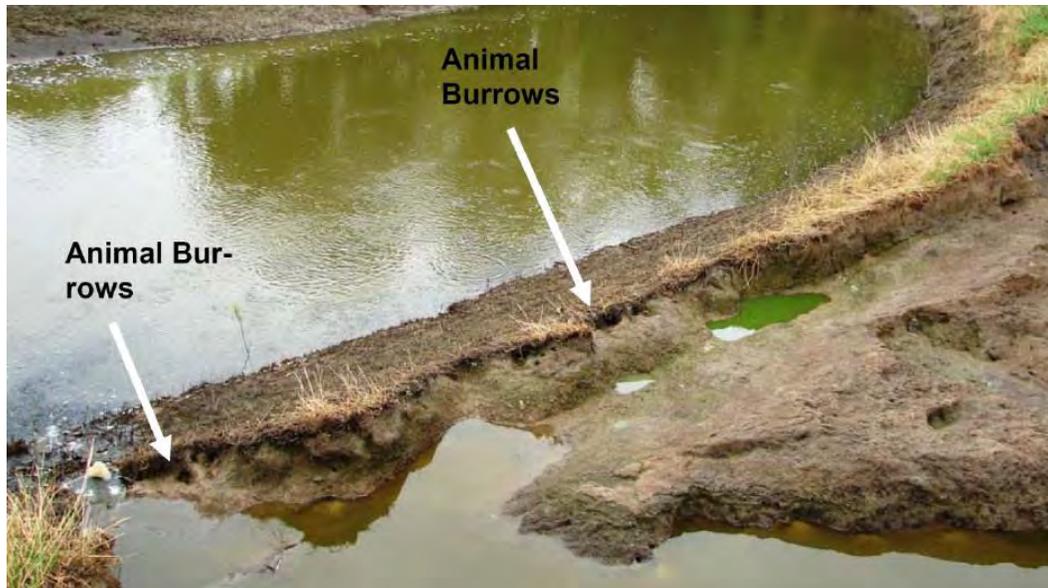
Figure 4-25. Animal burrows on Pin Oak Levee breached section (Harder et al., 2009)

The post-breach reconnaissance by Harder et al. (2009) reports several 5 to 8 cm (2 to 3 inch) diameter rodent holes in the vicinity of the breach along the waterside slope, extending from the toe to a few feet below midslope. Witness accounts report the presence of muskrats diving into the area where the tarp was placed during the flood and chunks of clay being ejected from the protected side. The extent of the animal activity appears to coincide with the eroded mass, as it only extended down to the elevation of the toe.

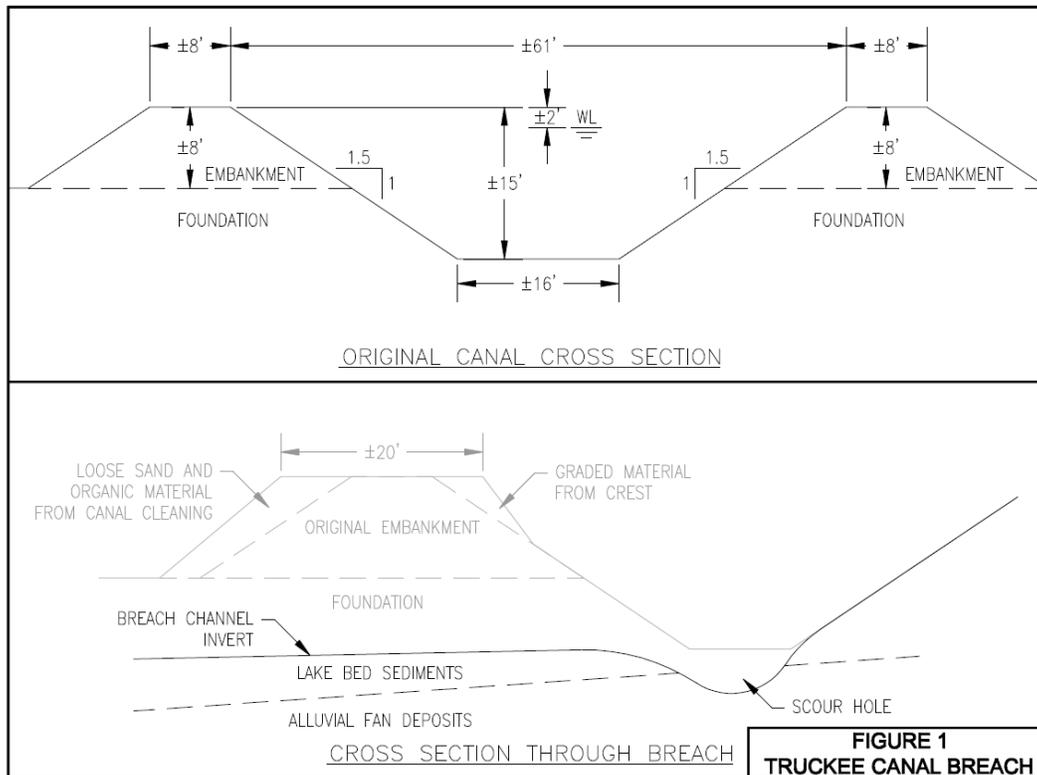
Figure 4-26. Truckee Canal cross sections (URS, 2008)

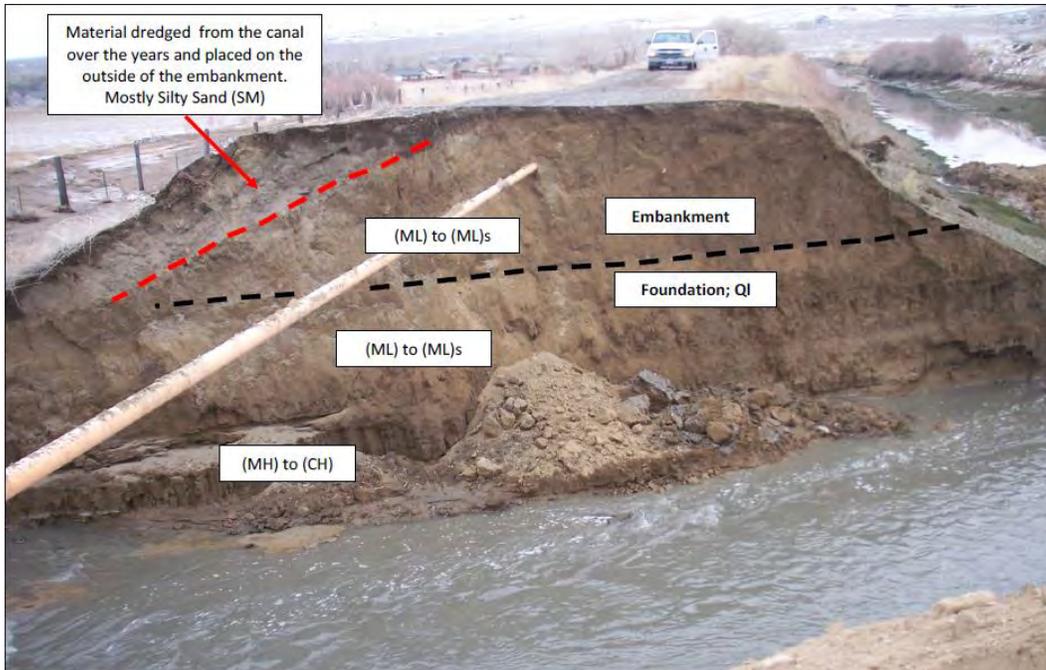
Figure 4-27. Developed breach looking downstream (URS, 2008)

The breach developed early in the morning and water flowed into the city of Fernley for about nine hours before it could be plugged, flooding the adjacent areas to depths up to eight feet (Figure 4-27). The investigative team concluded that because the embankment and foundation materials were composed by silts and clays of medium to high plasticity (ML, CL, MH and CH), underseepage or through seepage was an unlikely cause of the failure. Other potential failure modes, such as wave erosion, lateral instability, overtopping and seismic activity were also ruled out because of lack of evidence. The most likely failure mechanism was judged to be a piping failure due to rodent activity, as evidence of active rodent (muskrat) activity had been reported in the area by local personnel, and several rodent tunnels were observed during the forensic investigations. A previous smaller failure in 1996 was also related to animal burrowing in the area (Benedict, 2008).

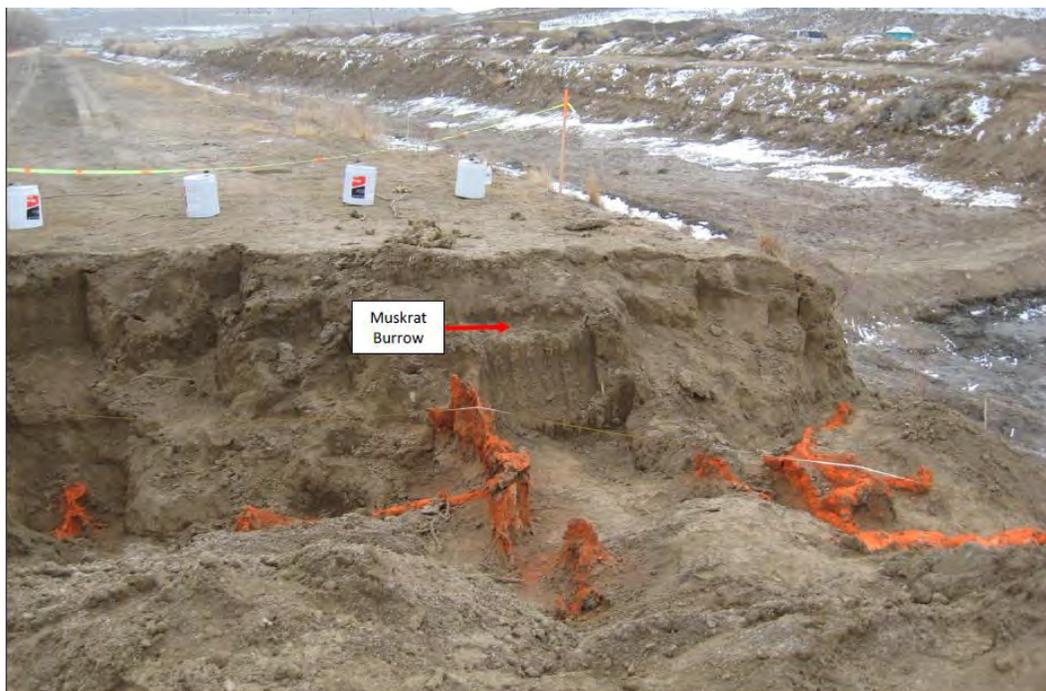
Figure 4-28. Exposed grouted burrows 250 ft downstream of breached site (URS, 2008)

URS also performed chemical grouting at a site 250 ft downstream of the breach in order to assess the extents of the Muskrat burrows present in the area. The investigation revealed a complex system of interconnected burrows (Figure 4-28) extending from the waterside slope to near the landside slope, reaching what the investigative team called a 'collapse feature' (Figure 4-29) with a fan of sand apparently coming from internal erosion along the burrows. The findings indicate that even if the holes did not fully extend to the face of the landside slope, such openings could have collapsed at some point during the failure.

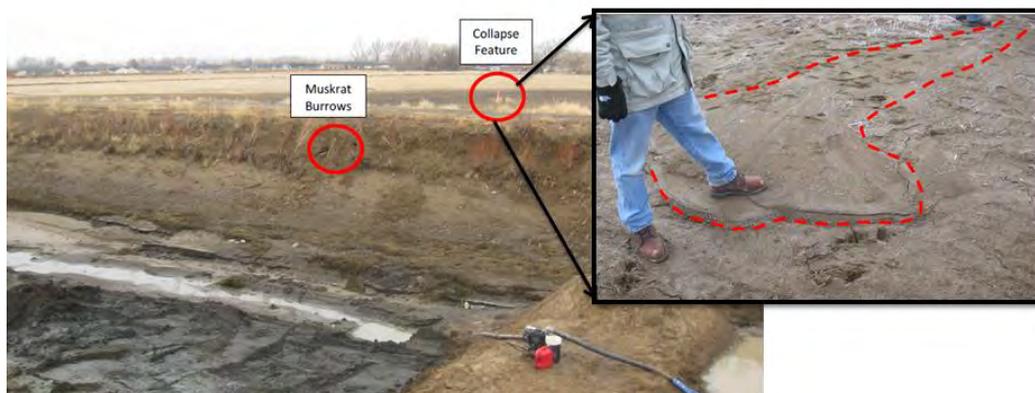
Figure 4-29. Collapse feature at the landside edge of burrow complex (URS, 2008)

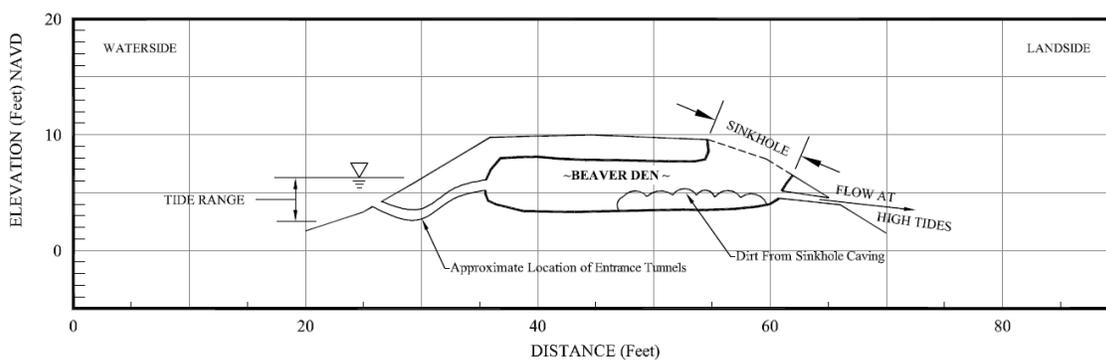
EMERGENCY REPAIR JAN. 25-26, 2009

Figure 4-30. Schematic of beaver den cave-in (MBK, 2009)

On 24 January 2009 a cave-in was reported on the southern end of Medford Island in the Sacramento-San Joaquin Delta, exposing a large Beaver den. The levee is approximately 2.5 to 3 meters (8 to 10 ft) high and 6 meters (20 ft) wide at its crown (Figure 4-30).

A survey of the den showed that it extended 4 meters (12 ft) from the landside hinge point of the levee towards the waterside. The void was 1.5 m (5 feet) high by 3 meters (9 feet) wide (MBK, 2009). The den extended from the landside to within 0.6 meters (2 feet) of the waterside face.

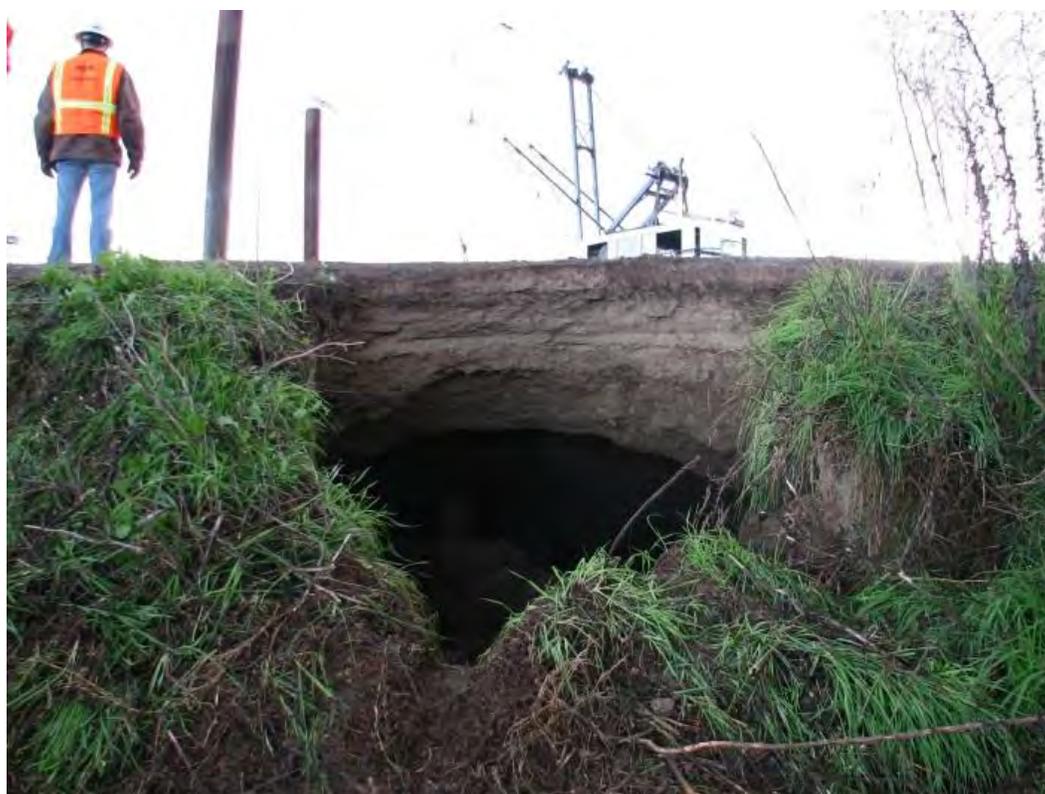
Figure 4-31. Beaver den cave-in, Medford Island, CA. Photo Courtesy Dustin Sanoski (DWR)

After the measurements were taken, less than two feet of soil remained above the ceiling of the den and the surface of the crown (Figure 4-31), posing a high risk for the collapse of the structure. Water was seen entering the den from two tunnels (Figure 4-32), and flowing out of the den through a single tunnel (Figure 4-33) that exited the slope at about mid-slope on the landside (MBK, 2009).

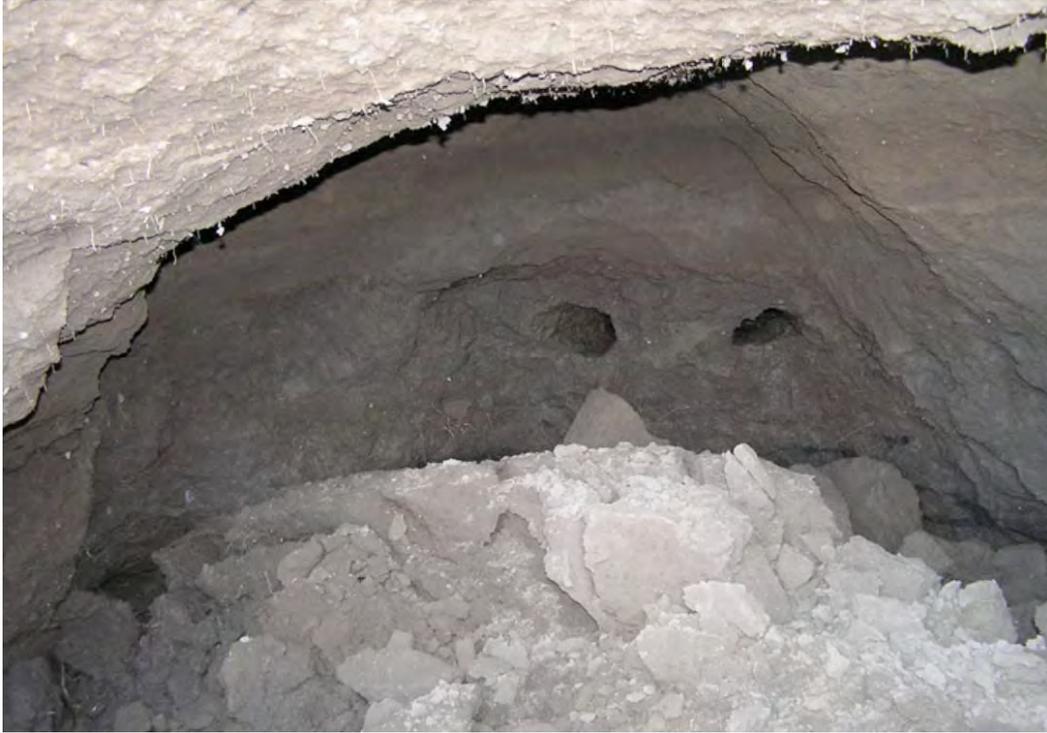
Figure 4-32. Internal view of the den showing access tunnels from the waterside (MBK, 2009)

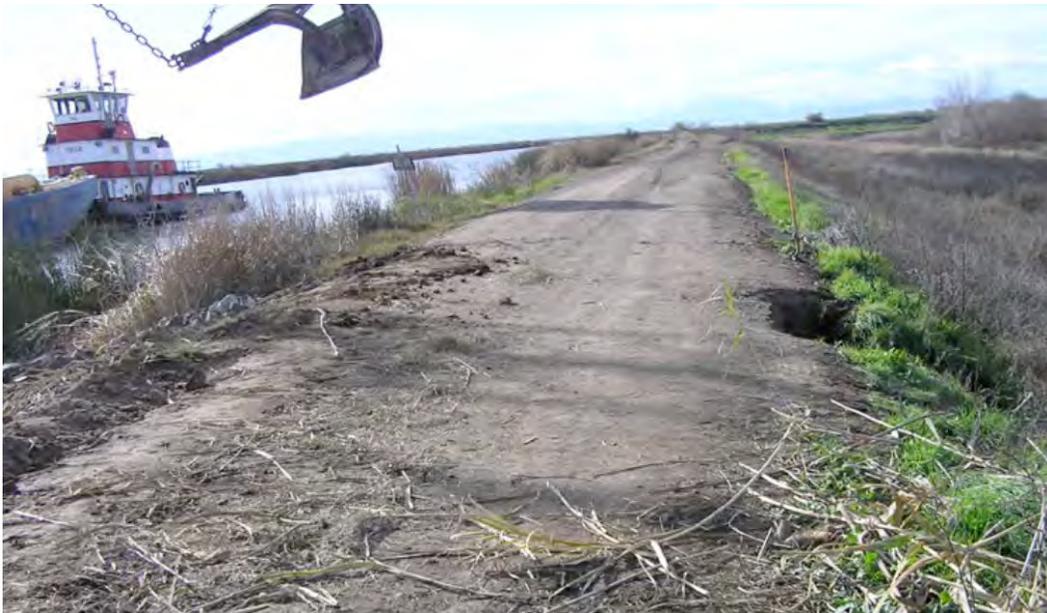
Figure 4-33. View of the landside cave-in from the levee crown (MBK, 2009)
