Transient Seepage Through Levees and the Influence of Roots and Animal Burrows

Ph.D., [Civil and Environmental Engineering](#) [UC Berkeley](#)

Transient Seepage Through Levees and the Influence of Roots and
Animal Burrows

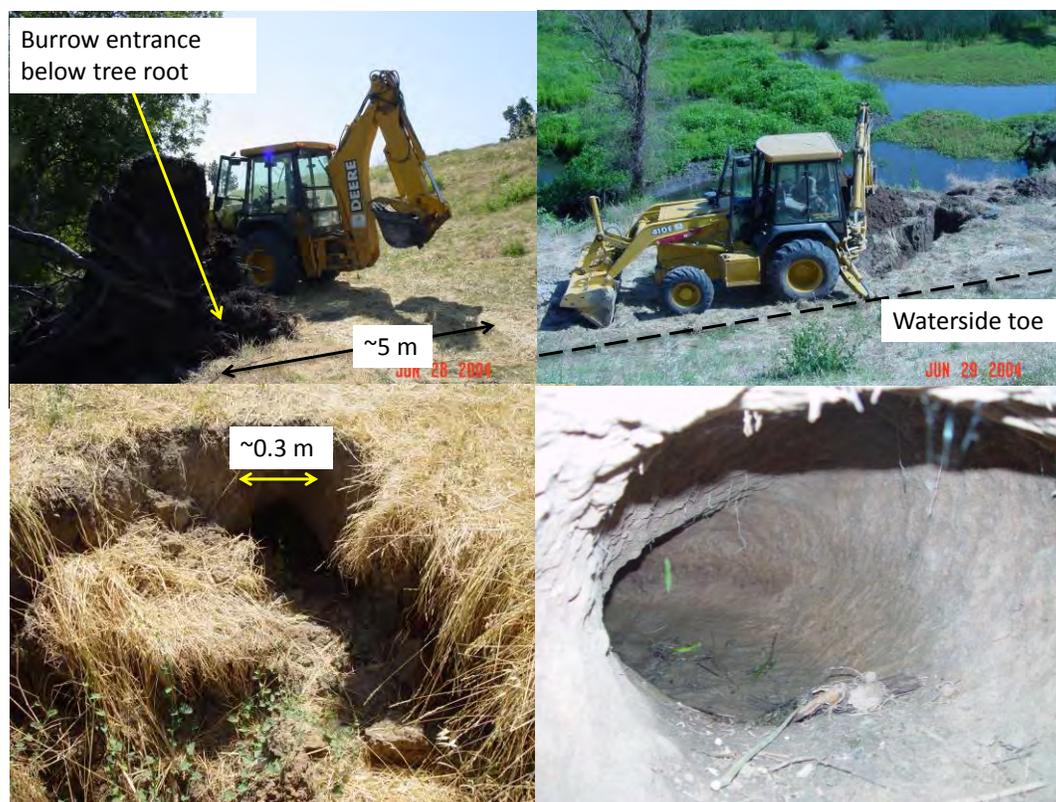
Figure 4-34. Waterside berm collapse at Arcade Creek levee. Images courtesy of Richard Marck (ARFCD)

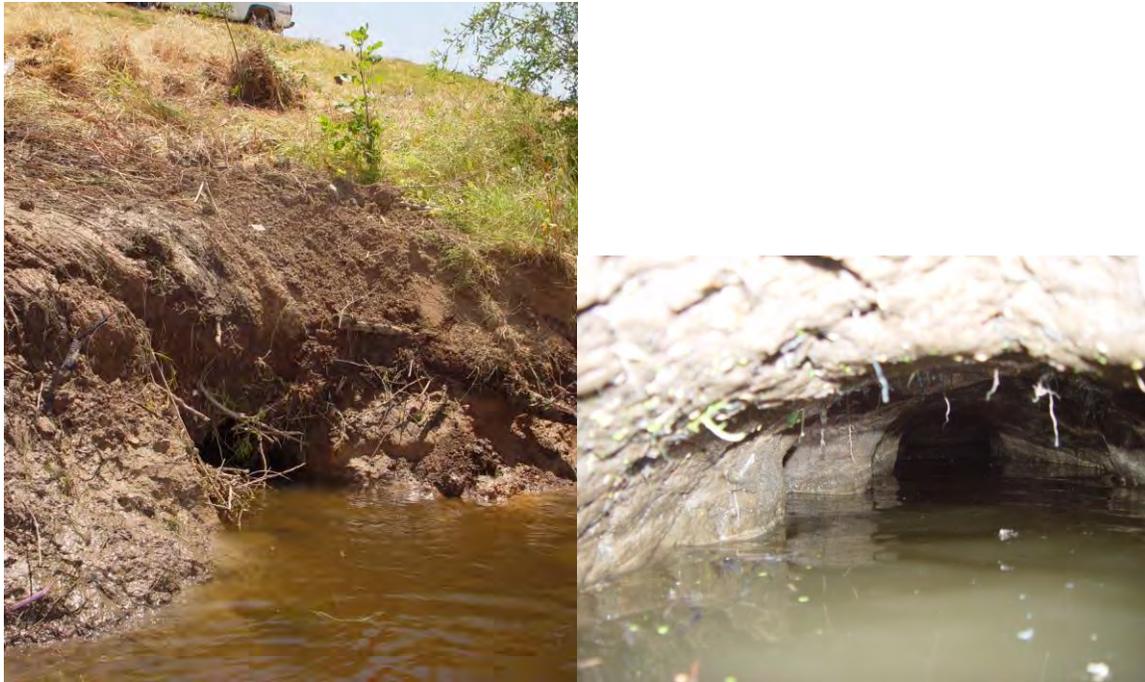
Figure 4-36. Beaver hole at waterside toe in 2004. Image courtesy of Richard Marck (ARFCD)

The beaver den shown on Figure 4-36 was found at the waterside toe of the levee along Arcade Creek in 2004. This levee segment did not have a waterside berm and the animal dug directly into the levee material. Obviously, this type of situation has the potential to inflict more damage than dens encountered along the waterside berm. The beaver den shown on Figure 4-37 is of particular interest because of its great size (at least 3 meters in length and 35 cm in diameter) and because it is located in an area historically known for beaver intrusions. The levee borders Arcade Creek near Sacramento and it too is part of the ARFCD maintained area, which is known for rapidly mitigating this type of animal intrusion. Mitigation consists of excavating the distressed or collapsed area and backfilling it with large rocks and soil so re-burrowing is discouraged. However, this type of practice does not eradicate the problem; rather it simply makes the burrowing animals dig new dens just a few meters upstream or downstream of the repaired levee section. During the first weeks of 2012, a new den was encountered between previous mitigated burrows (Figure 4-38). The new den was only 1 to 1.5 meters in length and about 35 cm in diameter, and given the presence of a recent waterline

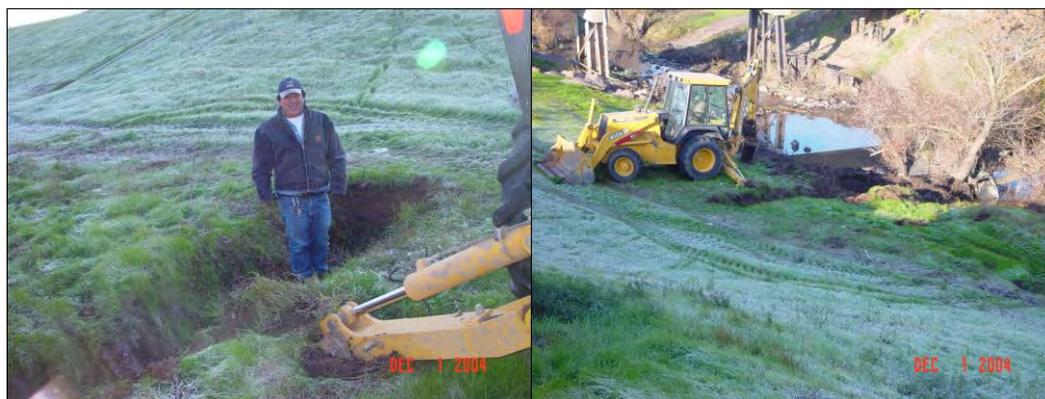
Figure 4-39. Beaver den at the southern end of Arcade Creek in 2004. Images courtesy of Richard Marck (ARFCD)

The burrow shown on Figure 4-39 near the southern end of Arcade Creek was located in the vicinity of a tree, which was removed during mitigation activities. The beavers seemed to have used large roots at the roof of their burrows, as shown on Figure 4-40.

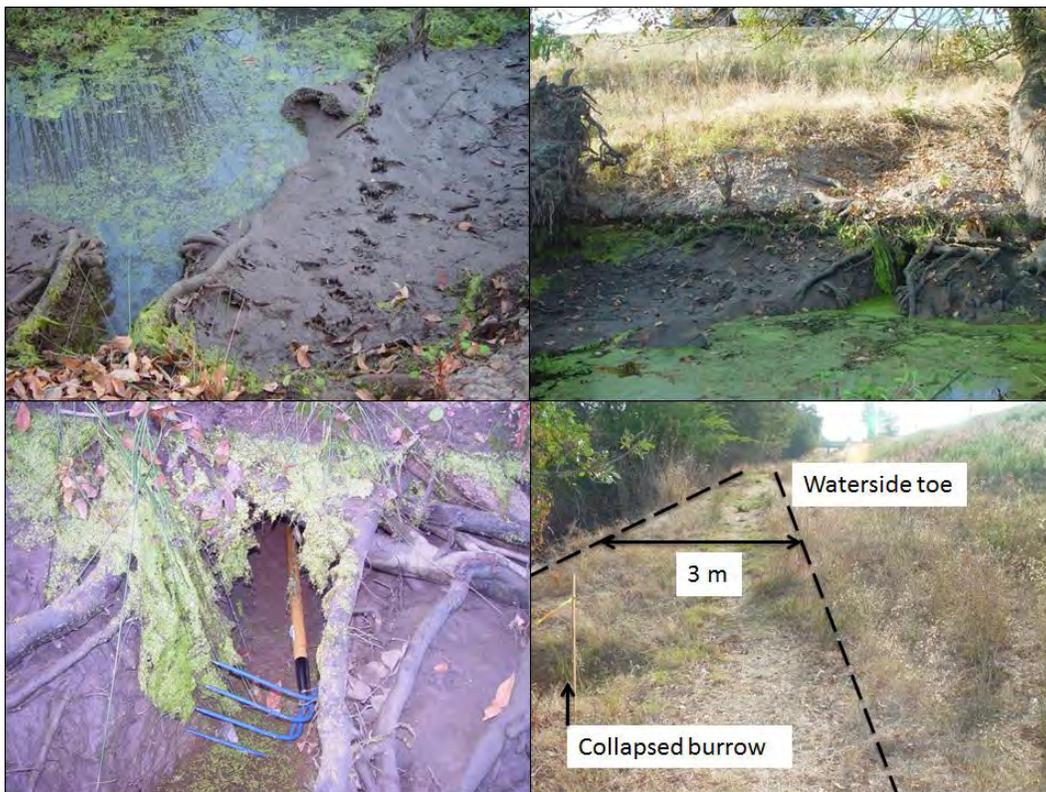
Figure 4-40. Beaver burrow collapse at waterside toe near Arcade Creek in 2004. Images courtesy of Richard Marck (ARFCD)

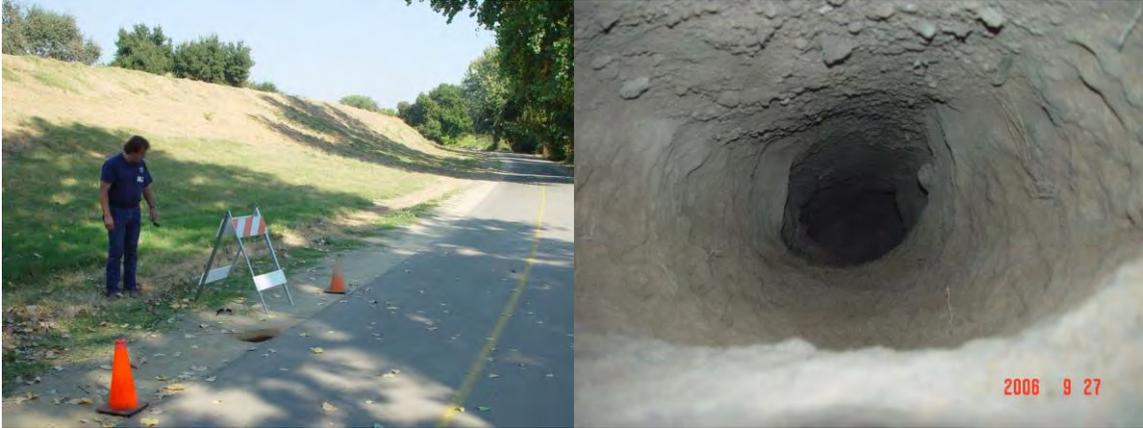
Figure 4-41. Beaver burrow below paved bike path along north levee of American River in 2006. Images courtesy of Richard Marck (ARFCD)

Other types of reported beaver damage do not necessarily threaten levee integrity but, if left unattended, can evolve into larger issues. For example, beaver induced damage was found on a paved bike path atop a waterside berm along the north levee of the American River in Sacramento (CA); ARFCD inspection personnel found a sinkhole on the edge of the pavement and some deformations on the paved bike path. Upon inspection, a large beaver entrance was found near the waterline, approximately 1.5 meters below the pavement level. Figure 4-41 shows the sinkhole, which extended vertically down until reaching the burrow connecting to the canal.

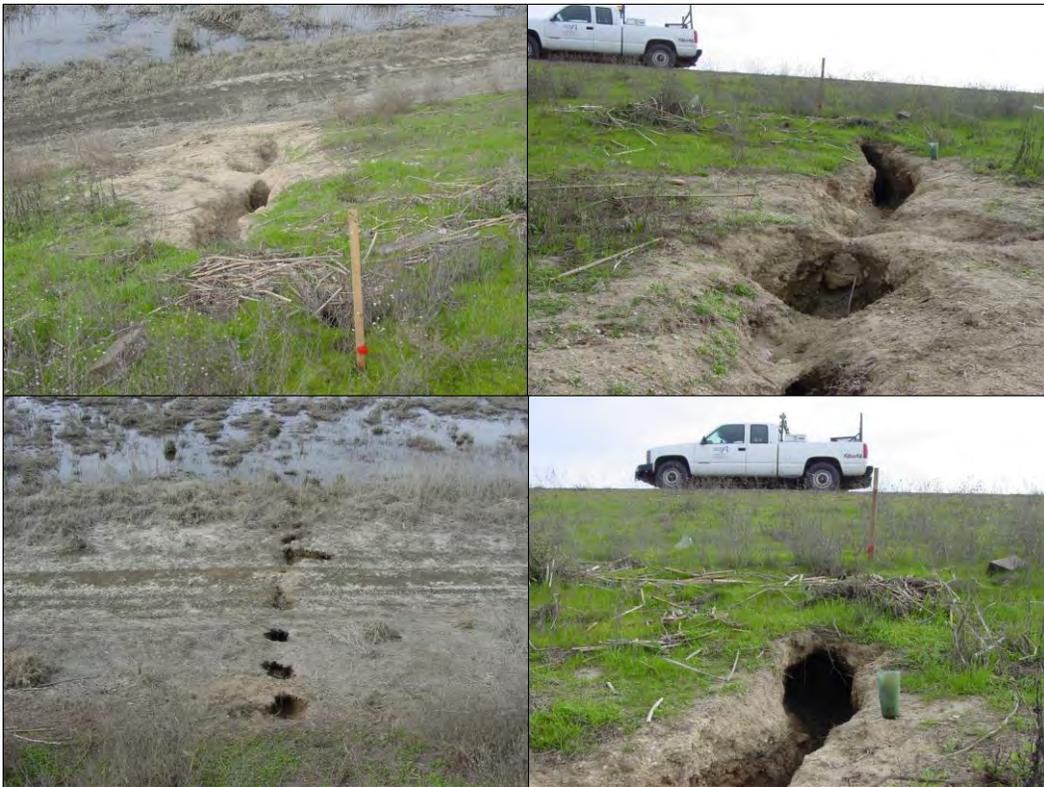
Figure 4-42. Waterside slope collapse from beaver burrow along NEMDC in 2006. Images courtesy of Richard Marck (ARFCD)

Another instance of beaver damage was also reported by ARFCD in 2006 along the Natomas East Main Drain Canal (NEMDC), an interior drainage canal bordering the Natomas basin north of Sacramento (CA). According to reports from ARFCD staff, this area is generally subject to beaver intrusions, but after sustained high waters in the winter of 2006, some beavers dug tunnels from the waterside trench and extended up the waterside slope until less than two meters (measured vertically down) from the crest of the levee (Figure 4-42). The tunnels

collapsed over time, exposing a large hole approximately 50 centimeters in diameter and about one meter below the slope of the levee. The holes seemed to remain parallel to the waterside slope and about one meter below ground surface, and did not extend towards the landward slope.

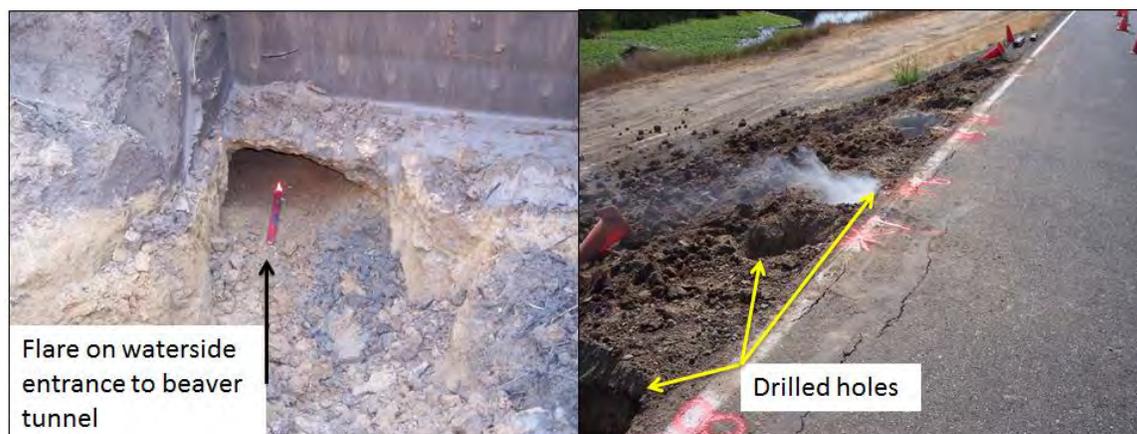
Figure 4-44. Remediation activities on beaver den at PGCC near Sacramento, CA. Photo courtesy Ray Costa (2012)

The levee in this area is composed of compacted clays of medium to high plasticity, which may have allowed the beaver(s) to extend the den from one side of the levee to the other without collapsing. Emergency remediation consisted in excavating the sinkhole area, exposing tules, a small cavern and the tunnel extending to the waterside toe (Costa, 2012), and constructing temporary earthen plugs on both levee toes. Final remediation took place by drilling several holes along the top of the levee and filling them with concrete. Flares were placed at the entrance of the beaver den before the concrete was poured to verify that the drilled holes had in fact intersected the tunnel (Figure 4-44).

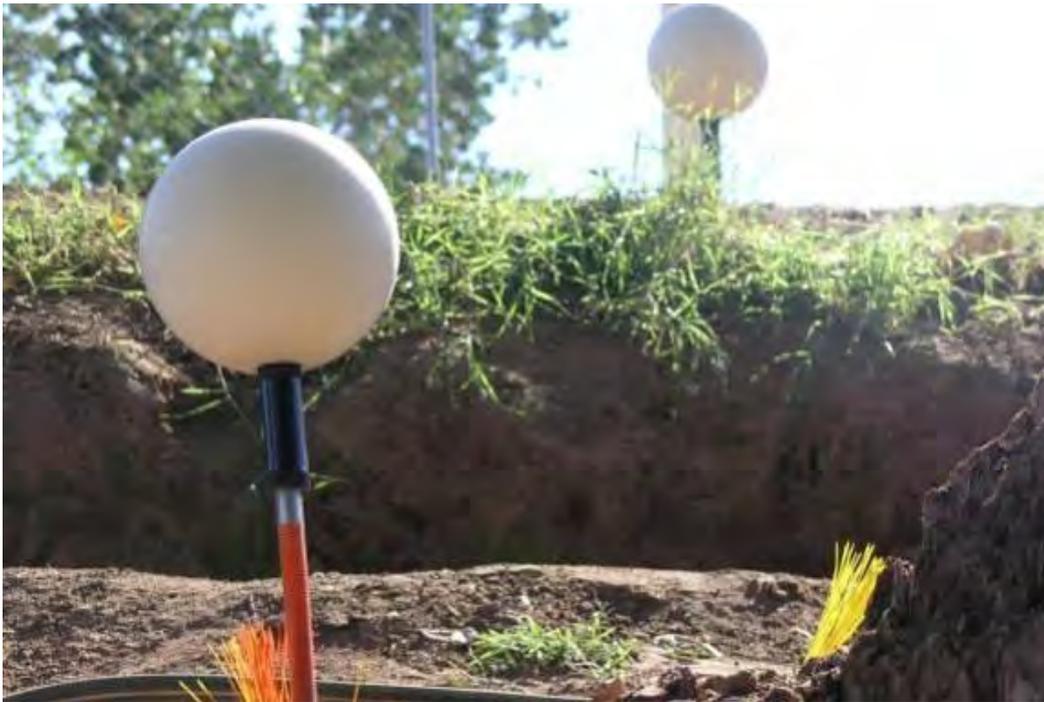
Figure 5-1. Reference targets used for aligning T-LiDAR scans

After the grid was laid out, survey flags were placed next to each hole and an initial high-resolution ground based T-LiDAR base scan was performed so a three dimensional image of the levee prior to the test was available. A local reference frame was established for the T-LiDAR systems by installing several benchmarks using one meter threaded rod pushed to refusal, and a set of six 4-inch PVC crosses outside the study area such that a minimum of six spherical (Figure 5-1) or PVC targets could be seen in each scan to optimize post-processing and aligning processes. Two types of T-LiDAR systems were used: an *Optech* ILRIS device, which captures infrared contrasts on the soil at a scan density of 2 to 3 millimeter spot spacing, or 2,500 data points per square meter; the second device employed was a *Faro* device, which is able to capture real RGB color of each scanned point, generating a 3D colored representation of the scanned area. The flags next to each hole were installed with a two to three centimeter long reflective strip that produces a signal spike on the T-LiDAR data (Cobos Roa et al., 2012) so the exact location of the holes in the study area were captured by the baseline laser scan.

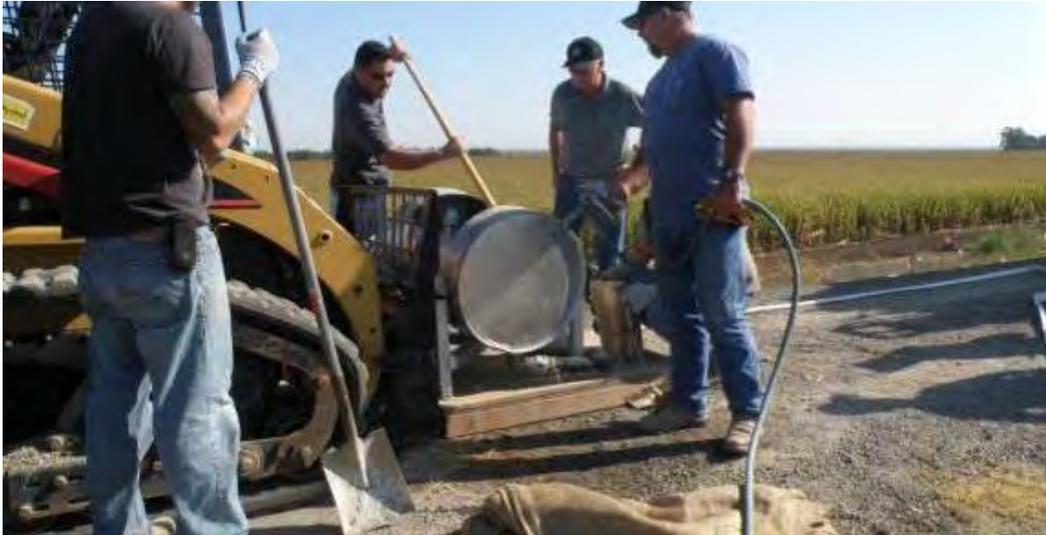
Figure 5-2. DWR portable grout mixer for field tests

The first round of grouting was performed using the typical cement-bentonite grout mix employed by the DWR and local maintenance districts in their periodic grouting campaigns, which consists of injecting a relatively viscous grout containing 5-10% bentonite. This phase of the grouting program used a portable grout rig (Figure 5-2), which consisted of a small drum fixed to a board, so a small forklift could transport it, and fitted with a pump, hoses and valves to allow the desired amount of mixed grout to flow by applying a small amount of pressure (approximately 0.5 psi [3.4 kPa]). Inside the drum, the mix of cement, bentonite and water was achieved manually; alternatively, a mix on-site cement truck can be used to pour the cement into the mix.

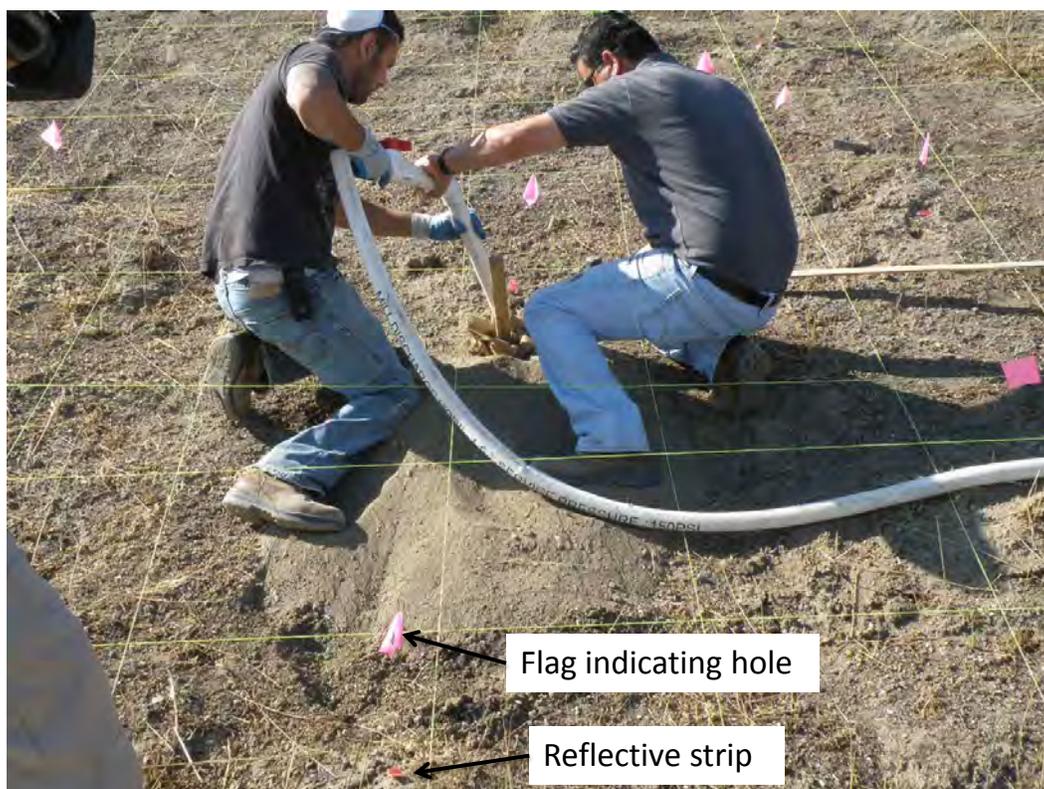
Figure 5-3. Typical DWR grouting procedure

Once the cement-bentonite mix was prepared, holes typically targeted during regular grouting operations (8 cm in diameter and larger) were filled until grout flowed back out of the hole or out of a nearby hole, at which point the hole was plugged using a burlap bag (Figure 5-3).

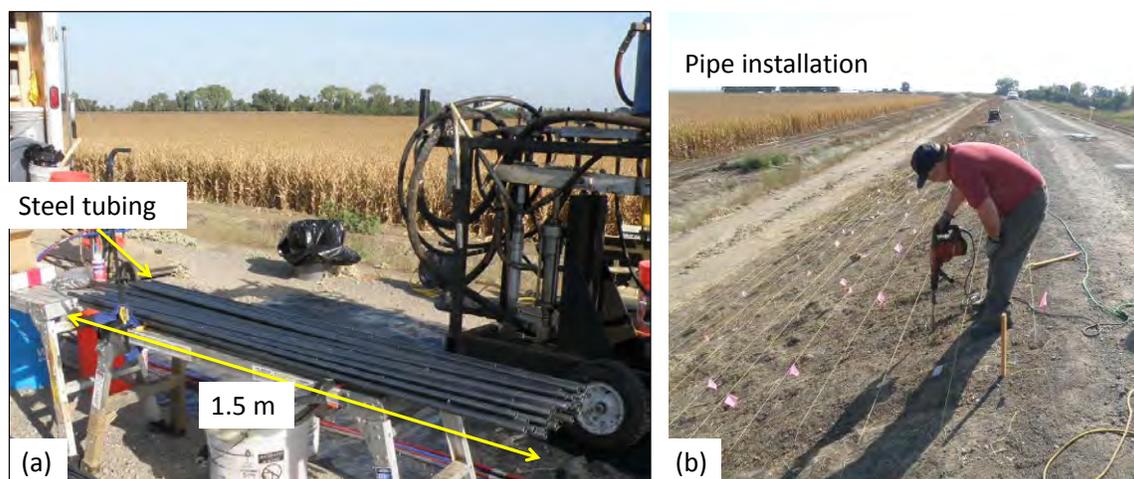
The polyurethane grout was injected into the soil using 2 cm diameter, 1.5 meter (5 feet) long steel tubing with holes drilled along the lower 1 meter (3 feet) of tube (Figure 5-4). The pipes were inserted into the soil using a jackhammer on a 1.2 m (4 feet) spacing in a triangular grid pattern (Figure 5-5). Several additional pipes were inserted near large active holes where large amounts of cement-bentonite grout were used during the first phase of the grouting program.

Figure 5-4. Experiment setup: (a) injection tubing prior to installation, (b) installation of tubing using jackhammer

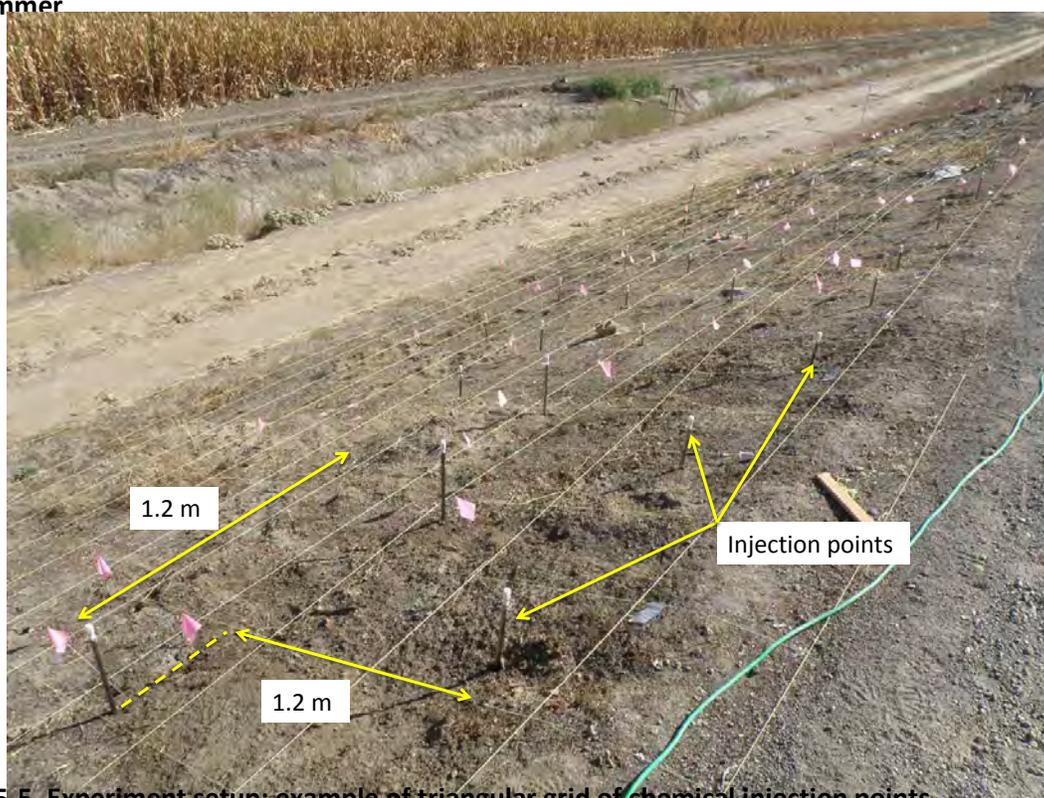
Figure 5-5. Experiment setup: example of triangular grid of chemical injection points

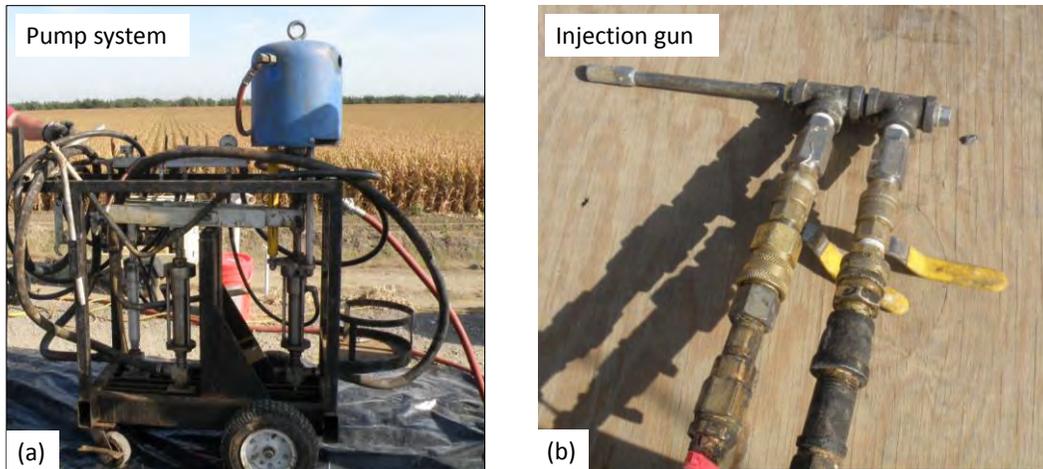
The polyurethane grout was pumped using a double stroke pump (Figure 5-6a) which regulates the amount of water and additive being transferred to the injection gun, commonly known as an 'F assembly' (Figure 5-6b). This gun joins the water and additive lines in a 0.5 cm diameter tube which mixes the two flows prior to entering each injection tube (Figure 5-7).

Figure 5-6. Experiment setup: (a) double-stroke pump system, (b) 'F assembly' injection device

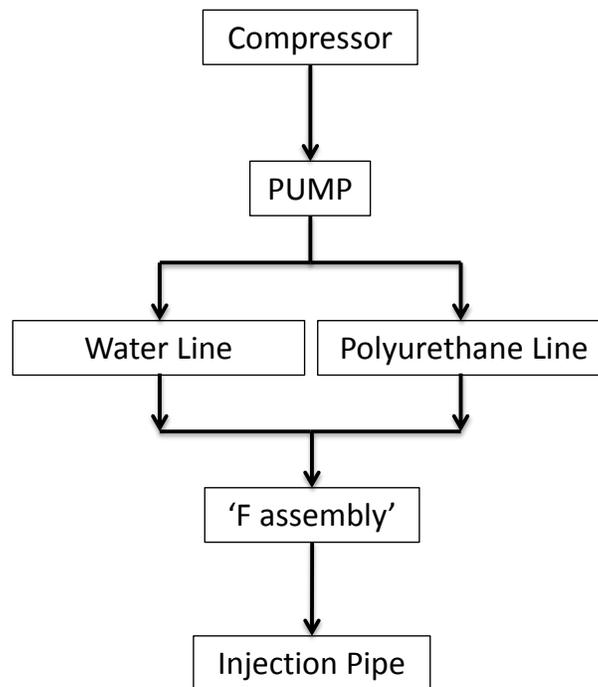
Figure 5-7. Flow chart of polyurethane grout injection process

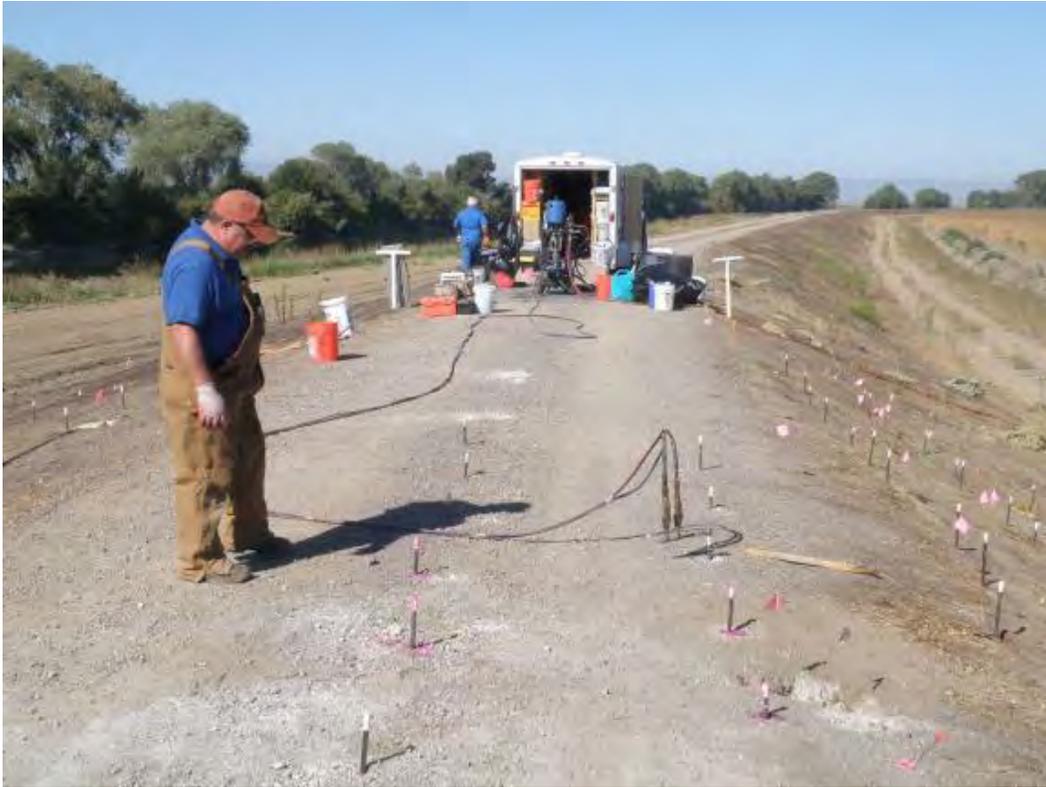
The polyurethane grout was pumped into each injection point (**Error! Reference source not found.**) until grout flowed back up around the tubing, out of the soil near the injection port, or out of a nearby burrow. Injections started at the lower line of pipes and moved upslope to form a barrier and decrease the amount of grout and water mix flowing downslope and away from the levee toe. This process generally took one to three minutes for each injection point, but some areas near the largest burrows took up to ten minutes per point.

Figure 5-8. View of chemical grout injection procedure

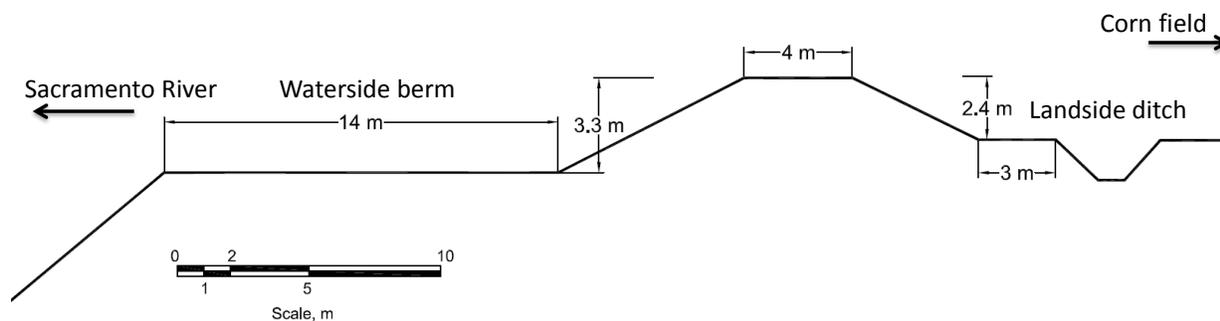
The sandy levee borders the eastern margin of the Sacramento River, several miles upstream of Sacramento, California. Figure 5-9 shows the cross section and the relative location of the embankment from the river and the available food source present approximately ten meters from the landside toe.

Figure 5-9. Cross section at Sandy Levee Site [1 m: 3.28 ft]

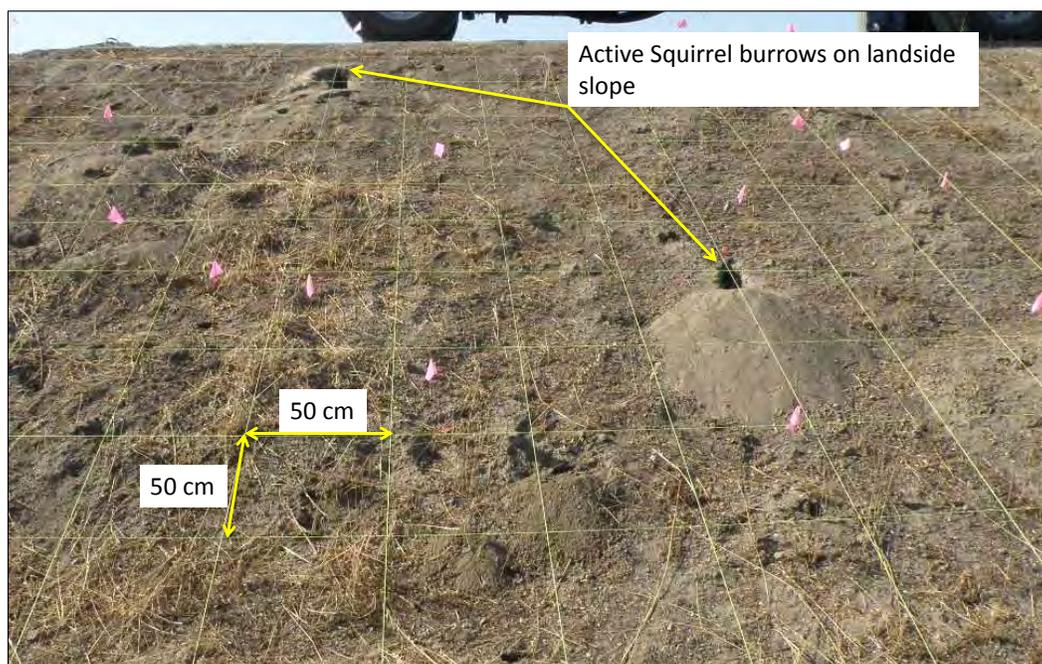
On the landside slope (Figure 5-10), several large active burrows were observed mid slope and towards the levee crown, with ‘porches’ of ejected material exceeding one meter in downslope length. Typical active burrow diameters ranged between 8 and 20 centimeters (0.3 and 0.7 ft), indicating the burrowing species was ground squirrel, which was confirmed later when several squirrels were observed emerging from nearby burrows. The upper bound of the diameter appears to be large for the common California ground squirrel, and can be explained by the fact that the levee material lacks cohesion or cementation and collapses easily; therefore the large size of some holes is likely the result of re-digging of previously smaller burrows (Van Vuren, 2012).

Figure 5-10. Typical active squirrel burrows on landside slope at Sandy Levee Site

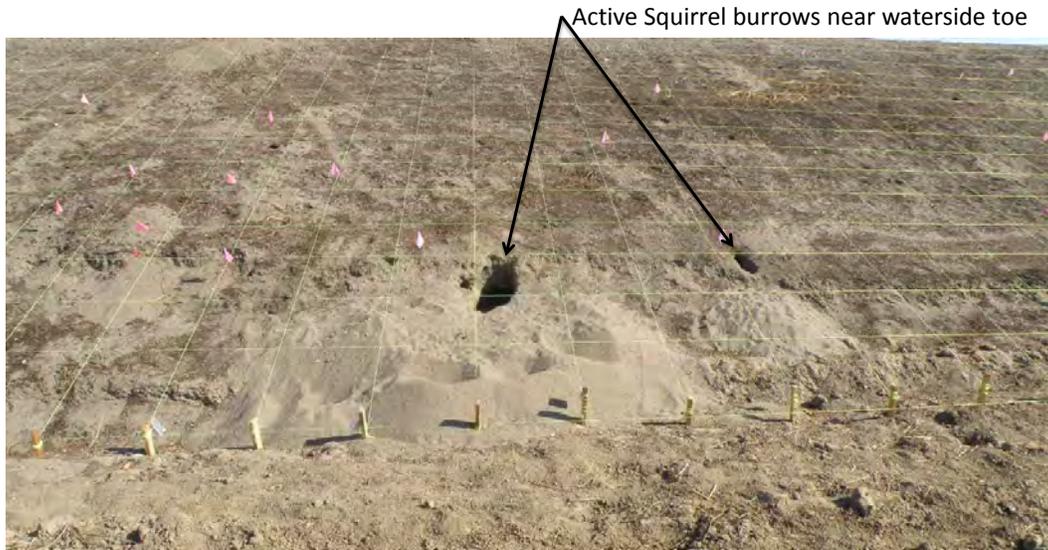
Figure 5-11. Largest active squirrel burrows on waterside slope at Sandy Levee Site

Figure 5-11 shows a view of the main burrows on the waterside slope. Two large burrows with an entrance diameter between 20 and 30 centimeters (0.7 and 1 ft) were observed near the waterside toe, and showed a large cone of ejected material. Other burrows along the waterside slope were generally small or inactive. Seventy-two burrows were surveyed on the landside slope; thirty-four burrows were encountered on the waterside slope, and six along the crown of the levee. The marked difference between landside and waterside slope is likely attributable to the proximity of the food source near the landside slope, and to layering of the levee embankment. The surveyed holes are indicated by pink flags on Figure 5-10 and Figure 5-11, and are shown in plan view on Figure 5-12. The plan view shows active squirrel burrows and all other holes where no differentiation of activity and species could be made because of recent burning of the levee slopes, which might have removed the material from the porches, and partially or completely collapsed some holes.

As noted above, a single large burrow was encountered on the waterside slope, approximately one meter above the levee toe. This burrow extended parallel to the toe between the two large active openings shown on Figure 5-11 and had two main arms extending into the levee. Figure 5-23 shows the initial excavation of this burrow, which extended approximately 2.5 meters in the direction parallel to the toe and was mostly filled with cement-bentonite grout between the two burlap bags indicating the cement-based grout injection points, except for a 40 centimeter (1.3 ft) segment filled with polyurethane that seemed to join the ends of the cement-bentonite grout. A 1.5 meter (5 ft) urethane-filled burrow was encountered to the western end (upper left side of Figure 5-23) of this system, extending approximately normal to the levee toe alignment.

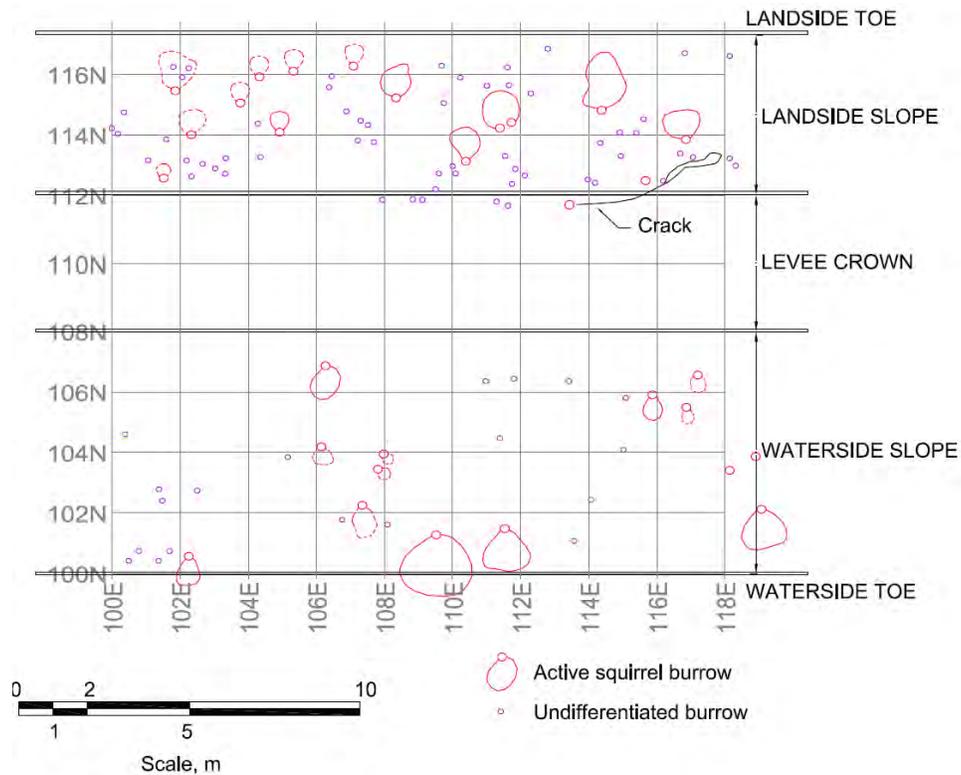
A burrow was classified as active based on the presence of material ejected downslope of the entrance, food waste and/or footprints in the vicinity of the entrance. A total of 14 active squirrel holes were surveyed on the landside slope, one on the crown near the landside hinge point and six on the waterside slope. Inactive burrows showed a similar trend; 58 inactive or collapsed holes were observed on the landside slope, while 19 were found on the waterside slope.

Figure 5-12. Plan view of surveyed burrows at Sandy Levee Site

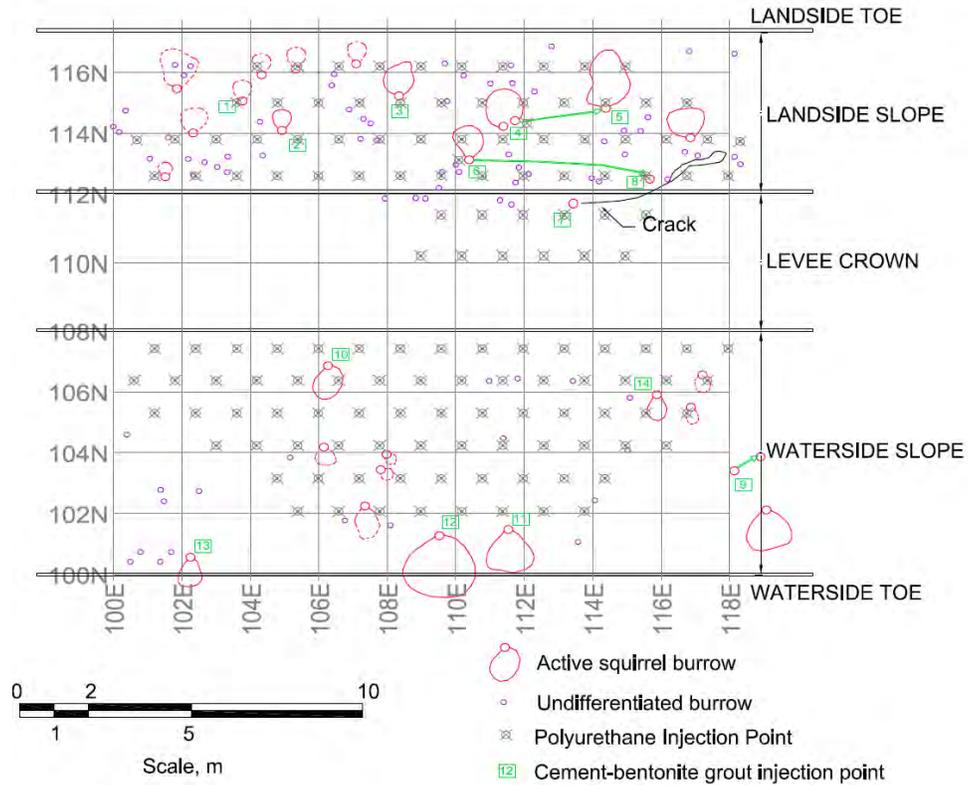
Figure 5-13 overlays the surveyed burrows and the injection points for the two types of grout used in this study. The green squares indicate the fourteen burrows where cement-bentonite grout was injected, and green arrows indicate instances when grout flowed out of holes adjacent to a burrow being grouted. The time required to fill every hole was recorded, and volumes were estimated using average flow quantities from the portable equipment ($0.01 \text{ m}^3/\text{s}$) used by DWR (Table 5-1). Typical DWR grouting activities target the largest holes with a clear and open surface expression; consequently only fourteen holes were grouted using this

A total of 140 polyurethane injection points were used at the Sandy Levee Site to cover the area under study (Figure 5-13). Similar to the cement-bentonite grout, times (and consequently volumes) of injection varied between injection points and were recorded.

Figure 5-13. Plan view of cement-bentonite and polyurethane injection points at Sandy Levee Site

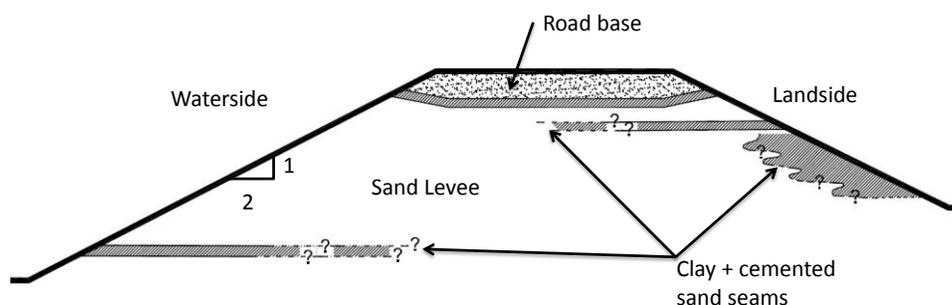
Samples LS-1, LS-2 and WS-1 correspond to the majority of the levee material, composed of silty sand with a mean grain size of 0.3 millimeters and 13 percent fines. The last sample was retrieved from a thin stiff silt seam near the waterside toe slope area. Most of the long burrows found during post-grouting excavation were encountered along the interface between the stiff seam and the loose sands. A simplified cross section for the Sandy Levee Site is shown on Figure 5-14.

Figure 5-14. Simplified cross section at Sandy Levee Site

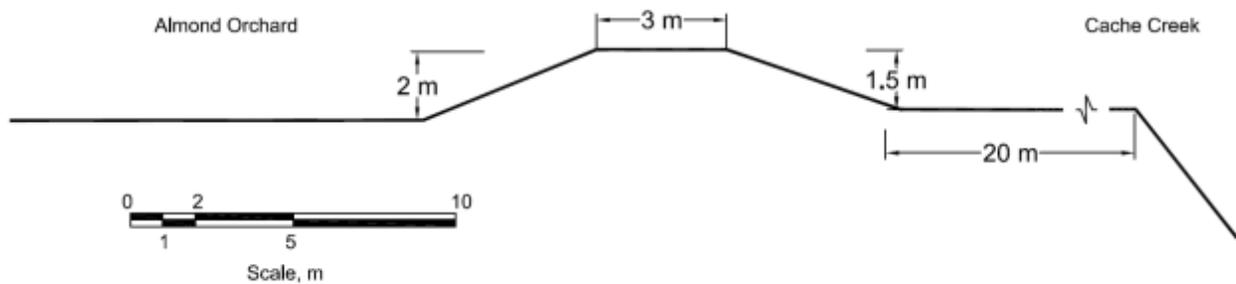
The clayey levee is located along the west bank of Cache Creek north of Woodland, California. Similar to the other site, this site also had an active small mammal food source very near the landside toe of the levee; Figure 5-15 shows the approximate cross section at this site. The creek channel is located 20 meters away from the levee and is deeply incised; therefore the levee is infrequently wetted during the flood season.

Figure 5-15. Cross section at Clayey Levee Site

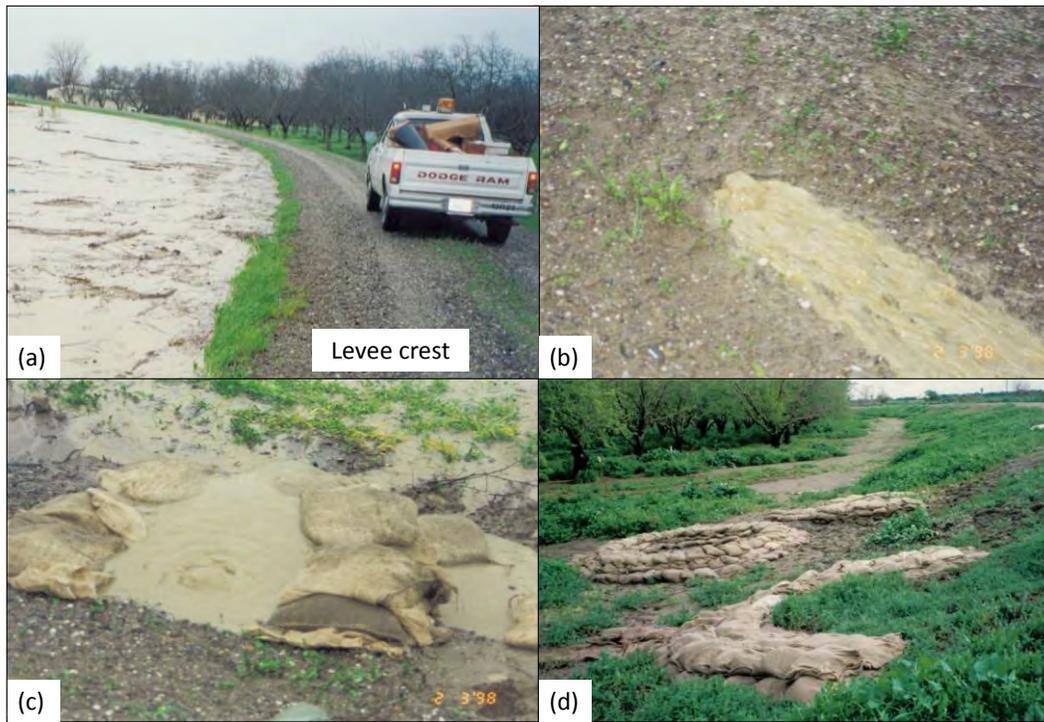
This site is of great importance to the history of grouting practices in California. During the floods of March 1998, this levee experienced water levels within 0.5 meters of the levee crown (Figure 5-16a). Sustained high water resulted in several sandboils and through-seepage on the clayey embankment (Figure 5-16b, c and d). This near failure was attributed to the presence of mammal burrows, which led to the beginning of current DWR grouting and maintenance programs. Since 1998, this levee has been used as a test site by the DWR, to perfect grouting techniques and mix compositions. Grouting takes place at the end of the spring season, and records of grouting volumes and number of burrows have been kept and were provided by DWR personnel (Figure 5-17). The figure shows that the volume of grout required to fill active or new burrow holes along this stretch of levee decreased every year despite having a food source next to the levee. The fact that several holes were flowing muddy water during the 1998 flows indicates that some of these burrows were completely penetrating the embankment and piping was occurring.

Figure 5-16. High water on Clayey Levee Site during 1998. Images courtesy Al Romero, DWR

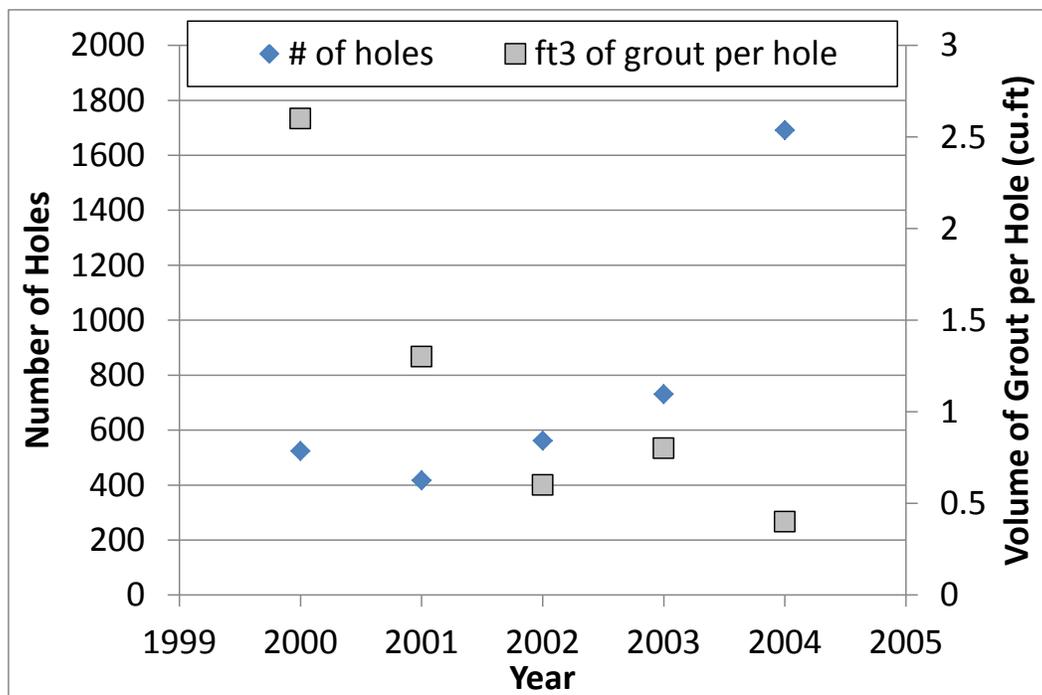
The data in Figure 5-17 suggests that even though the number of burrows encountered along the levee reach under study had increased by approximately 300%, the amount of grout used per hole has declined five-fold. Not shown on the plot is the amount of labor hours per hole, which declined from about two man-hours in 2000 to less than 0.5 in 2004. These results suggest that the adoption of a periodic burrow grouting program can mitigate the likelihood of a large burrow or network of burrows from penetrating a levee, and decrease the maintenance cost.

Figure 5-17. Volume of grout used on the Clayey Levee Site from 1995 to 2004 (data provided by Al Romero, DWR)

The total volume of cement-bentonite grout was 8% larger for the site with regular maintenance, which at first glance may not appear to be a significant difference to warrant yearly grouting. However, the data on Figure 5-17 suggests that through the implementation of a regular, ongoing grouting program the amount of cement bentonite grout needed to fill burrows decreases over time, which would correspond to reduced maintenance effort and reductions in yearly materials and manpower costs over time.

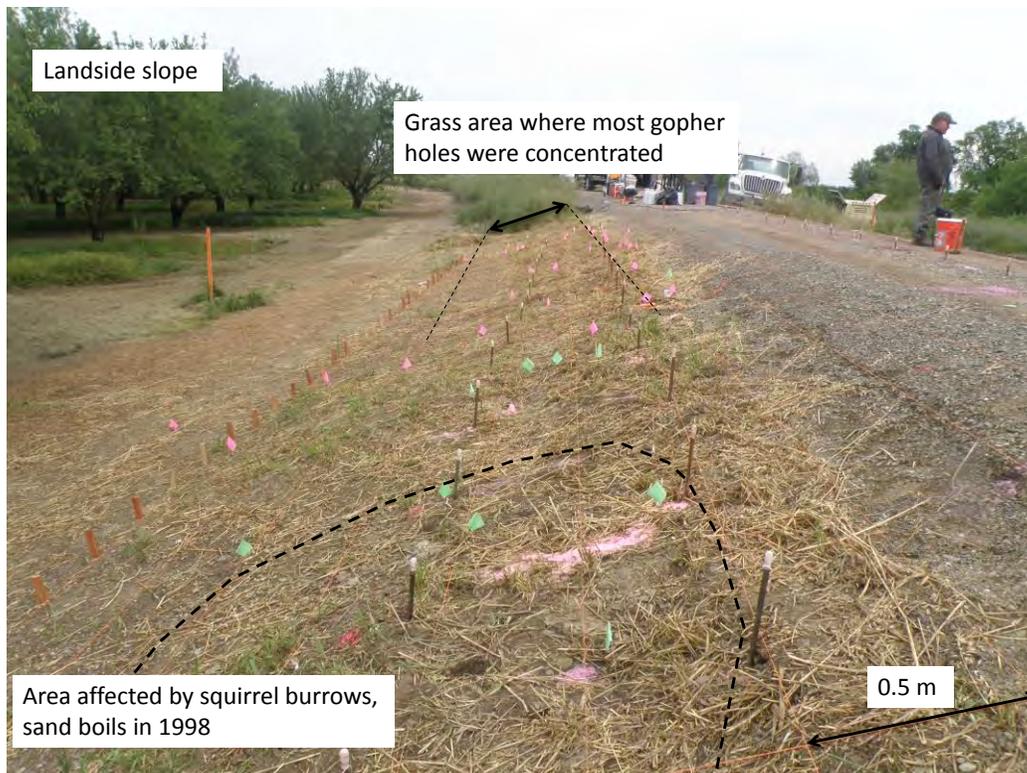
In general burrowing activity observed during the present study was mainly by gophers, with a few isolated squirrel burrows. Typical burrows had diameters ranging from five to ten centimeters, and were mostly concentrated in the upper half of both landside and waterside slopes, coinciding with a strip of grass that was not mowed by the landowner. Most evidence of recent small mammal activity was unfortunately lost shortly before the site work commenced because of mowing and burning of the slope surfaces, but the entrances to the main burrows remained relatively intact. Figure 5-18 shows the landside slope prior to excavation, indicating the location of burrows and one of the sandbag rings shown on Figure 5-16d.

Figure 5-18. Location of burrows on landside slope at Clayey Levee site. Pink flagging indicates location of undifferentiated burrows, green flagging indicates burrows historically grouted with cement-bentonite by DWR.

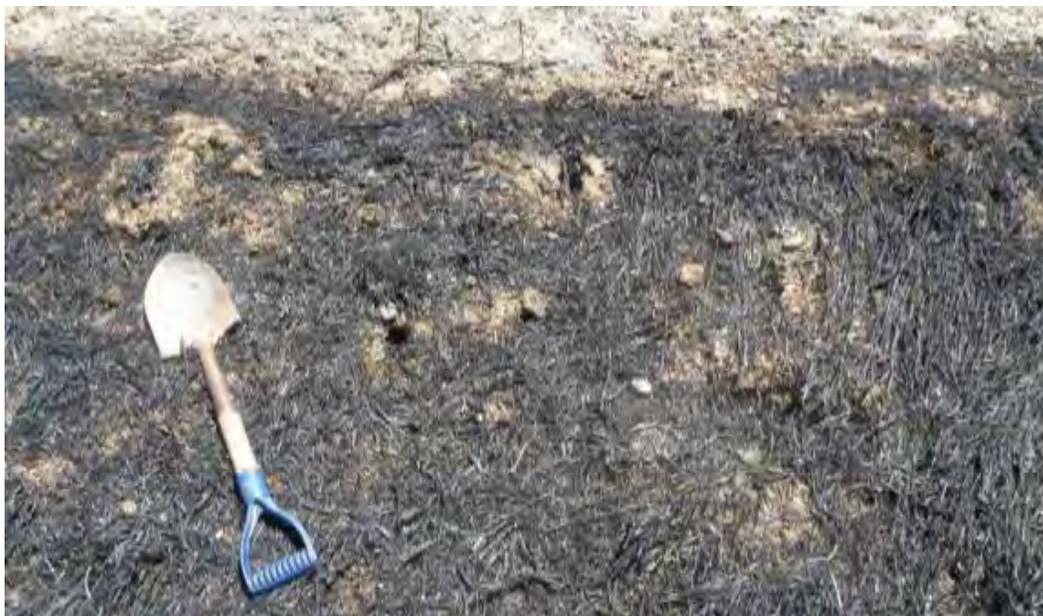
Similar level of burrowing activity was observed on the waterside slope, with most of the burrows concentrated on the upper half of the slope (Figure 5-19). In contrast with the sandy levee, the few remaining ejected soil ‘porches’ were composed of chunks of clay and few gravel particles, representative of the material composing the levee embankment. The site was surveyed following the same procedure as described for the other site, but differentiation of active and inactive holes was more challenging on this site because of the previously mentioned mowing and burning. A plan view of identified burrows is shown on Figure 5-20. Twelve active squirrel burrows were encountered along the 20-meter long test section; fifty-two unidentified burrows were logged on the waterside slope, and seventy such holes on the landside. Based on conversations with Dr. Dirk Van Vuren of UC Davis, most of these small, unidentified holes were classified as gopher holes. The urethane grout injection plan (Figure 5-21) included seventy five ports distributed in a grid pattern and spaced at 1.2 meters (four feet).

Figure 5-19. Typical squirrel burrows on waterside slope at Clayey Levee Site

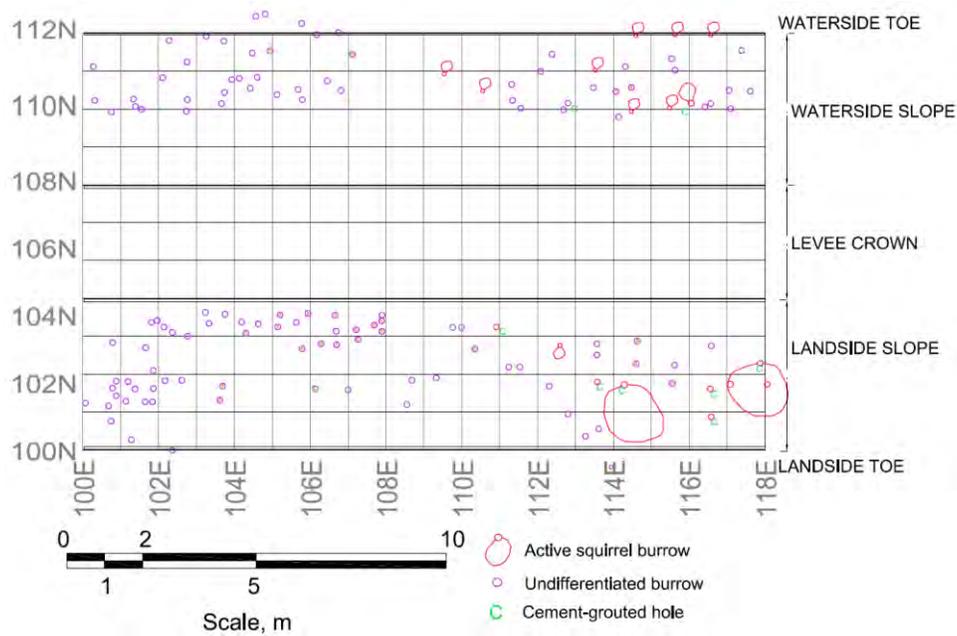
Figure 5-20. Plan view of identified burrows at the Clayey Levee Site
