Transient Seepage Through Levees and the Influence of Roots and Animal Burrows

Ph.D., [Civil and Environmental Engineering](#) [UC Berkeley](#)

Transient Seepage Through Levees and the Influence of Roots and
Animal Burrows

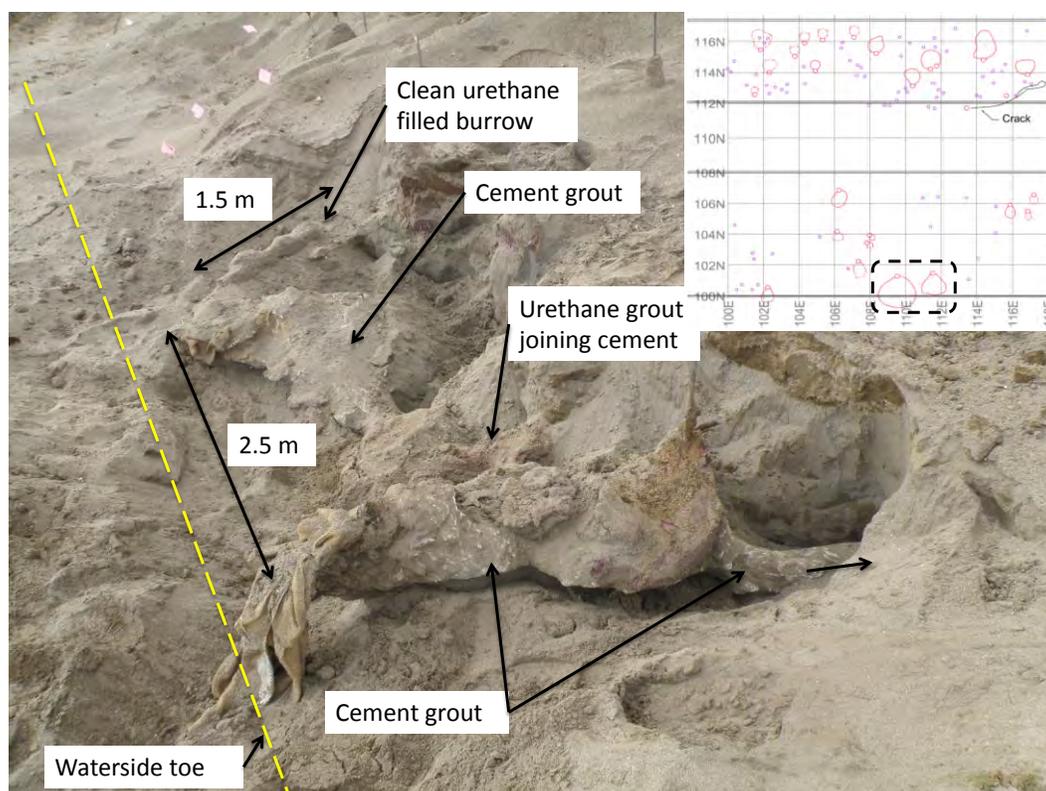
As noted above, a single large burrow was encountered on the waterside slope, approximately one meter above the levee toe. This burrow extended parallel to the toe between the two large active openings shown on Figure 5-11 and had two main arms extending into the levee. Figure 5-23 shows the initial excavation of this burrow, which extended approximately 2.5 meters in the direction parallel to the toe and was mostly filled with cement-bentonite grout between the two burlap bags indicating the cement-based grout injection points, except for a 40 centimeter (1.3 ft) segment filled with polyurethane that seemed to join the ends of the cement-bentonite grout. A 1.5 meter (5 ft) urethane-filled burrow was encountered to the western end (upper left side of Figure 5-23) of this system, extending approximately normal to the levee toe alignment.

Finally, the largest and more important component of this burrow system was observed near the eastern edge of the burrow (bottom right of Figure 5-23), where a large diameter burrow mainly grouted with cement extended from the burlap bag approximately 2 meters (6.6 ft) into the levee with an average diameter of 40 centimeters.

Figure 5-23. Exposed burrow system near waterside toe, Sandy Levee Site

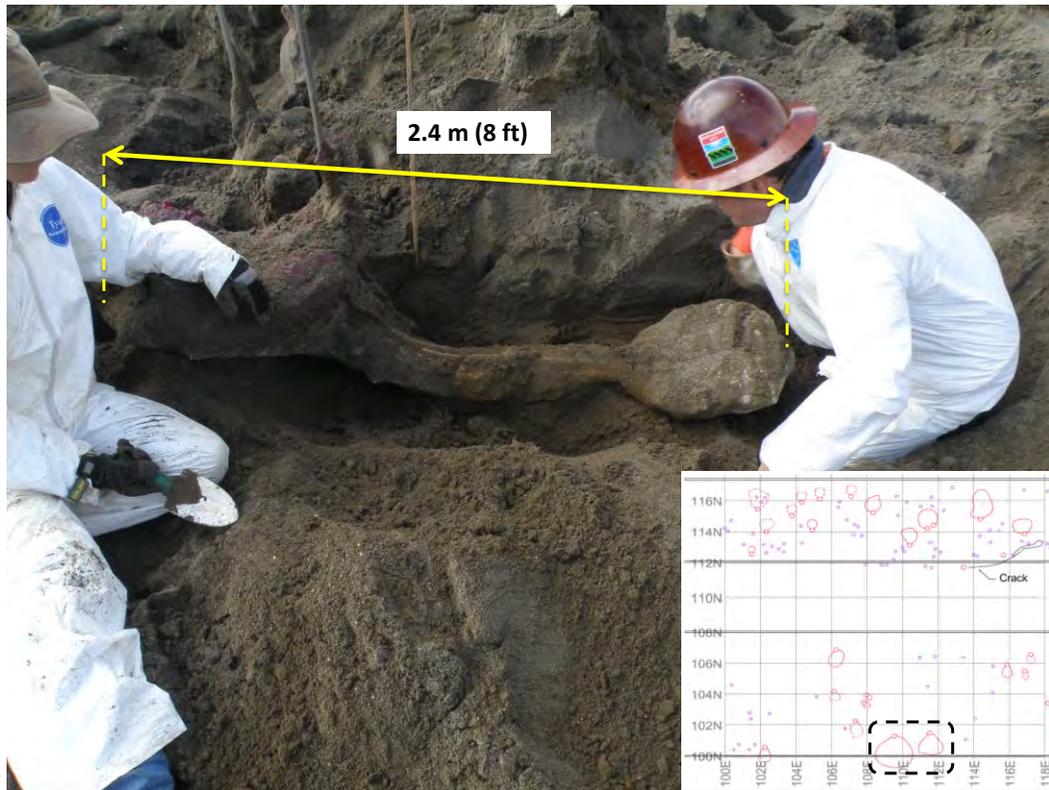
The diameter of the burrow decreased to approximately 20 centimeters and continued into the levee for an additional 2.4 meters (7.9 ft) (Figure 5-24). It terminated in a disc-shaped den of approximately 35 centimeters in diameter and 20 centimeters in thickness. A 30 centimeter long tunnel was observed extending below the den (Figure 5-25), which could have been used as a disposal for droppings by the burrowing animal (Van Vuren personal communication, 2012).

The location of the main burrow and den coincided with the interface between the silty material and the loose sand composing the majority of the levee. The stiffer fine-grained soil apparently provided a stable roof for the burrow and allowed the animal to dig efficiently in the loose sand. This observation was consistent for almost all burrows at this site.

Figure 5-24. Continuation of waterside burrow into the levee, Sandy Levee Site

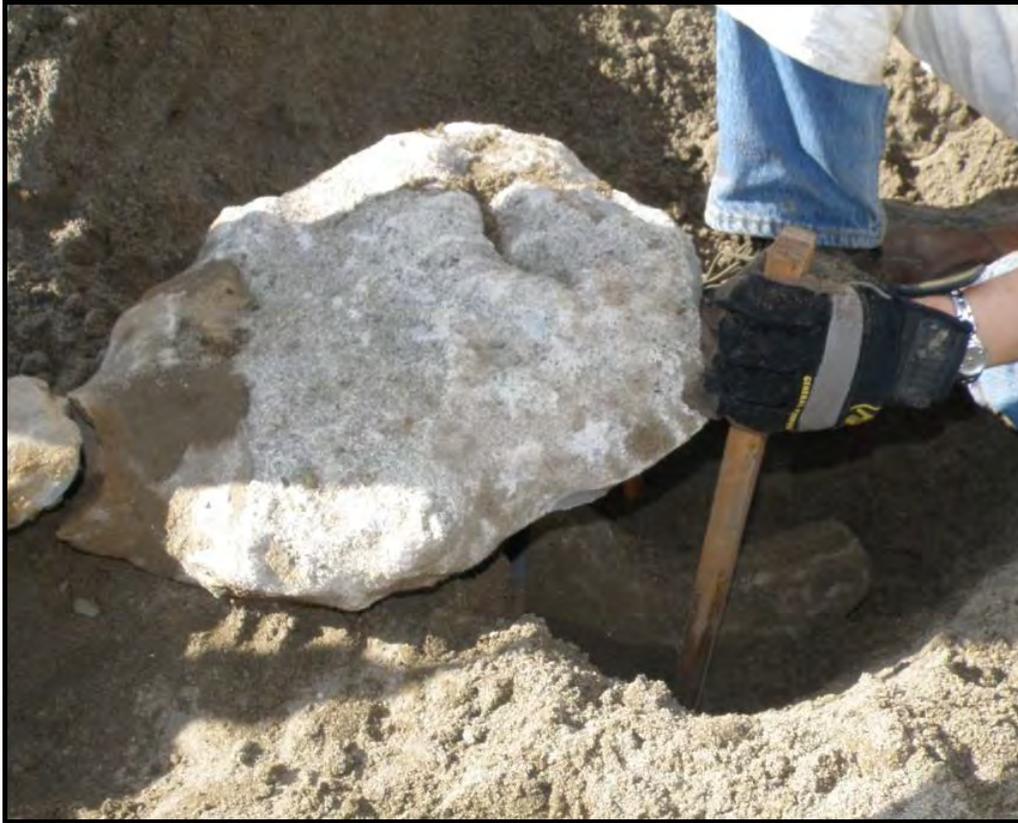
The total length of the waterside burrow system was measured to be 5.2 m, and its approximate volume was 0.3 m^3 (10.5 ft^3). Approximately 70% of this volume was comprised of cement-bentonite grout, and the remaining 30% of polyurethane grout. The void left by the new burrow was not considered in these volume estimates.

Figure 5-25. Close up of den (grout mass) near waterside toe, Sandy Levee Site. The wooden stake points to a short burrow below the den

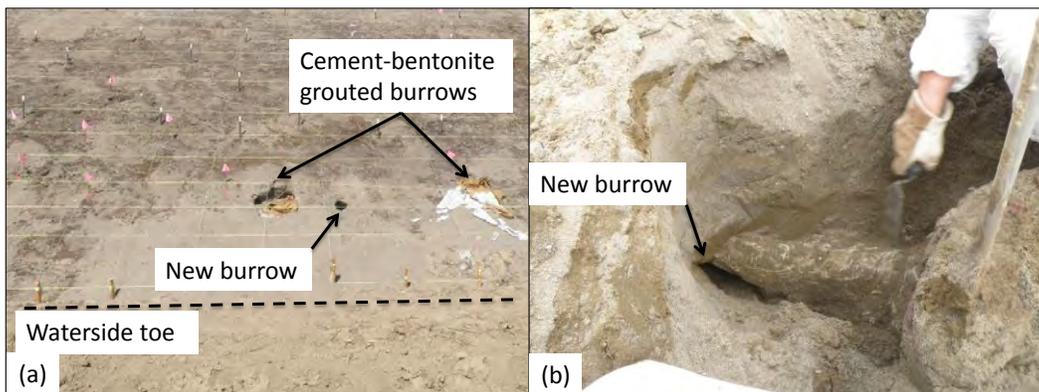
Evidence of the persistence of burrowing activities was observed during the grouting: sometime during the two weeks between the end of the cement-bentonite grouting and the start of the polyurethane grouting programs, a new hole was observed between the two large active burrows near the waterside toe shown on Figure 5-11. Excavation revealed that this new hole followed the previously grouted linear burrow into the levee and likely reached the disc-shaped

den; but it is unclear whether it was created as a new burrow or if it was dug as an escape route by an animal trapped in the adjacent grouted tunnel. Figure 5-26a shows the location of the new burrow entrance relative to the previously grouted large burrows. Figure 5-26b is a close up of the 10 centimeter-diameter (0.3 ft) ungrouted new burrow below the cement grouted burrow.

Figure 5-26. New hole after cement-bentonite grout on waterside toe, Sandy Levee Site. (a) shows the location of the new burrow and (b) shows the partially excavated open burrow below the cement-grouted main tunnel

Another key observation is the persistence of burrowing activities, as shown on Figure 5-26, a new burrow was dug between the two large burrows near the waterside toe after the cement-bentonite grout was injected, and followed the alignment of the grouted burrow. Furthermore, during a field visit several months after the test was completed and the levee had been rebuilt, new burrows were observed within the repaired levee section (Figure 5-40) and on the landside berm.

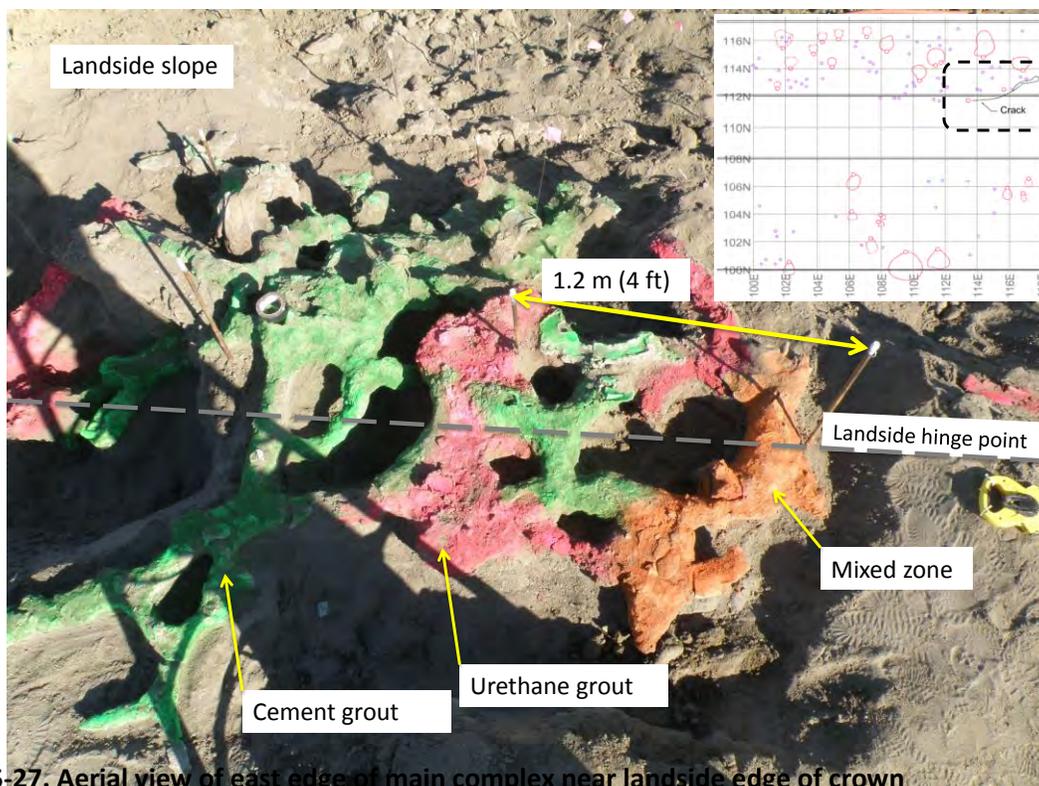
Figure 5-27 shows a view from the top of the eastern edge of the main burrow complex, which consisted of a series of intertwined tunnels ranging from five to fifteen centimeters in diameter occupying an area of approximately 2.5 meters (8.2 ft) in the direction parallel to the slope (left to right of photo) and 1.7 meters (5.5 ft) in the normal direction. This area contains the largest volume of grout in the study and coincides with cement-bentonite injection point number 4 in Table 5-1, which took approximately 25 minutes to fill.

The colored grout on Figure 5-27 indicates a large portion of the complex was filled with cement-bentonite grout (green color), and several large pieces were filled by the polyurethane grout (pink color). Several additional polyurethane injection ports were installed in this area with the objective of effectively filling all voids; however, some of these ports were inadvertently pushed through the already hardened cement-bentonite grout, causing it to break and allowing polyurethane to flow through the cracks and generate a mixed grout area, colored with orange spray paint (right edge of burrow complex).

Figure 5-27. Aerial view of east edge of main complex near landside edge of crown

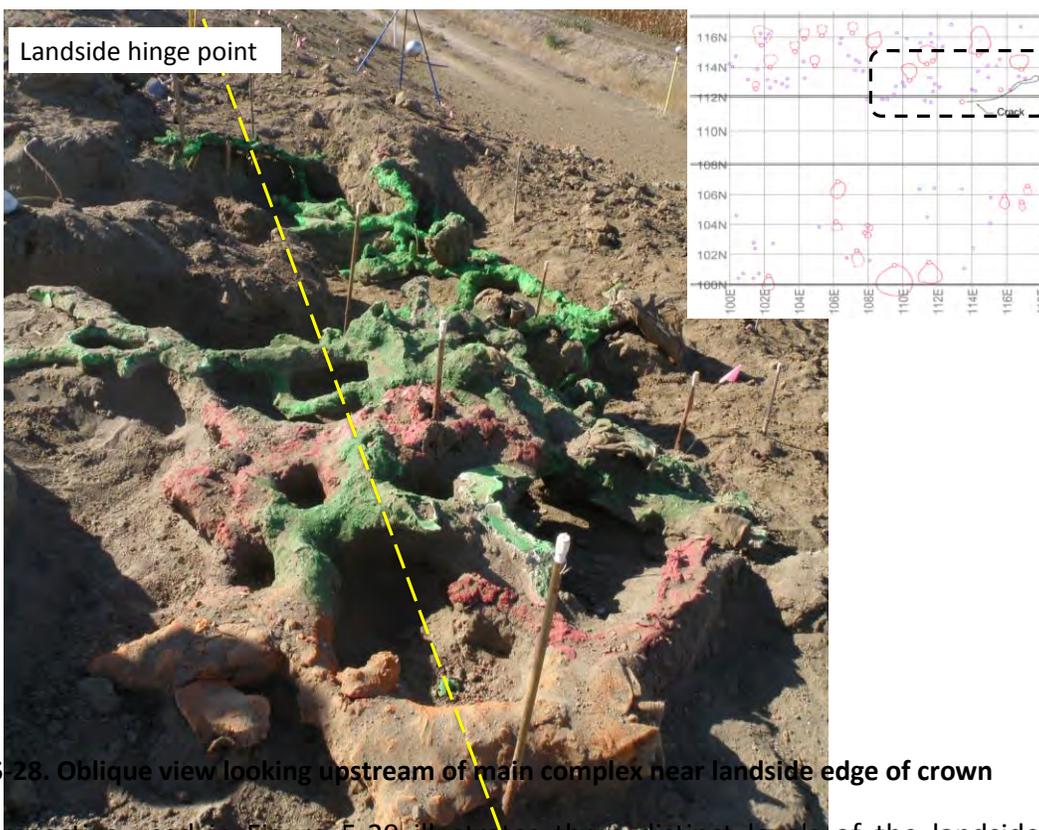
The burrow complex extended upstream (top of Figure 5-28) and divided into two main tunnels of approximately 15 centimeters (0.5 ft) in diameter; the alignment of these tunnels dipped down approximately 50 centimeters (1.6 ft) and converged into a single tunnel that sharply increased in elevation at the end of the burrow system. Figure 5-29 shows a lateral view of the landside burrow complex at the end of the excavation activities, at which point the main intertwined portion (Figure 5-27) had been removed to expose deeper portions of the system.

Figure 5-28. Oblique view looking upstream of main complex near landside edge of crown

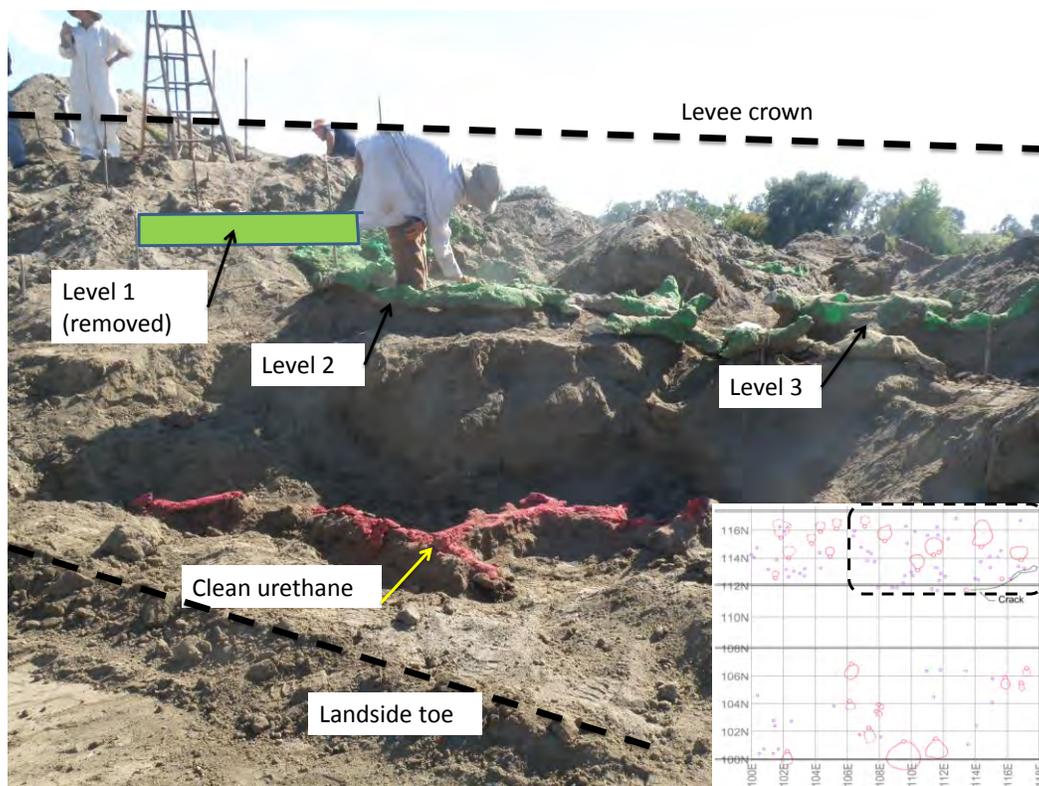
The perspective used in Figure 5-29 illustrates three distinct levels of the landside burrow system: (1) the shallowest portion of the complex coincides with the very dense and

intertwined zone previously described, which connected all the cement-bentonite grout injection points; (2) a deeper level, where the system of burrows is composed by two main tunnels, and (3) a single tunnel that sharply rises to an elevation similar to level 1. An isolated burrow grouted exclusively with polyurethane was observed near the landside toe (bottom of Figure 5-29); approximately 1.5 meters (4.9 ft) below level 2 of the main complex and extended 2 meters (6.6 ft) parallel to the levee alignment, with a sharp turn towards the interior of the levee.

Figure 5-29. Lateral view of landside levee slope burrow system

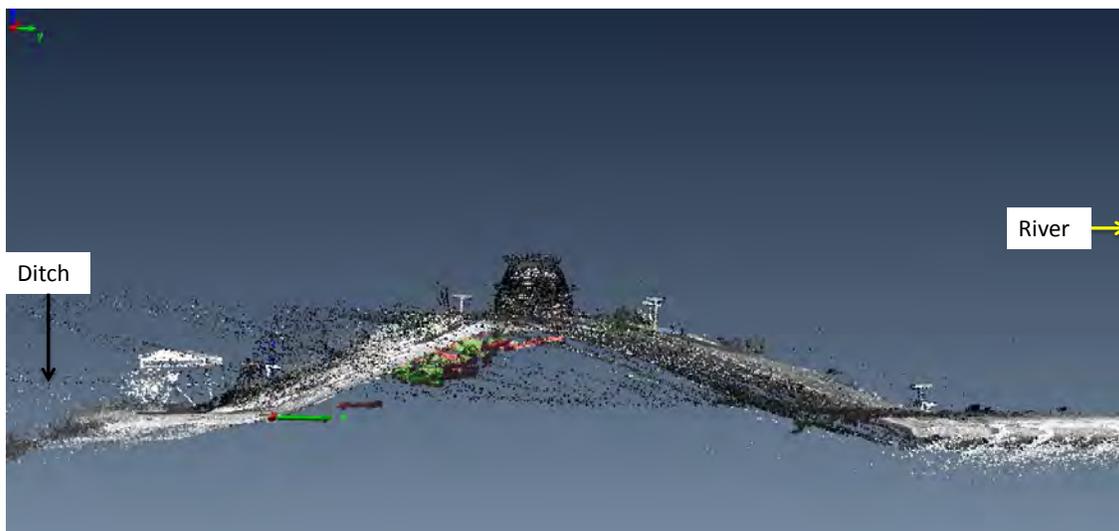
Figure 5-30. Cross section showing LiDAR data on Sandy Levee Site

T-LiDAR data collected by USGS was processed using the program IMVIEW, allowing the differentiation of the different types of grout and consequently estimating lengths and volumes. For estimation of grout volumes, individual burrow segments were exported as point clouds to AutoCAD, and a three-dimensional surface was fitted along the points on the surface of the burrow. Figure 5-30 shows a cross sectional view of the T-LiDAR data, with the waterside slope to the right of the figure. This image allows visualizing the extension of the landside burrow system from the toe to essentially the centerline of the embankment. Figure 5-31 and Figure 5-32 contain close-ups of the landside and waterside burrow systems, respectively.

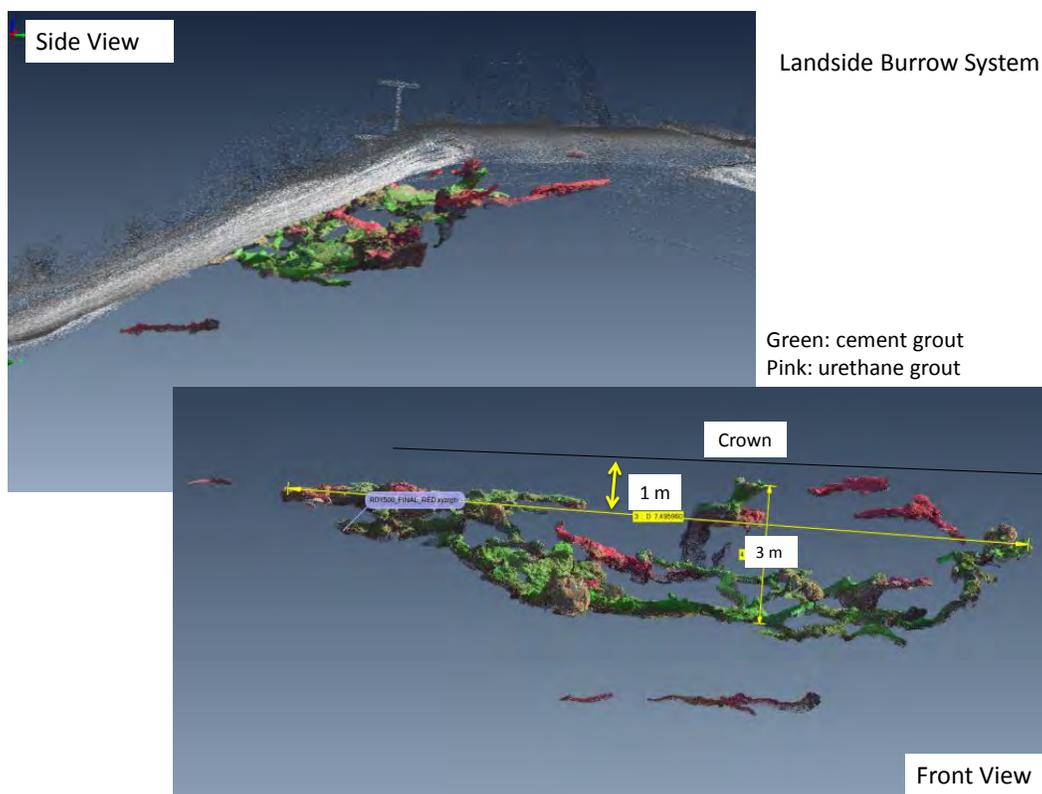
Figure 5-31. Close-up of landside burrow system (a) shows a cross section view, (b) a front view [1 m: 3.28 ft]

The figures below illustrate how intricate and large burrow systems can become if no grouting (or void filling) or species control is performed on a levee. The surveyed burrows extend for several meters in all directions. Even though a burrow extending from one side of the levee to the other was not encountered, the potential for wetting front penetration and rapid saturation is clear given the large volume of voids generated within the embankment.

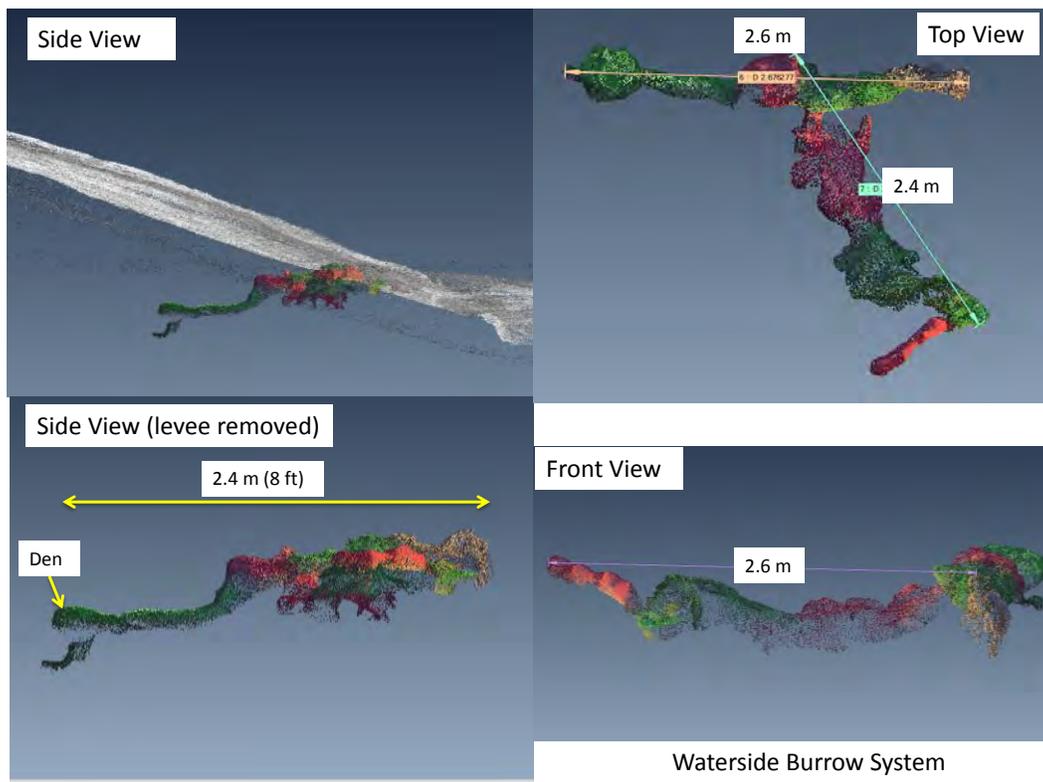
Figure 5-32. Views of the waterside burrow system [1 m: 3.28 ft]

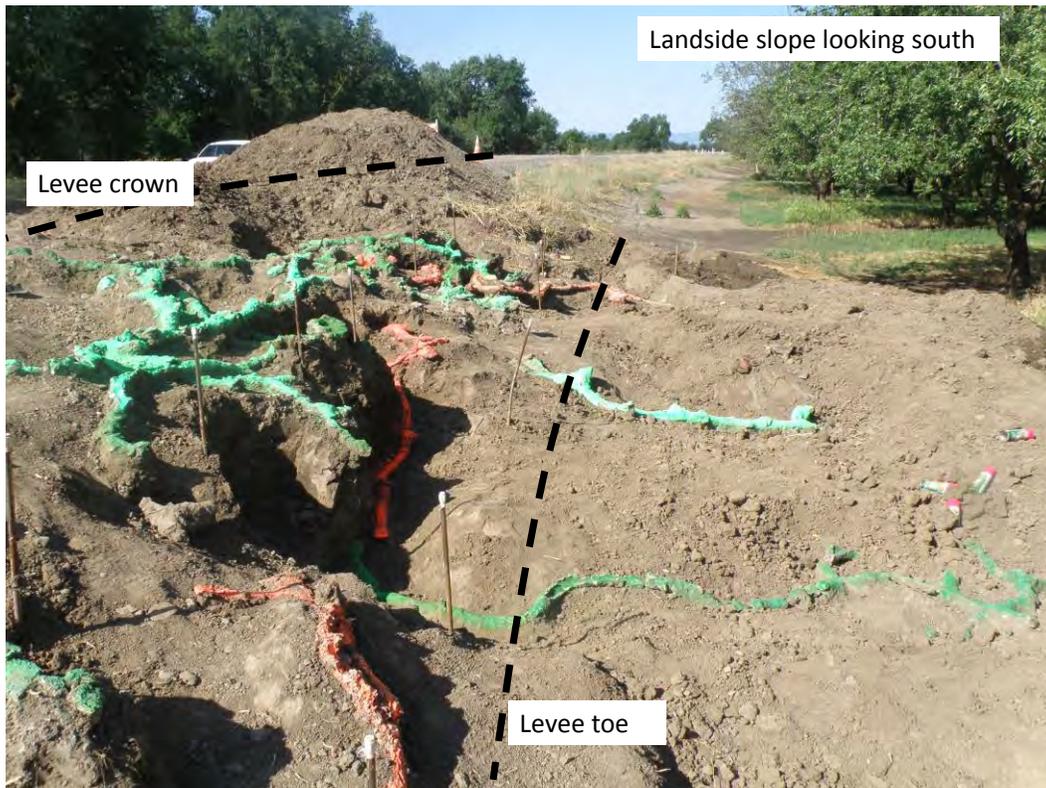
Figure 5-33. View of excavated landside slope at Clayey Site

The majority of the burrows were found approximately 0.5 to 1.0 meters (1.6 to 3.3 ft) below the surface of the slope and crown, and only a few isolated burrows extended landward into the toe area, as shown on the right hand side of Figure 5-33. A single burrow was encountered extending from the waterside toward the landside slope (Figure 5-34 and Figure 5-35), approximately one meter below the elevation of the crown. This burrow was approximately 12 to 15 cm in diameter, and was grouted during a previous maintenance campaign with cement-bentonite grout. The grout was observed broken up and relatively easily friable, suggesting that the grout filling this hole belongs to early practices, when DWR used a higher percentage of

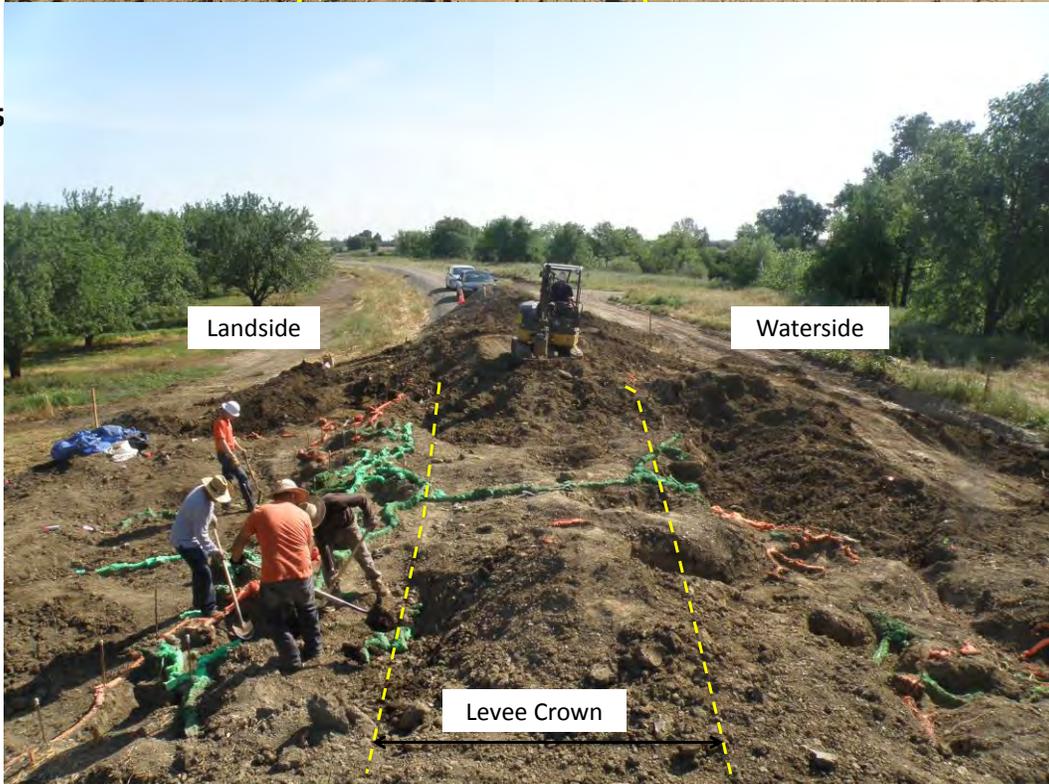
Figure 5-35. View looking north of completely penetrating burrow

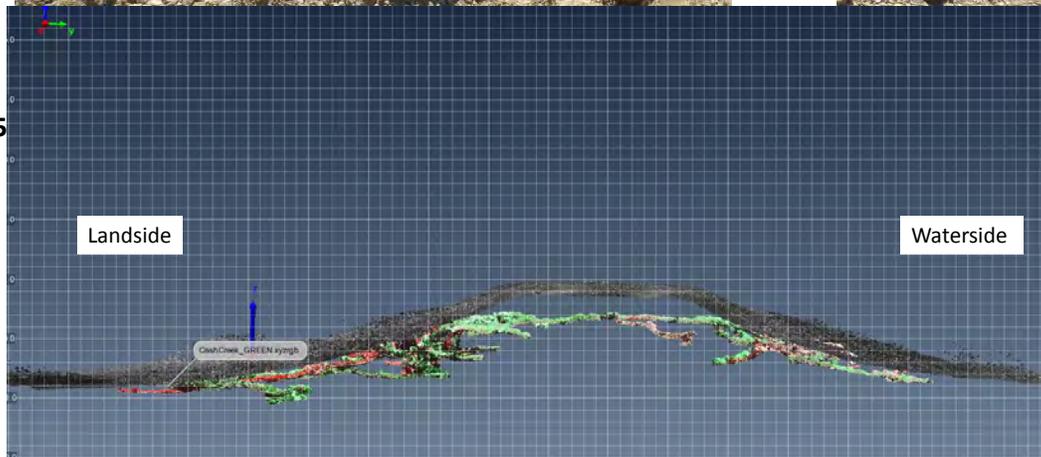
Figure 5-37. Cross section view of completely penetrating burrow at Clayey Levee Site

Numerical simulations are employed in the following chapter to assess the influence of animal burrows on the seepage performance of embankments, from the point of view of wetting front instability and soil piping. Piping, which is considered an important threat to levee safety is highly dependent on three factors: (1) flow through the porous media around the pipe, (2) length and size of the pipe, and (3) particle stability. The fact animal burrowing has the capacity to create completely penetrating burrows eliminates the variable of flow through the porous media, since the full hydraulic heads from the riverside are charging along the entire cavity with minimal energy loss, and piping potential is reduced to a function of flow velocity inside the pipe, which in turn is dependent on the head differential between the water surface on the riverside and the entrance to the pipe. Figure 5-37 and Figure 5-38 show a cross section and plan views of the completely penetrating hole and burrow system. The penetrating burrow was approximately one meter below the top of the levee, almost perpendicular to the levee alignment.

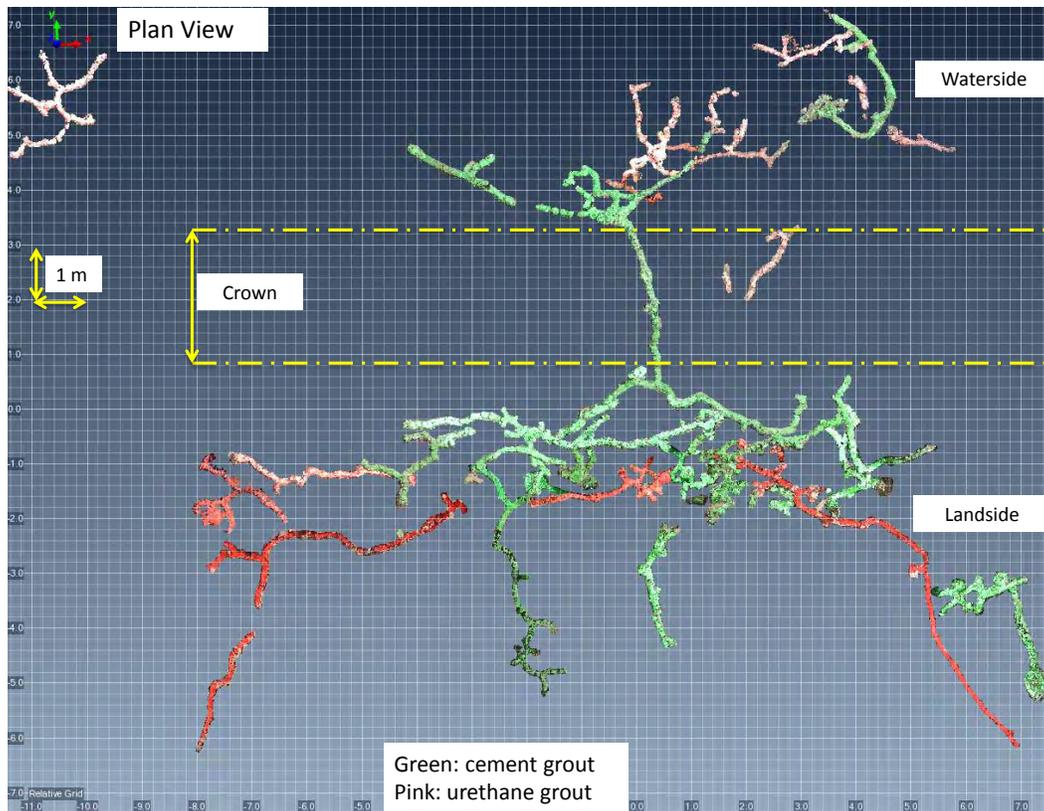
Figure 5-38. Plan view of burrow system at Clayey Levee Site

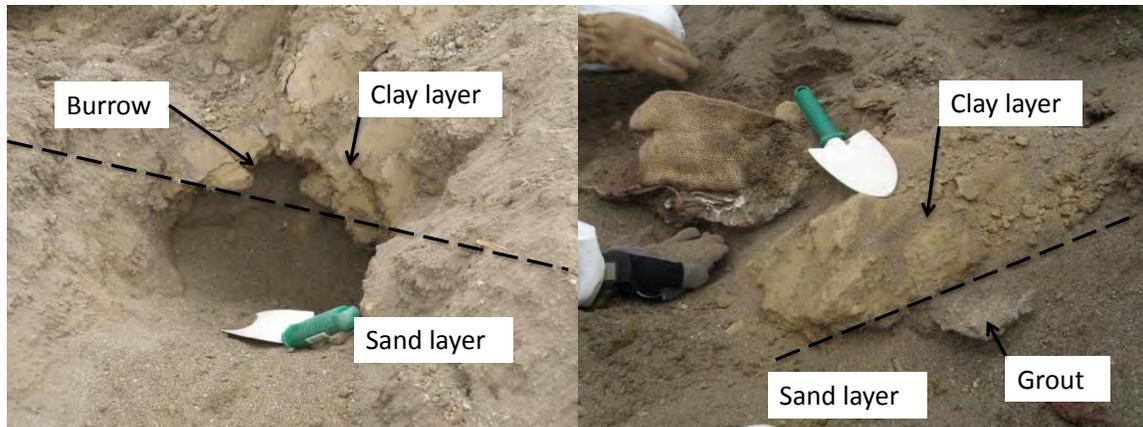
Figure 5-39. Layer interface facilitating burrowing at Sandy Levee Site

Layering was also observed to have a strong influence on the amount and extent of burrowing at the site. Figure 5-39 shows two instances where the burrows follow an interface between a stiff fine-grained or cemented sand layer overlying the loose sand material composing most of the embankment, most likely because the animals prefer to dig through the loose materials, while at the same time having a stiff and stable roof. This was the case for most of the burrows observed at the site as well as other sandy levees. Similarly, Harder et al (2012) investigated root penetrations into a slurry wall and found a squirrel burrow penetrating the slurry wall from the crown of the levee and extending several feet below the crown along the interface of the slurry wall and surrounding sandy embankment.

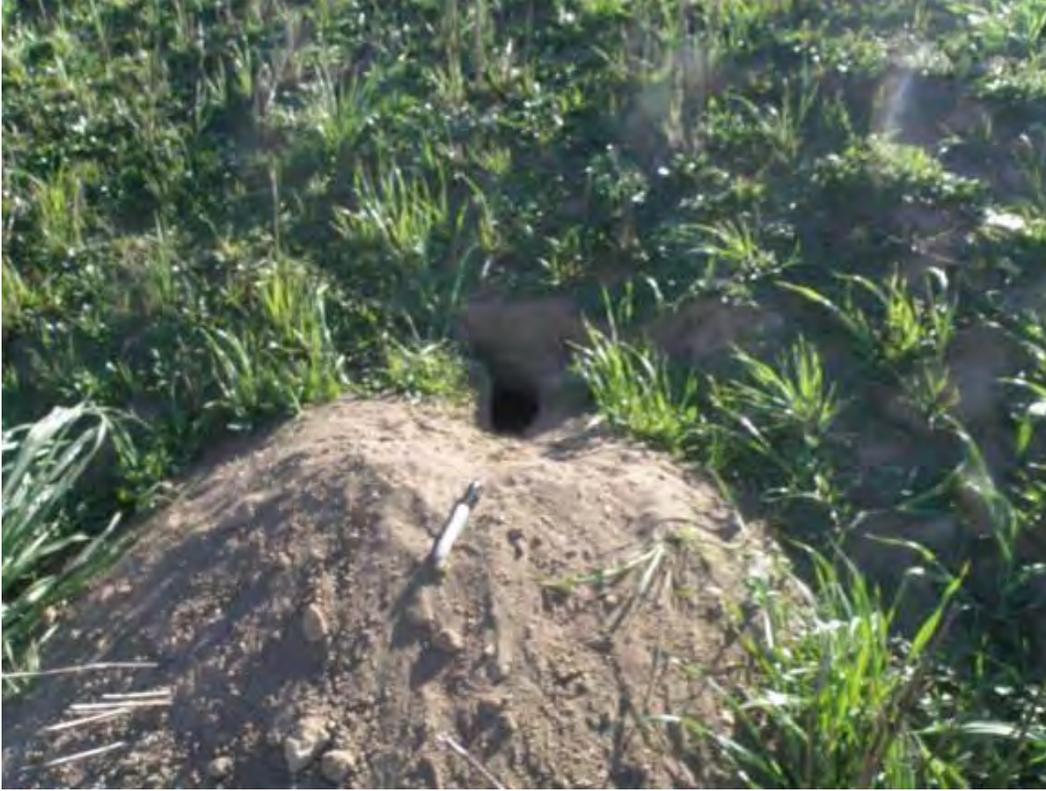
Figure 5-40. New burrows on landside slope of reconstructed Sandy Levee Site

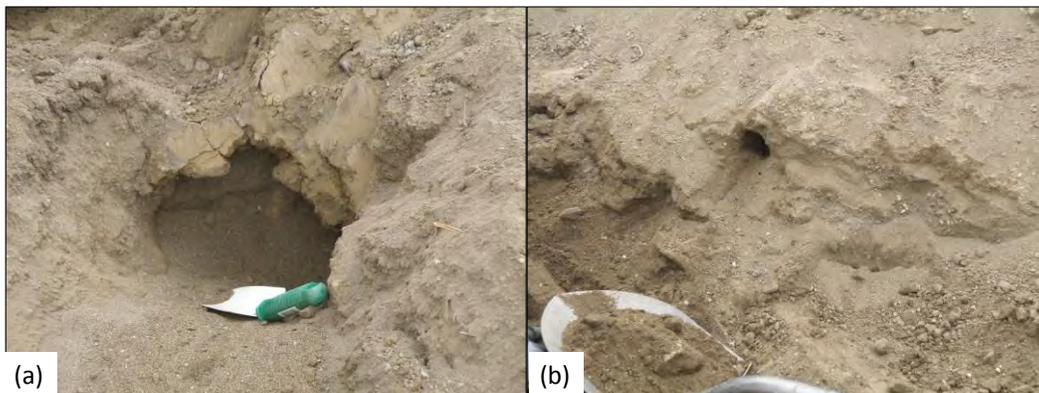
Figure 5-41 UngROUTED burrows on Sandy Levee Site. (a) shows a burrow near Level 1 of the large landside burrow complex, and (b) is an ungrouted burrow to the west of the same complex

Despite the relatively large amount of cement-bentonite and polyurethane grout injected into the embankments, several ungrouted burrows were encountered during excavation of both sites, especially at the sandy levee site, which, as discussed earlier, does not have a regular grouting program in place by the reclamation district. Figure 5-41 shows two ungrouted burrows encountered during excavation. These once again coincided with the interface between a stiff fine-grained layer and the sandy embankment (Figure 5-41a) and the contact between the compacted road base and underlying levee material (Figure 5-41b).

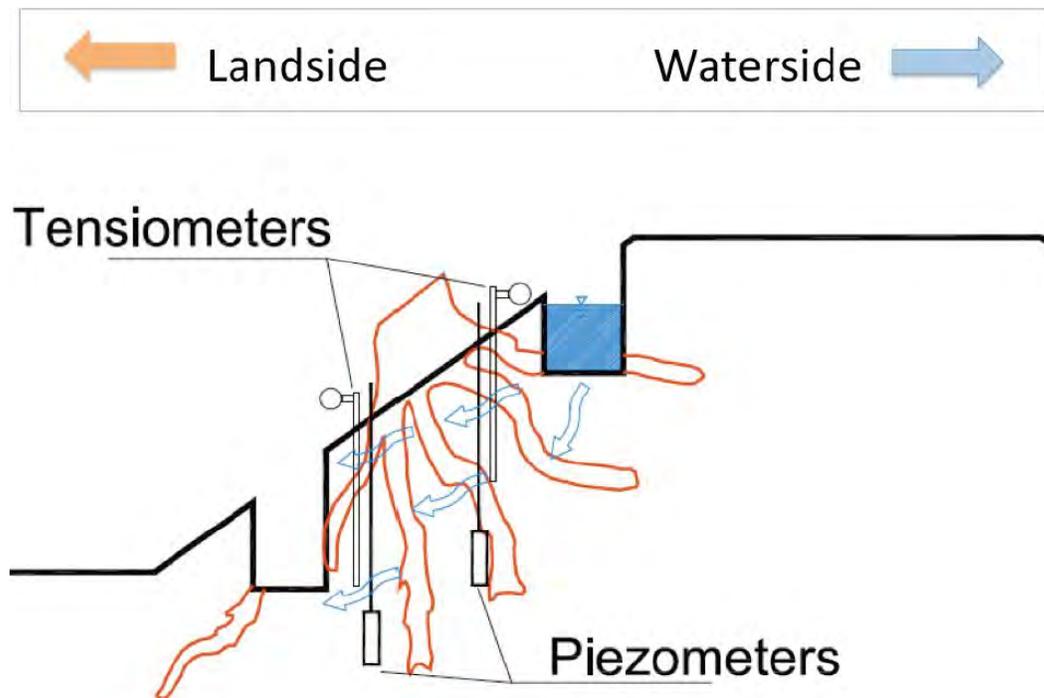
Figure 6-1. Generalized cross section of wetting front test (Shriro et al., 2011)

The principal objective of the field test was to study the influence of woody vegetation on the seepage patterns through the unsaturated portion of an embankment. Figure 6-1 is a simplified cross section showing the main elements of the test. Parallel trenches were excavated above (near the landside levee crown) and below (near landside levee toe) of a decomposing stump of a eucalyptus tree that was cut down around 1993. An additional set of trenches was excavated

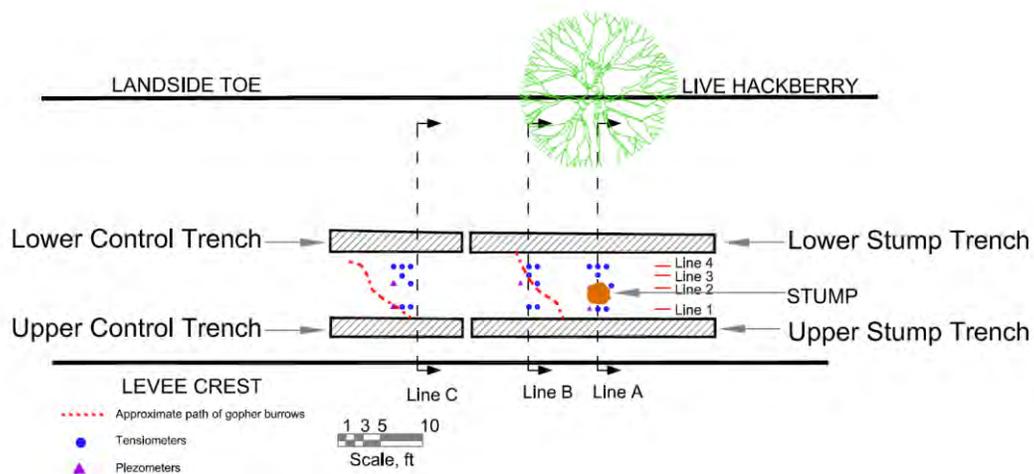
Figure 6-2. Plan view of wetting front test (Cobos et al., 2012) [1 ft: 0.31 m]

away from the stump to provide control conditions (Figure 6-2). The wetting front test consisted on filling the upper trenches with water, establishing a pressure head condition of 60 to 90 cm (2 to 2.5 ft) and monitoring the progression of the wetting front from the upper to the lower trench using an array of tensiometers and piezometers.

Three lines of instruments (Lines A, B and C on Figure 6-2) were laid out with nests of tensiometers installed in depths ranging from 45 cm to 150 cm and vibrating wire piezometers from 150 to 210 cm, with the objective of covering the shallower soil layers where most of the root mass was located. Figure 6-3 shows a detailed instrumentation layout, with the location and name of each instrument installed at this site. The nomenclature used to name the instrument is as follows: the first letter indicates the type of instrument (T: tensiometer, P: piezometer), the following number indicates the row the instrument was located at (1 through 4 – line 1 was located near the upper trenches, and line 4 just above the lower trenches), the following letter indicates the instrument line (A through C), and the last number indicates the depth of the instrument in inches. Instrument Line A was located through the decomposing stump, Instrument Line B was located approximately 2.5 m left (east) of Line A, and Instrument Line C was located through the control trenches.

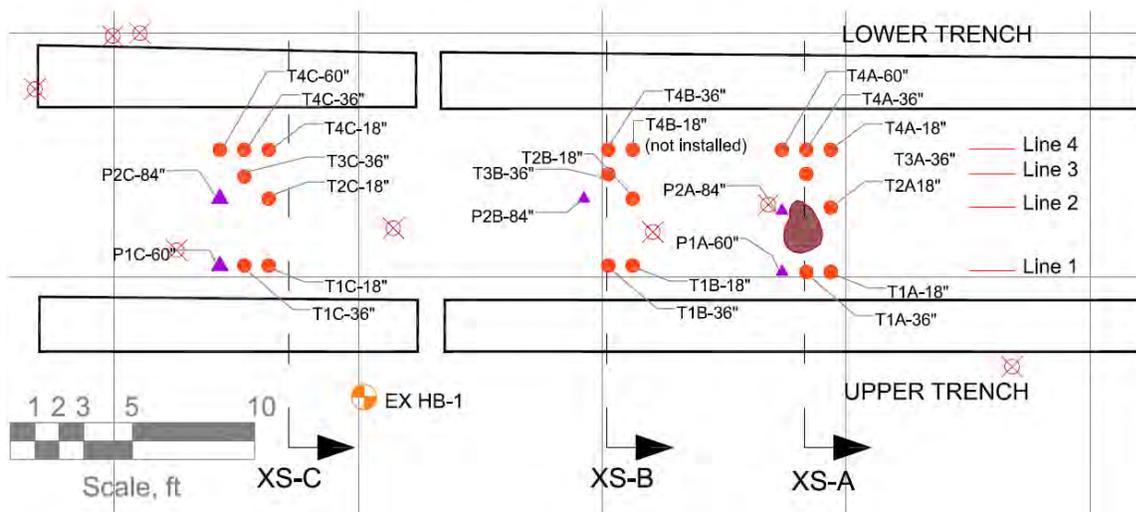
Figure 6-3. Instrument layout of wetting front test. T: tensiometer, P: piezometer, EX: hand augered boring [1 ft: 0.3 m]

A mammal burrow was encountered approximately 2.5 meters east (left) of instrument Line A, which was later found to connect upper and lower stump trenches; surficial evidence of burrowing activity was also observed along the test area, as shown by the red circles on Figure 6-3. The existence of these holes proved to be a dominant factor on the wetting front test, as will be described in subsequent sections.

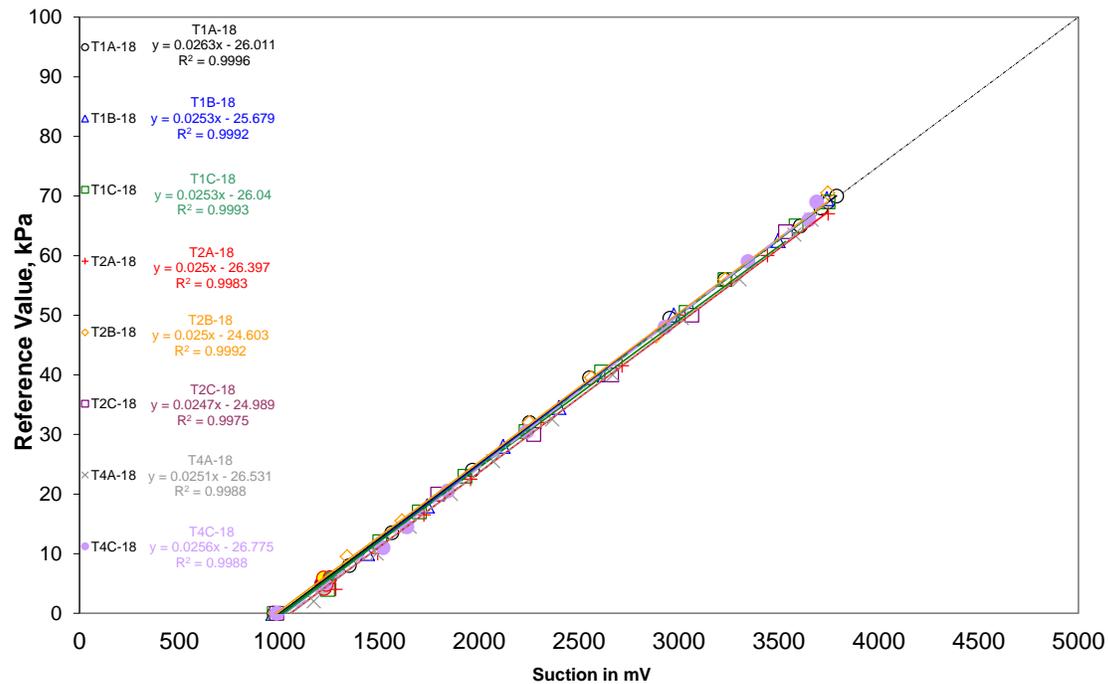
Calibration Sheet - 18" Long Tensiometers

The electronic pressure transducers used to measure suction values on the Soil Moisture Equipment® tensiometers were calibrated after the test was completed in the laboratory. Calibration consisted of inserting each tensiometer/transducer assembly as it was used in the field (with the same cable lengths and splices) into a jar filled with loose, moist Monterey Sand, and applying controlled values of suction through the top of the tensiometer probe. Voltages recorded in this process were plotted against suction values from the dial pressure gage so a calibration curve was generated for each instrument (Figure 6-4). Applied suction values ranged from a few Kilopascals to approximately the cavitation value for each tensiometer length. Once the maximum value was reached on a tensiometer, the sand specimen was saturated so the voltage and suction values at saturation were determined for each instrument. This 'zero' value is a key calibration parameter as different length tensiometers have different saturation values.

Figure 6-4. Calibration for 18" long tensiometers

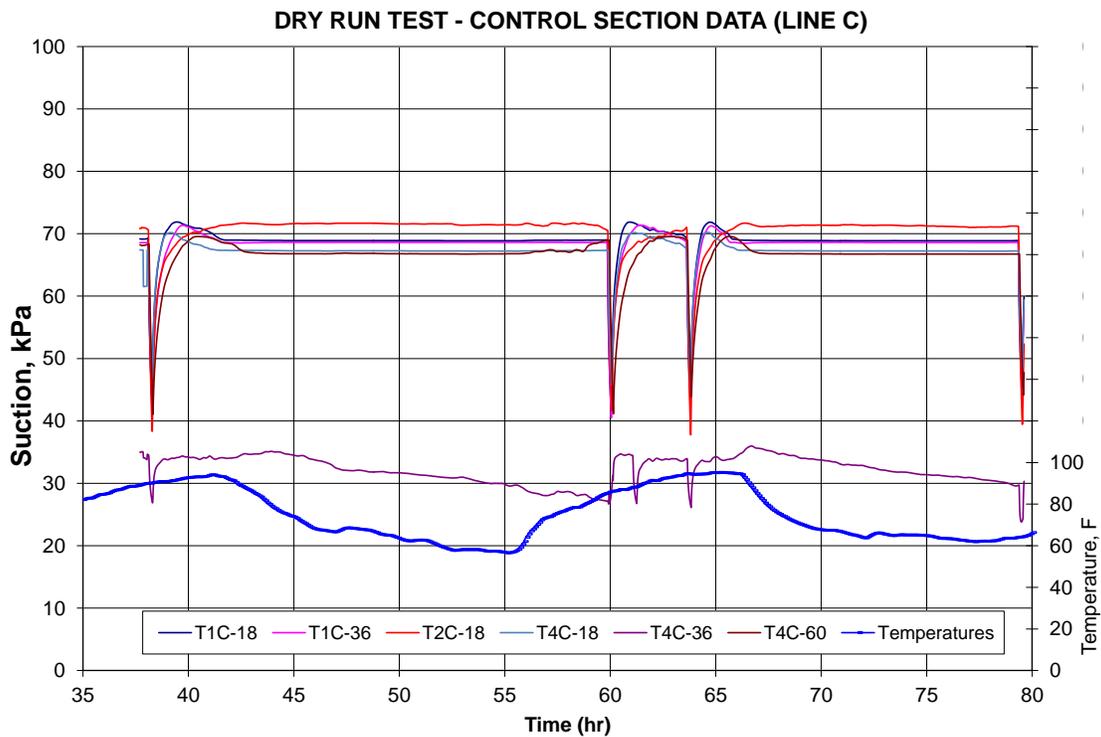
Figure 6-5. Test run data for control trench

Prior to commencing the wetting front test, a 'test run' was performed to assure all devices, power sources and loggers were functioning correctly. Figure 6-5 and Figure 6-6 show the tensiometer data for the test run. Suction values ranged between 30 and 70 kPa during the 40 hours of the test, and temperatures ranged from 60 to 100 degrees Fahrenheit. Sudden drops on recorded data represent times when the tensiometer tube was refilled with water, therefore losing the vacuum inside the tube and gauge throat. During the test run refilling was performed several times given the high suction and temperatures that contributed to the quick emptying of the tensiometers.

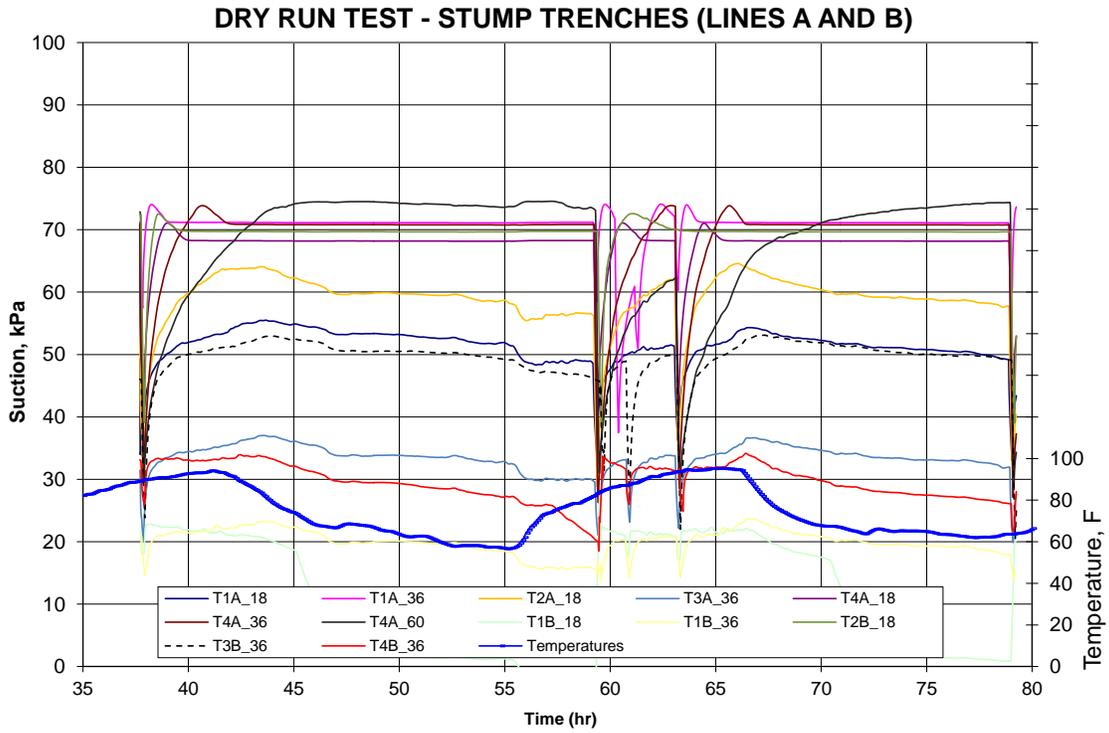
Figure 6-6. Dry run data for stump trench

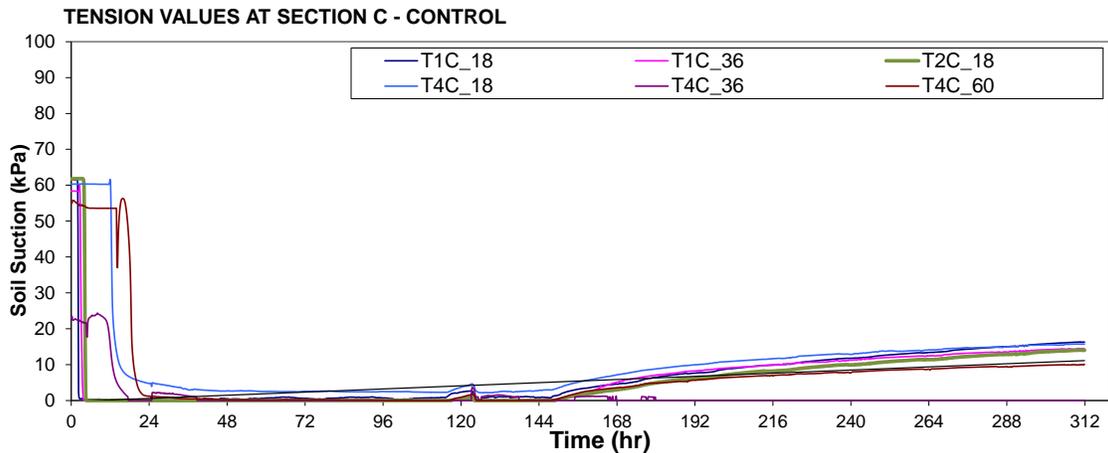
Figure 6-7. Test data for control section (Line C)

After all instruments were saturated, the upper trenches were allowed to empty and the soil mass between the two trenches started to slowly drain. This is evidenced by the slight increase in suction after time = 120 hours. Figure 6-7 through Figure 6-9 show the entire suction time histories for Lines C, B and A, respectively.

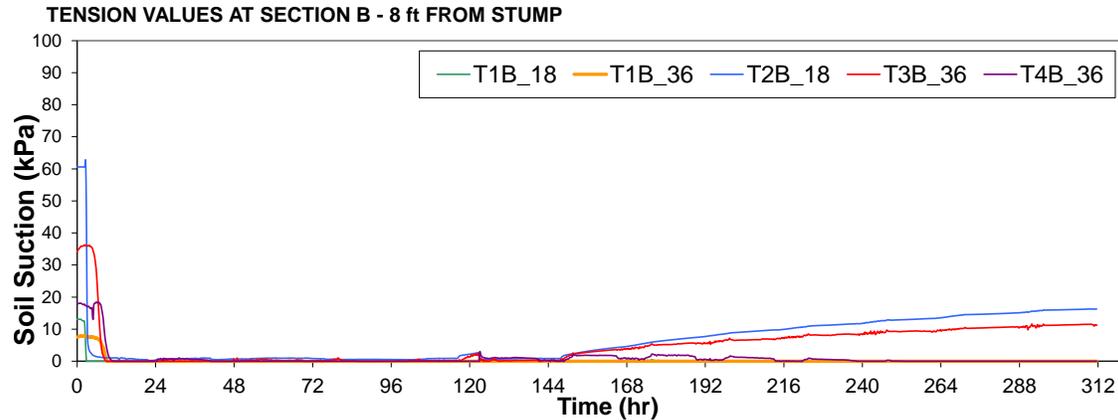
Figure 6-8. Test data for section away from stump (Line B)

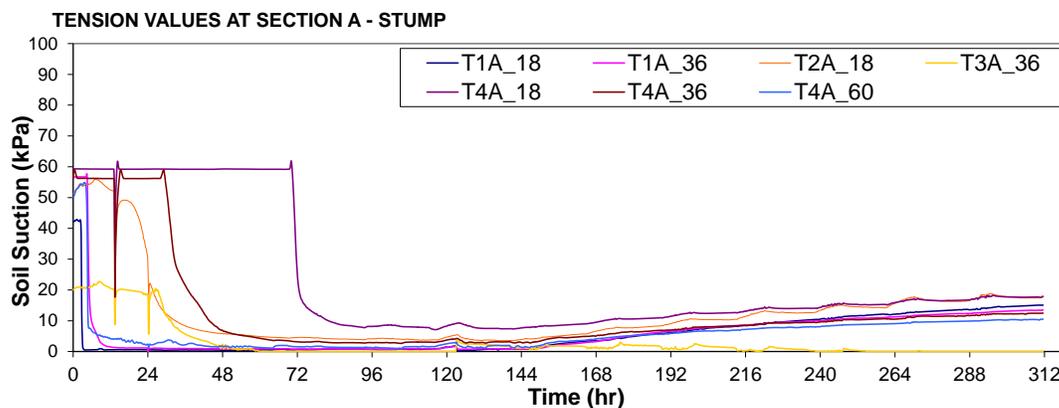
Figure 6-9. Test data for stump section (Line A)
