Transient Seepage Through Levees and the Influence of Roots and Animal Burrows

Ph.D., [Civil and Environmental Engineering](#) [UC Berkeley](#)

Transient Seepage Through Levees and the Influence of Roots and
Animal Burrows

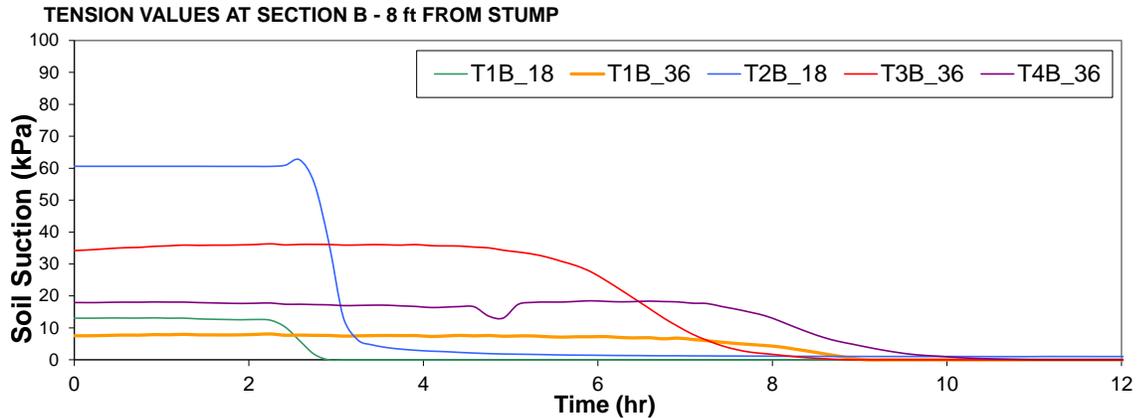
The measured progression of the wetting front was significantly different between the three instrument lines. Instruments on Line B (Figure 6-10) saturated in less than twelve hours, mainly because of the presence of a mammal burrow extending from the upper to the lower trench. This burrow was directly connected to the source of water and was able to transmit the full hydraulic head applied on the upper trench throughout the levee material, causing some surface seeps and small collapses on the lower trench wall within 30 minutes of start of test. The saturation path on this instrument line extended from upper to lower trench and radially out from the continuous burrow. The first instrument to saturate was T1B-18, located 30 cm downslope from the upper trench wall, and 45 cm (18 inches) below slope surface. Suction values on this instrument went to zero approximately two and a half hours after the start of the test. The next instrument to saturate was T2B-18, located approximately 1.2 m (4 ft) downslope from the upper trench wall and 45 cm deep. This instrument saturated in three hours as flow from the pressurized burrow saturated this area.

Figure 6-10. Saturation times of Line B

The remaining three instruments saturated between six and ten hours from the start of the test, driven by the fact that the burrow was essentially at the same head as in the upper trench, thus allowing for a faster saturation of the mass of soil between the two trenches.

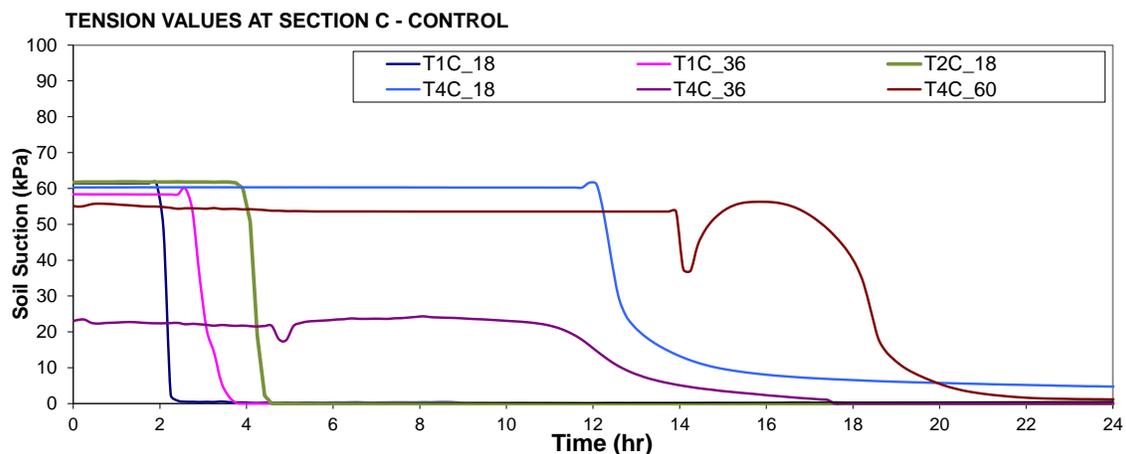
Instrument Line C (Figure 6-11), located through the control section showed a similar behavior to line B, as a small burrow was encountered extending from the upper trench to approximately halfway between the upper and lower trenches. A small seep was encountered on the lower trench wall a few hours after the test started (Shriro et al, 2013), but did not expel as much water as the burrow on Line B. Saturation times for instruments on this line ranged between two and 22 hours, with the instruments in the vicinity of the small burrow saturating in less than four hours, and the remaining devices achieving saturation between 12 and 22 hours.

Figure 6-11. Saturation times for Line C

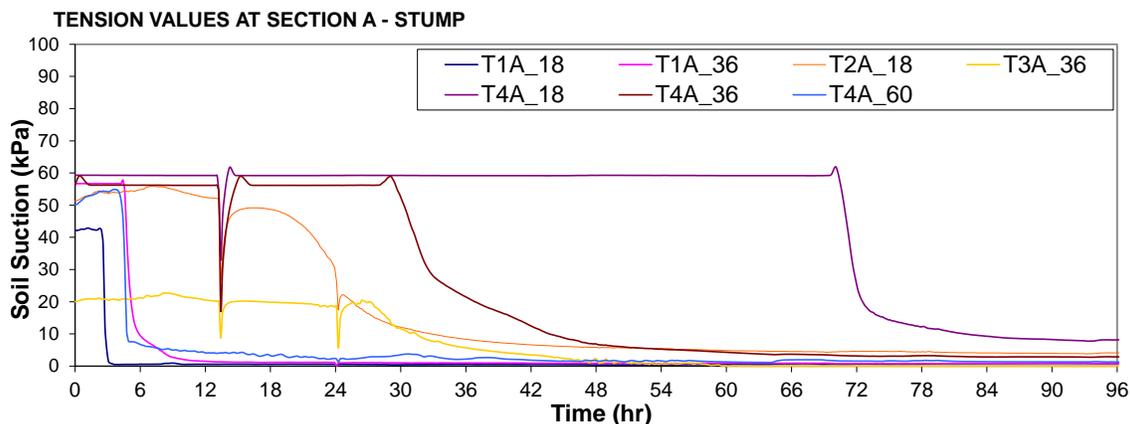
Instruments along Line A (Figure 6-12) exhibited significantly longer times to reach saturation when compared to the other two instrument sections on the field test. Devices near the upper trench (T1A-18 and T1A-36, located 18 and 36 inches deep and approximately 30 cm from the upper trench wall) saturated between two and six hours from the start of the test, while most of the remaining instruments saturated between 30 and 70 hours later. Instrument T4A-60, located 60 inches deep and less than half a meter from the lower trench wall also exhibited a rapid saturation, approximately five and a half hours after the start of the test; this can be explained by capillary saturation from the bottom of the lower trench, which was partially filled by the discharge flowing out of the mammal burrow near instrument Line B, located about 2.5 m east of the stump (on the same trench). The height of the water ponding on the lower trench was controlled using a pump, but 2-4 inches of water were present in the bottom of the trench as the pump was unable to drain it completely. Consequently, instrument T4A-60, which was almost at the same depth as the bottom of the lower stump trench was saturated from the bottom of the experiment section via capillary rise.

Figure 6-12. Saturation times for Line A

The instruments around and downslope from the stump consisted of lines 2, 3 and 4 (T2A-18, T3A-36, T4A-18 and T4A-36) appeared to reach saturation more than one day later, suggesting that the progression of the wetting front was delayed by the presence of the decomposing stump. Even though some short and isolated gaps between the soil and the decomposed roots were encountered during excavation activities (Shriro et al., 2011), no tensiometer or piezometer recorded increased pore pressures near these features.

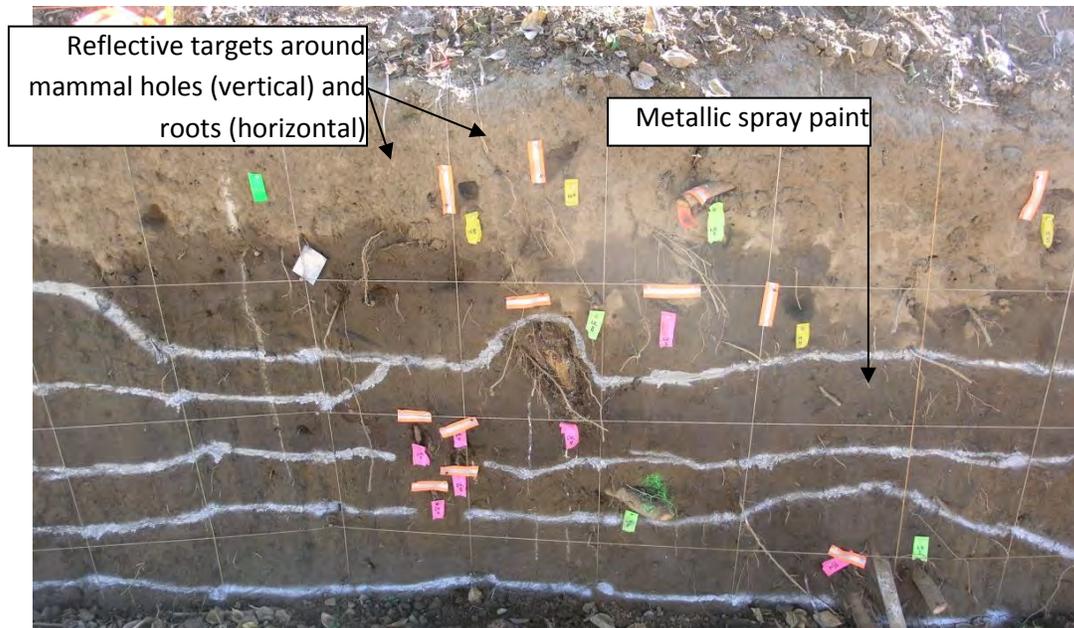
Figure 6-13. Reflective targets around mammal holes and decomposed roots, and metallic paint along stratigraphic contacts. Image modified from Cobos et al (2012).

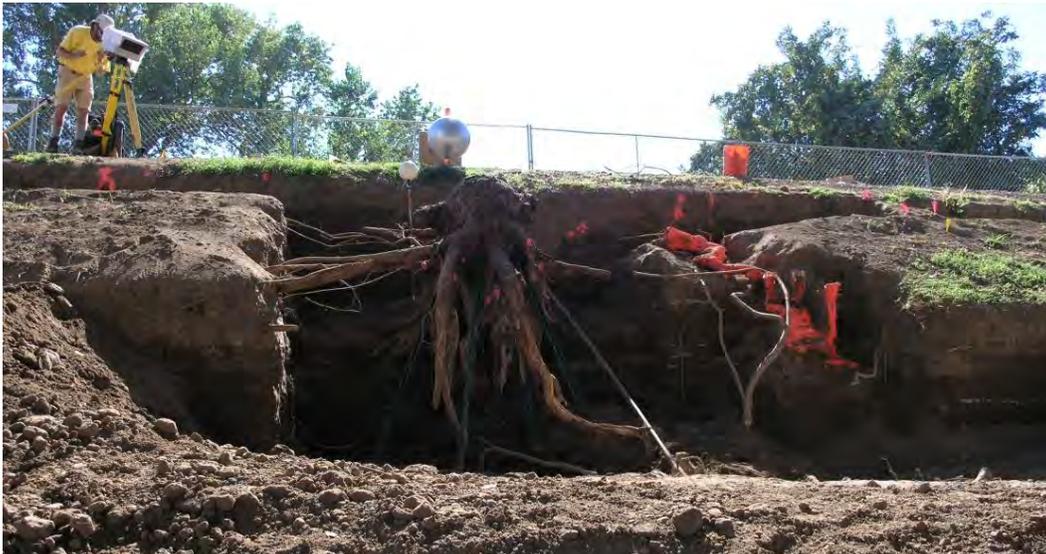
Figure 6-14. Excavated stump

The final stage of excavation is shown on Figure 6-14, at this point the soil between the trenches and around the stump had been removed and all roots and soil contacts had been logged. The mammal burrow along instrument Line B was grouted using a cement-bentonite mixture so its path would be conserved during excavation activities. This burrow is shown to the right of Figure 6-14, painted bright orange.

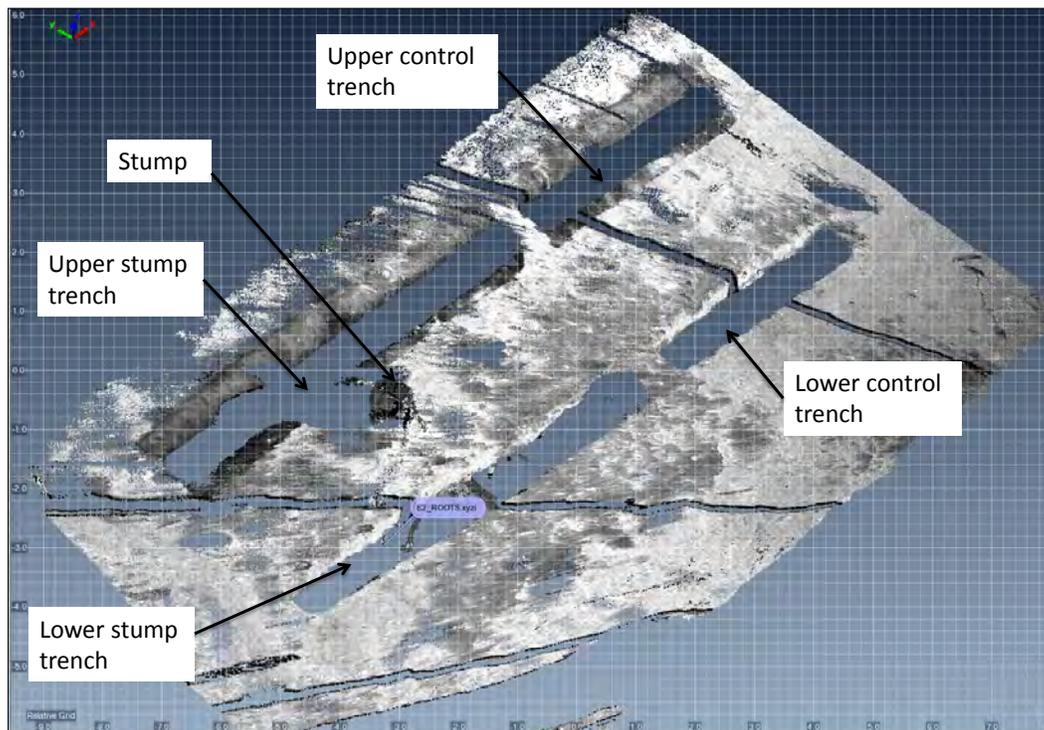
Figure 6-15. Baseline scan

The results from the baseline T-LiDAR scans are shown on Figure 6-15. Some shadows from fence poles are still present on the dataset, but the four trenches and stump are visible. This dataset was used to generate the topography layer for the analyses presented in following sections. The different scans performed as excavation progressed are included on Figure 6-16. These are unfiltered surfaces created using the entire point cloud for each scan (a scan was comprised of at least five different setups and surveys to minimize shadows), which includes the excavated soil wall, exposed roots and reflective strips and paint. Personnel from the USGS-

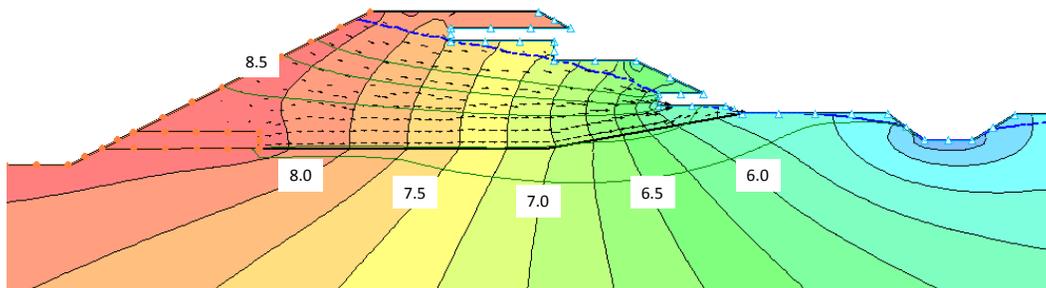
Figure 6-53. Steady state simulation of Sandy Levee Site burrows. Total head contour interval 0.25 m.

The results from the steady state simulation are shown on Figure 6-53. The resulting flow field indicates that the combined effect of the waterside burrow and the burrow near the downstream toe of the levee is to shorten the seepage path and increase the gradient. The water side burrow allows the full water side head to reach into the levee and the landside burrow acts as a toe drain, concentrating flow paths and velocities toward the burrow. In contrast, the burrows located near the levee crown have little influence on the distribution of heads as the crown of the levee is likely to remain unsaturated even under steady state conditions

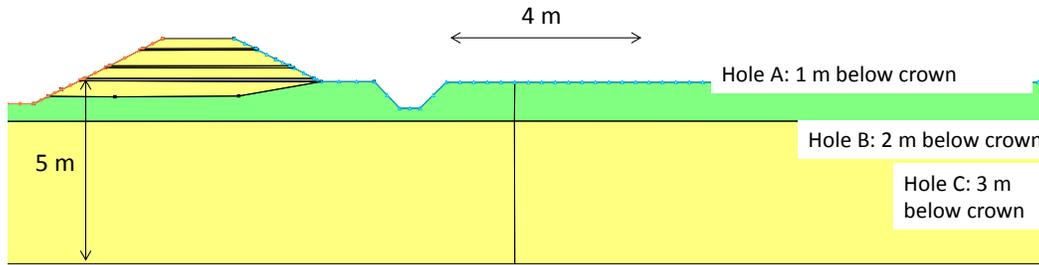
Figure 6-54. Geometry of the model section with completely penetrating burrows

Second simulation was performed to analyze the influence that the location of a completely penetrating burrow has on the distribution of gradients within the embankment and on the piping potential. Figure 6-54 shows the section employed, with three model burrow locations labeled A, B and C, extending from one to three meters below the crown of the levee. Boundary conditions, material properties and model dimensions were kept the same as in the previous simulation.

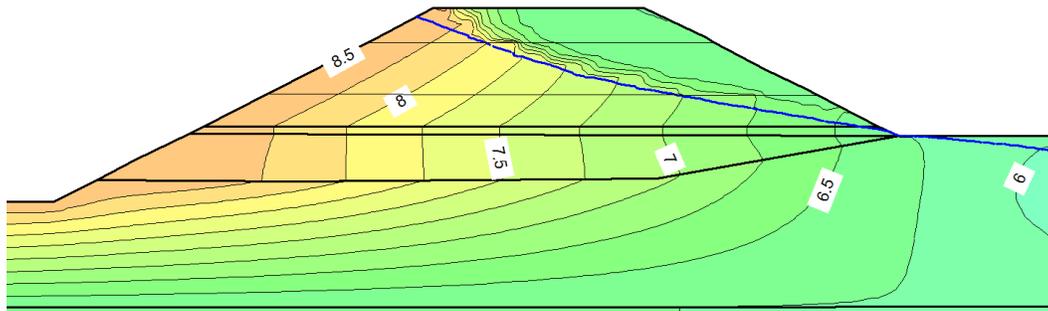
Figure 6-55. Results from transient analysis after one day of simulation with burrow at C. contour interval: 0.25 m

Figure 6-55 shows the simulation results for model burrow C (3 m below levee crown) in terms of head distribution for a transient simulation of one day. At this point in time the geometry of the seepage front is similar to the saturation pattern observed in the case with no burrow (Figure 6-57). A pore pressure profile across a vertical section through the centerline of the embankment for this case is shown on Figure 6-56. The plot indicates that the presence of the burrow near the foundation level will produce a faster saturation of the embankment than if no hole were present (Figure 6-58). After two hours, the section with a hole near the bottom of the embankment has reached the maximum total head value (about 7.5 m), whereas the section with no holes reaches these values in about 20 hours.

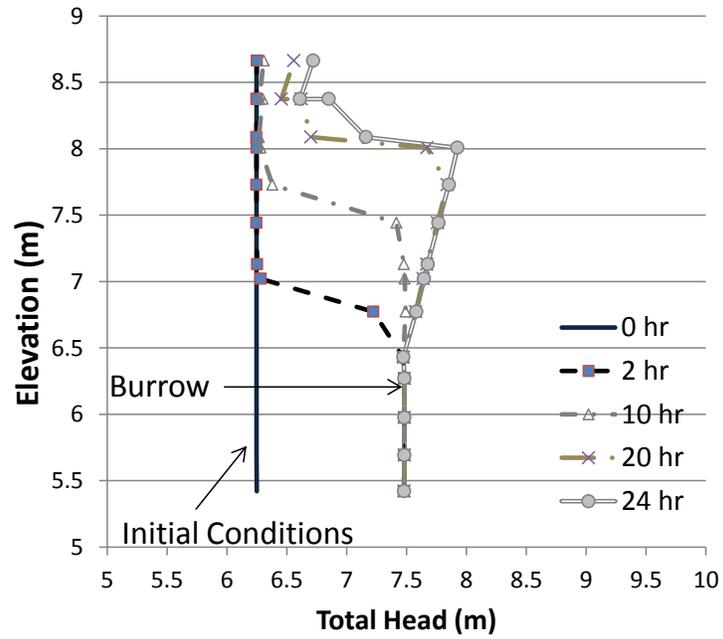
Figure 6-56. Evolution of pore pressures on a vertical section across the levee crown for Hole C

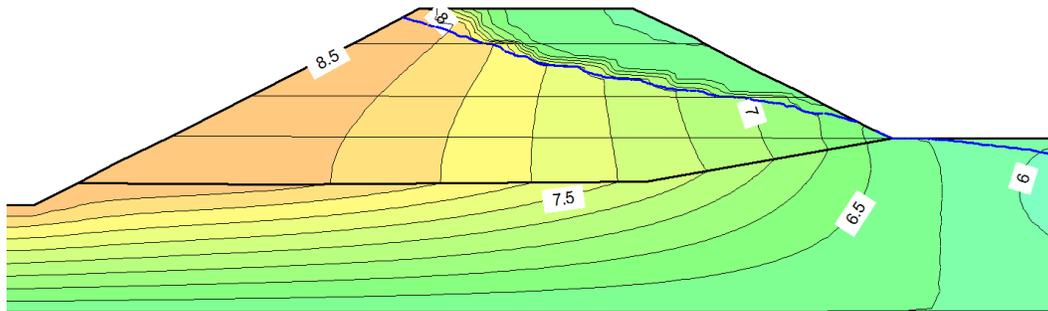
Figure 6-57. Results from transient analysis after one day of simulation. No holes present. Total head contour interval: 0.25 m.

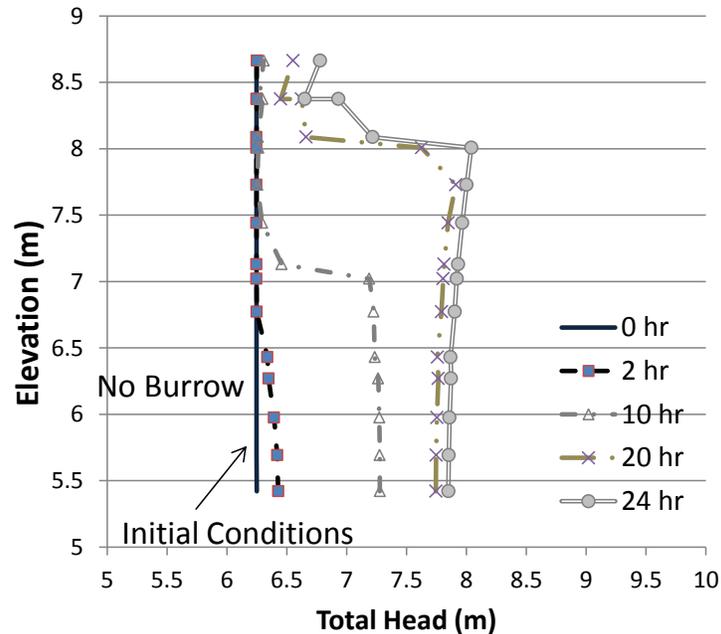
Figure 6-58. Evolution of pore pressures on a vertical section across the levee crown for the case of no hole

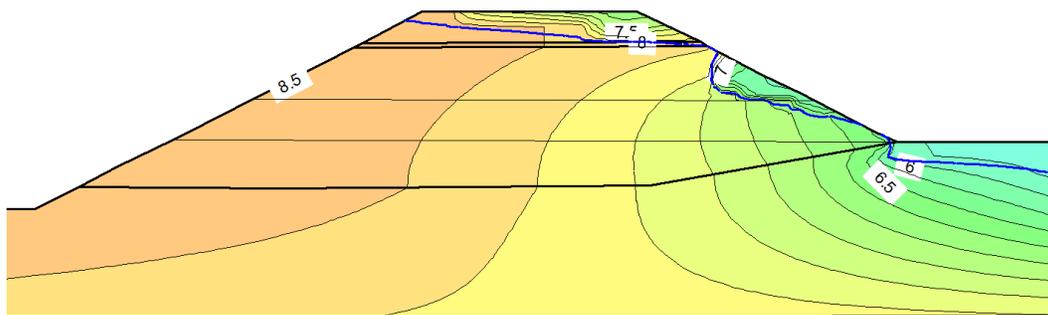
Figure 6-59. Results from transient analysis after one day of simulation with burrow at A. Total head contour interval: 0.25 m

The results from the simulations with a burrow at location A (1 m below levee crown) and B (2 m below levee crown) are shown in Figure 6-59 and Figure 6-61, respectively. The pore pressure evolution across the centerline of the levee along A (Figure 6-60) and along B (Figure 6-62) indicates a similar behavior similar to that observed with the burrow located near the bottom of the embankment: the soil in the vicinity of the hole reaches its maximum head very rapidly (two hours) because of seepage from the burrow, which results in a shorter saturation time for the entire embankment along modeled section.

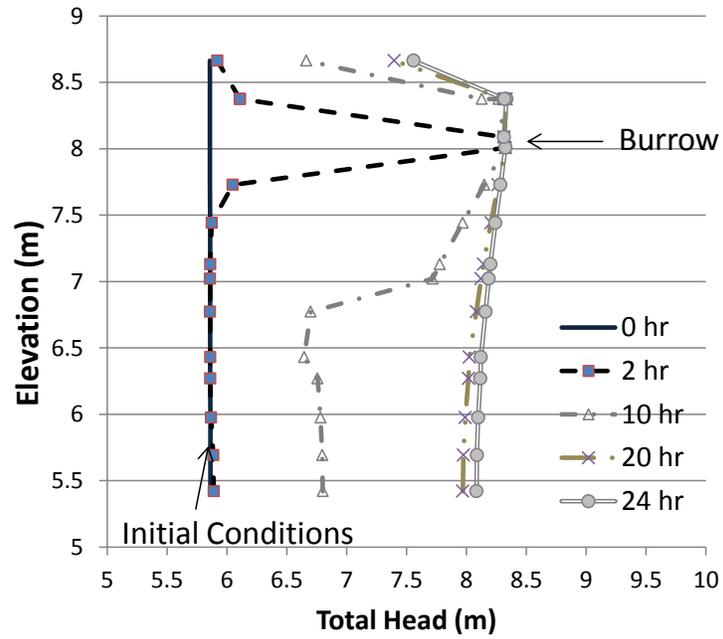
Figure 6-60. Evolution of pore pressures on a vertical section across the levee crown at burrow A

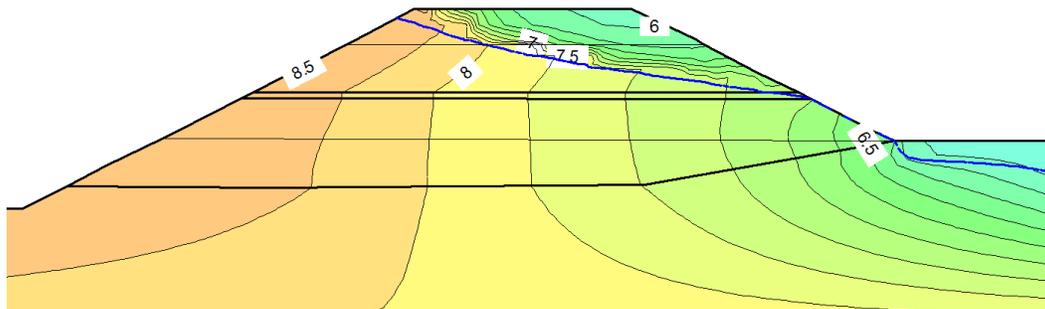
Figure 6-61. Results from transient analysis after one day of simulation with burrow at B. Total head contour interval: 0.25 m

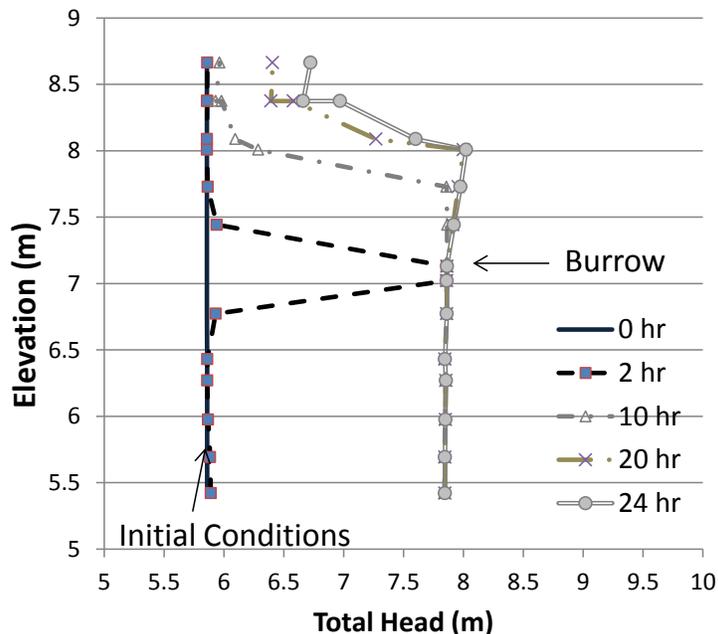
Figure 6-62. Evolution of pore pressures on a vertical section across the levee crown for Hole B

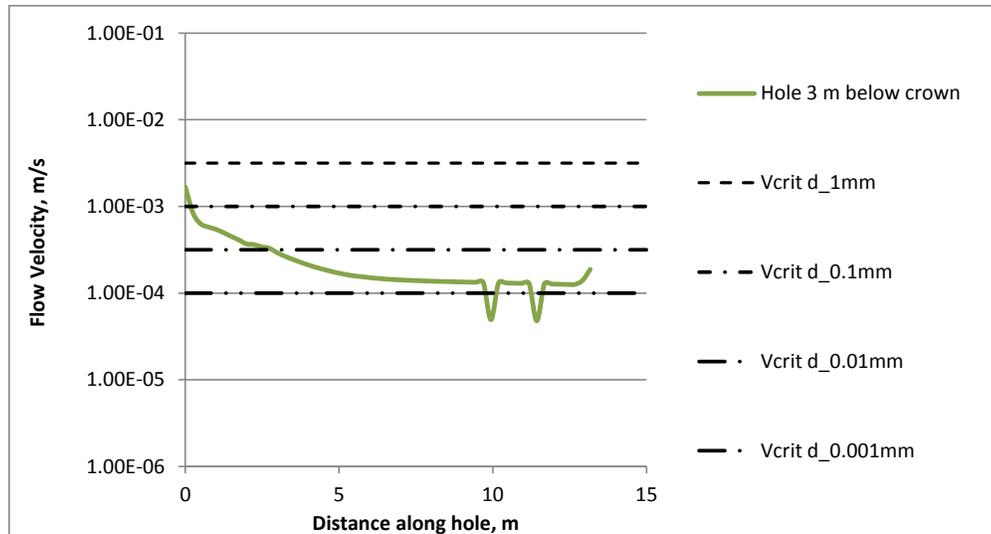
Figure 6-63. Piping potential evaluation using the Ohja (2003) formula

The green series on Figure 6-63 represents the longitudinal profile of velocities along the soil/burrow interface. The data are compared to four critical velocity values according to Ohja (2003), for particle sizes ranging from 1 mm to 0.001 mm. The plot shows that the computed velocity field along the bottom of the burrow is sufficient for piping initiation. Similarly, using the Sellmeijer (1988) formula a critical potential head value (Figure 6-64) for a sandy soil with a D_{70} of 0.03 mm piping would initiate along the first several meters from the upstream entrance to the burrow.

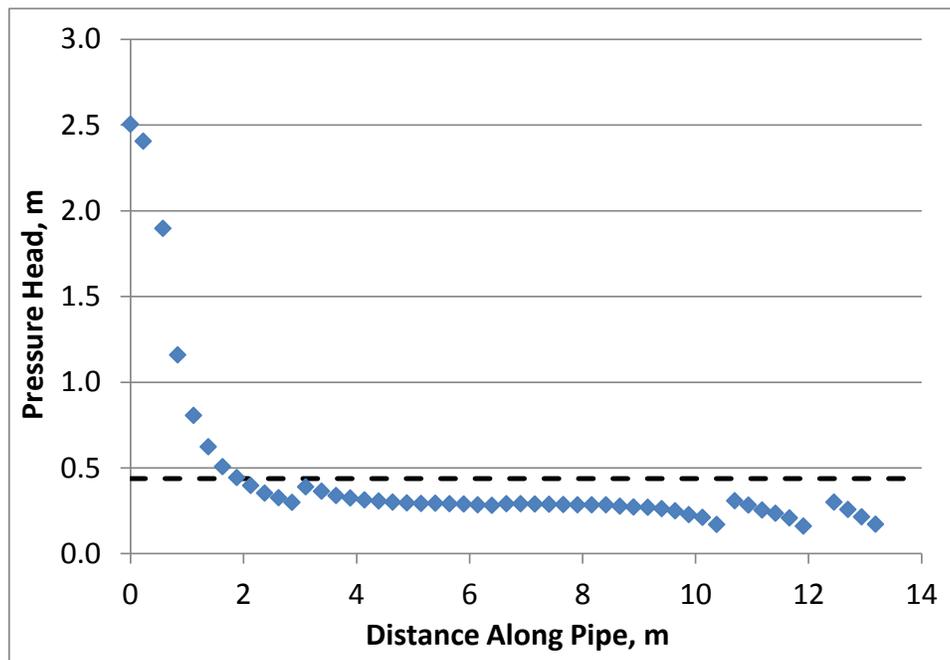
Figure 6-64. Piping potential evaluation using the Sellmeijer (1988) formula

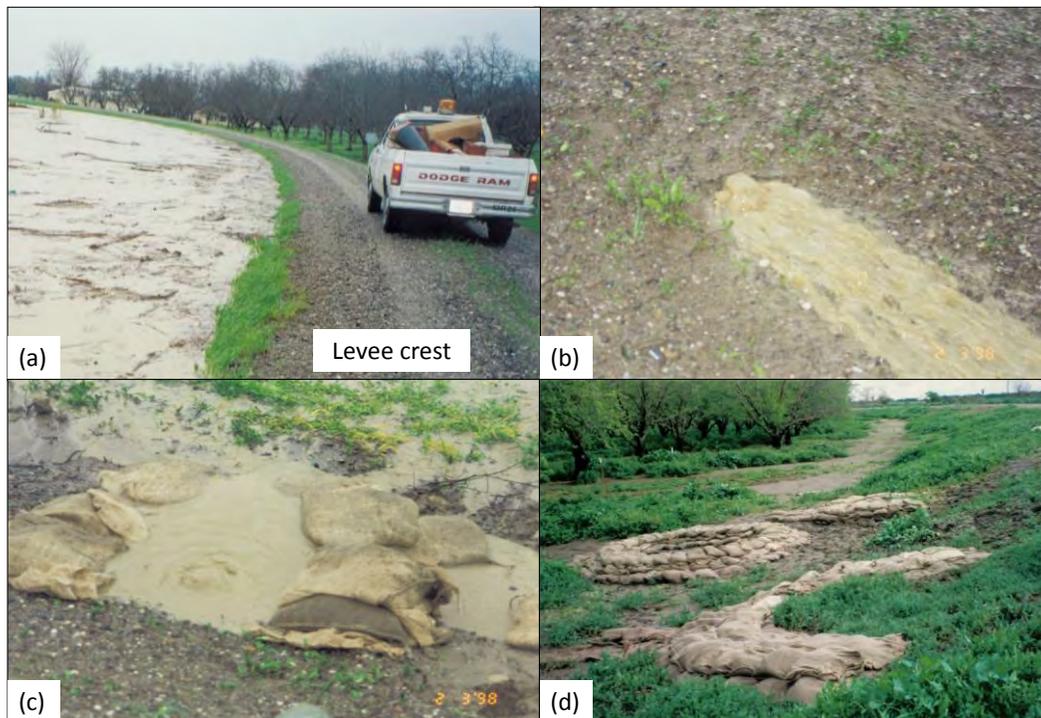
Figure 6-65. High water on Clayey Levee Site in 1998. Images courtesy Al Romero, DWR

A simulation of the conditions in March 1998 during high water levels on the clayey (Figure 6-65) site was performed to further compare the simulation results to a well-documented case history. A 3D finite element model of the 2 m (6 ft) tall levee, with 2:1 slopes and 2.4 m (8 ft) wide crown (Figure 6-66) was constructed. The silty (67% fines) levee and foundation materials were assigned a saturated hydraulic conductivity of 5×10^{-6} cm/s, and unsaturated properties were estimated using the VanGenuchten (1980) equation as before.

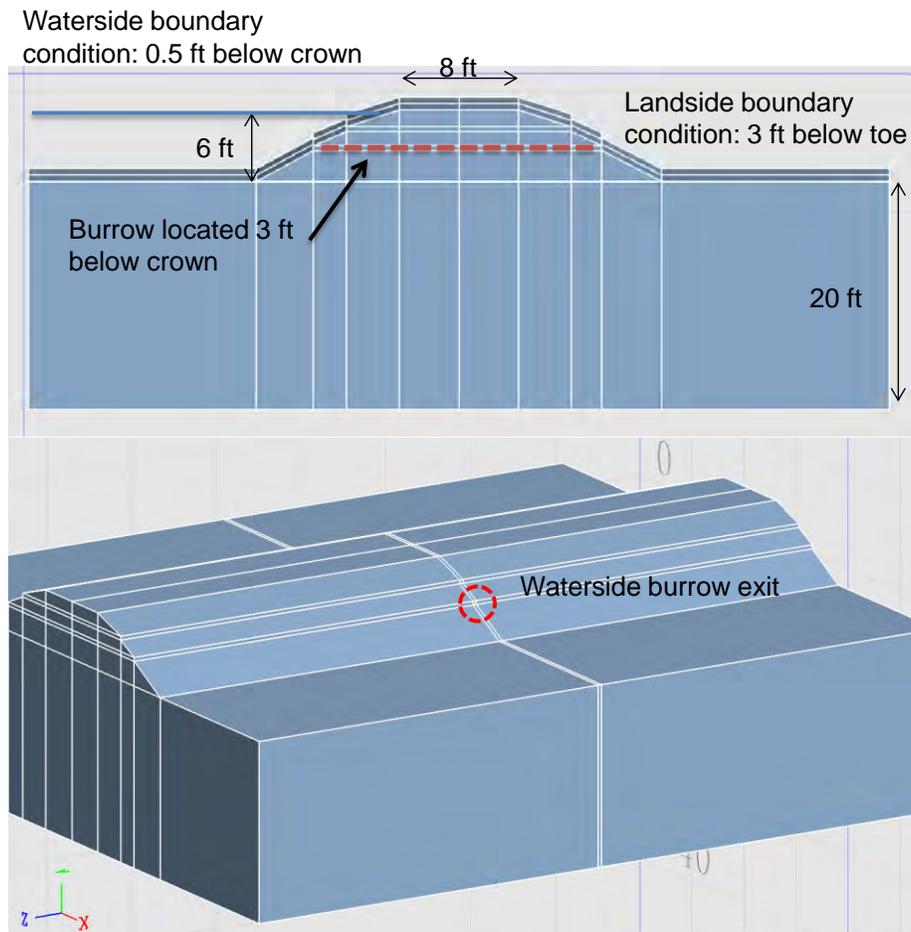
Figure 6-66. Clayey levee site 3D model

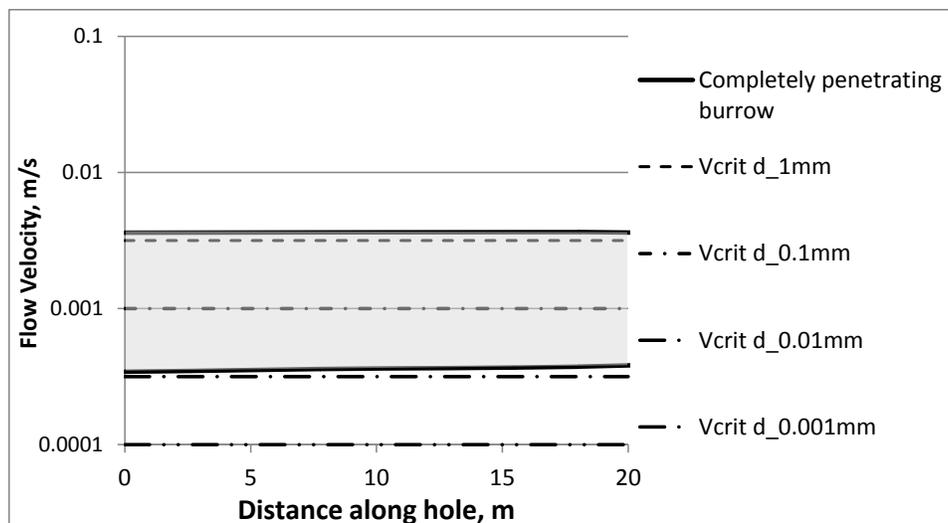
Figure 6-67. Critical flow velocities for different particle sizes compared to range of velocities along burrow

The conductivity of the burrow was varied in the analyses and comparing the resulting velocities along the hole/soil interface were compared with velocity values for piping potential according to Ohja (2003). Figure 6-67 shows the range of flow velocities obtained by varying the

conductivity values of the burrow between 0.1 and 0.01 cm/s. Computed flow velocities along the hole range between 0.003 and 0.0003 m/s, which appear to be sufficient to trigger internal erosion for particle sizes above 0.01 mm. These velocity and piping potential estimations corroborate the observations during the high water in 1998 and show that a simplified approach to modeling burrows or other discontinuities in levees is adequate.
