Multiple flow slide experiment in the Westerschelde Estuary, The Netherlands¹

Dick Mastbergen¹, Geeralt van den Ham¹, Matthieu Cartigny², André Koelewijn¹, Marco de Kleine¹, Mike Clare², Jamie Hizzett², Maria Azpiroz², Age Vellinga²

¹Deltares, The Netherlands

Abstract

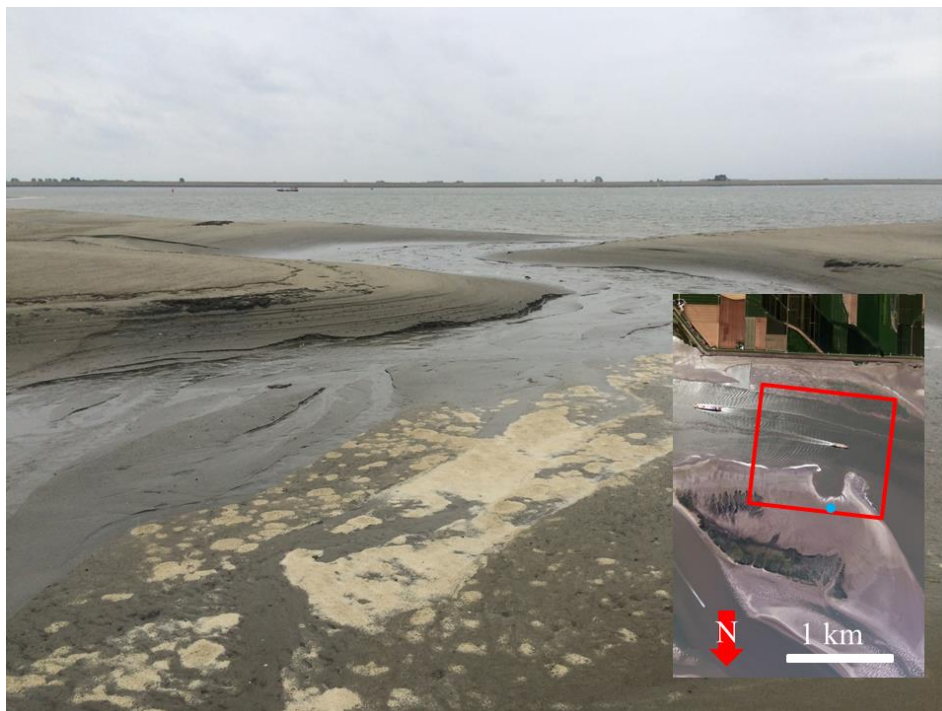
Fig. 2 View towards the South from Plaat van Walsoorden sand flat at location of 22nd of July 2014 flow slide. Inset aerial view. Scar of flow slide clearly visible. Blue dot is position of photo. Test area indicated by red square, see also Fig. 1 and 3.

Most recently a large flow slide (almost 1 Million m³) occurred on 22nd of July 2014 (see Fig. 2 and 3), exactly at the originally proposed test site. After a week, on 28th of July 2014, further activity was observed on the shoreline, where gullies incised the tidal flat. Vertical slabs of sand were observed to gradually fall into the water. The duration of the event was at least several hours, but probably lasted for over 24 hours (Van den Ham et al. 2015). The eroded sand was deposited into the shipping channel, leading to a decrease in the water depth of more than 5 m. As a result, the minimum navigation depth needed to be restored by dredging to the depth required by the Antwerp Port authorities. The bulk of the sand is still present after six months and will erode by reworking through tidal currents. The scarp that was created forms a natural bay (Fig. 2) and is being filled in with loosely packed fine sediments. Given the occurrence of this recent failure, the test site was relocated 400 m to the east (see Fig. 3), where almost identical pre-failure conditions were found.

It is likely that the flow slide of 22nd of July 2014 started in a similar way with a small retrogressing breach, but it continued retrogressing for many hours into the subaerial zone of the tidal flat, finally resulting in the observed large amphitheatre shaped scar and depositing the eroded sand in the shipping channel. Seemingly, the turbidity current extended over a much longer distance (over 750 m). It may have been catalysed by the effects of draining of pore water at low tide in combination with flushing of fresh rain water in gullies (see Fig. 2), since, unlike our test, this natural flow slide was preceded by heavy rainfall.

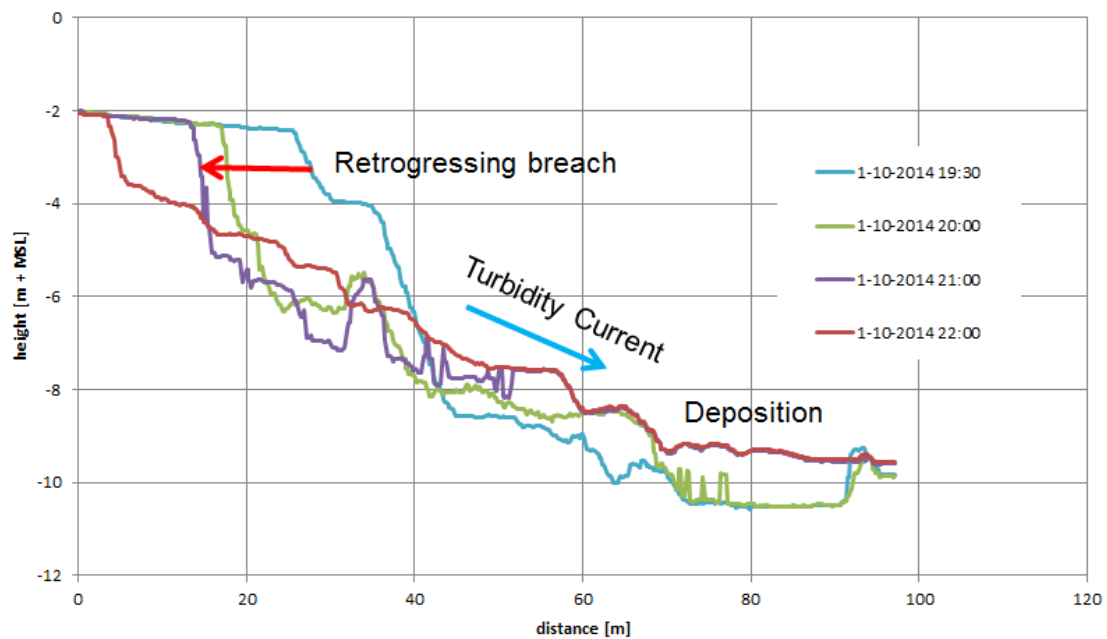
Fig. 5 Cross-section flow slide of Fig. 4. Breach retrogression speed about 20 m in 2 hours. Active breach height 6 - 8 m. Flow length 60 - 100 m.

It is still uncertain what condition is responsible for the upslope breaching process to continue or to stop, but it may be related to the downslope turbidity current. Since the slope of the dredged area was quite gentle (see Fig. 5), the sand may have settled quickly and blocked the flow downslope, resulting in a decrease of the breach height and halting of the flow. This will be further analysed by means of simulation of the observed flow slides with numerical models (Van den Ham et al. 2015) and more detailed data analysis.
