Emergency closure of dike breaches

The effect and applicability of emergency measures

Master Thesis

T.S. Albers

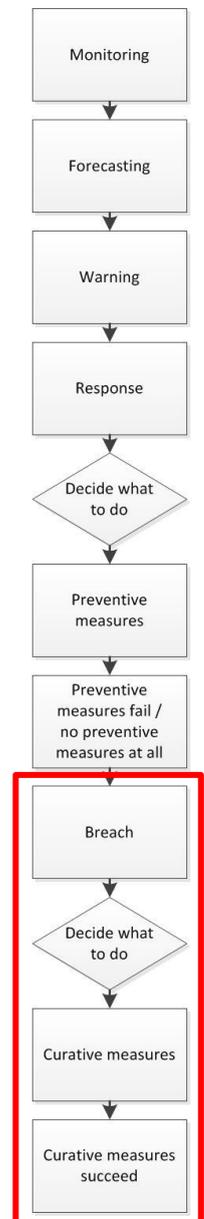
Figure 2.1: Simplified process of a dike breach and the scope

If there is zoomed in on the diamond shapes of Figure 2.1, which are the decision moments where emergency measures are implemented, three critical aspects are important. These three aspects are the technical, the organizational and the logistical (Deltares, 2013), (Lendering, et al., 2014). Literature focuses mainly on the technical and logistical side (Deltares, 2011), (Gerven, 2004), (Resio & Boc, 2011). The *technical* problem consists of the type of dike, the characteristics of the dike and the failure mechanism. These aspects are important for the breach development. If a breach is formed, the development and the flow pattern inside the breach will affect the effectiveness and stability of the emergency measures. Interaction between the breach processes and the emergency measure is

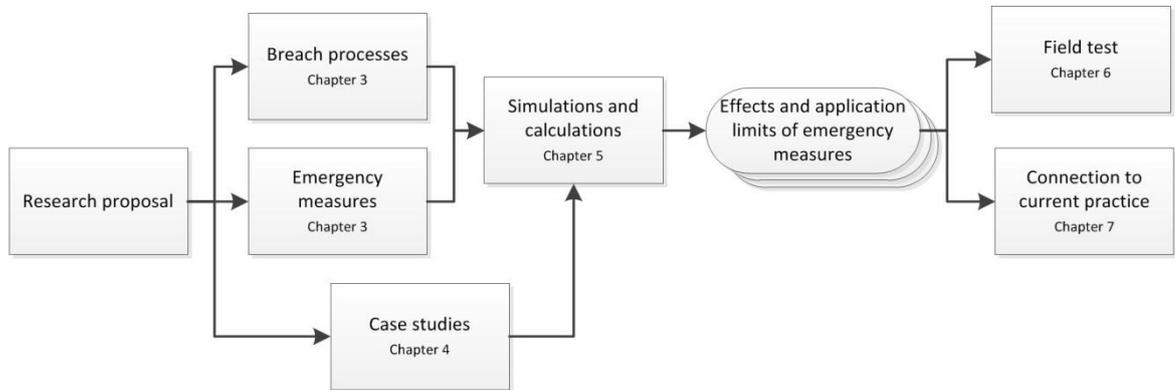
Figure 2.2: Methodology

To fulfil the objectives and answer the research questions, a methodology framework is set up. Figure 2.2 displays this in a sort of time line from left to right. The methodology starts with the research proposal. Thereafter the analysis of the breaches and their processes and characteristics is started, together with the analysis of the available emergency closure measures. If the most critical processes and characteristics are found, case studies are investigated. A reconstruction and hindsight calculations are performed on successful closures. In this way an insight in the essential technical, logistical and organizational set up around these closures are obtained. If the closure was not successful the analysis will be about why it did not succeed.

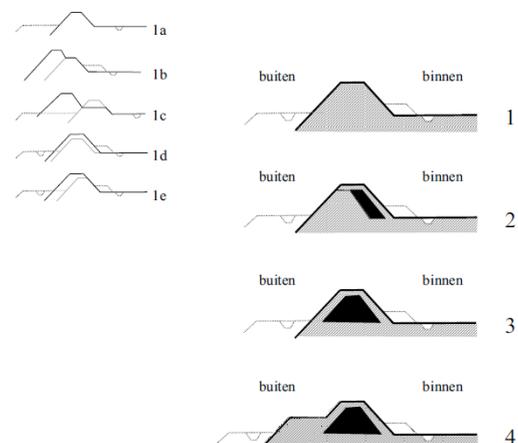
The first type is a dike which consists completely of clay. This is the 'original dike', as it was constructed in the past. Dike number two is a with sand on the inner slope strengthened clay dike. A clay cover is on top of the sand. Dike type three is a sand dike. The

Figure 3.1: Characteristic dike bodies (GeoDelft, 2002)

body of this type consists of sand and is covered with a clay layer. The last dike type is a large reinforcement where the old clay dike is used as an outer berm for the new dike. The new dike consists of a sand core with a clay cover. The first type of dike is usual an old lake dike. New polder dikes are sand dikes like type three. Also repaired dikes after breaches can be grouped under type three. Sea dikes are often sand dikes with an old clay core, like type two and four. All the types can have geometries as displayed on the left side of Figure 3.1, labelled a to e.

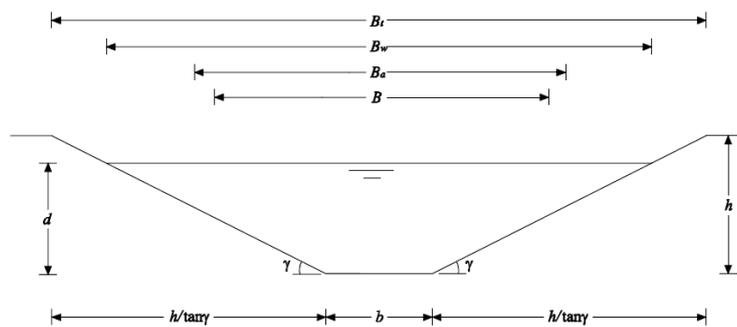
Figure 3.3: Cross section of initial breach in the crest (Zhu, 2006)

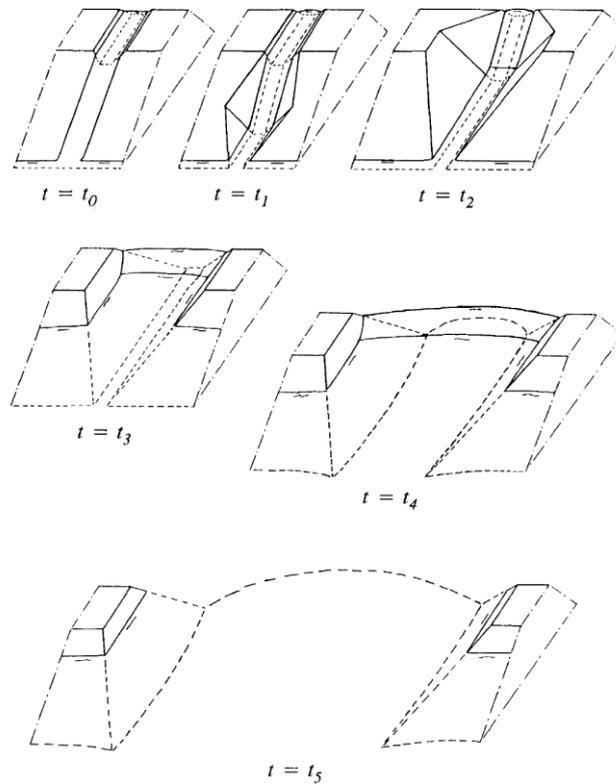
in the polder has equalled the outside water level and the flow through the breach stops. Most of the discharge through the breach takes place in stages IV and V. The five stages and their characteristic appearance are visible in Figure 3.5.

Figure 3.5: Schematic illustration of breach growth in sand-dikes (Visser, 1998)

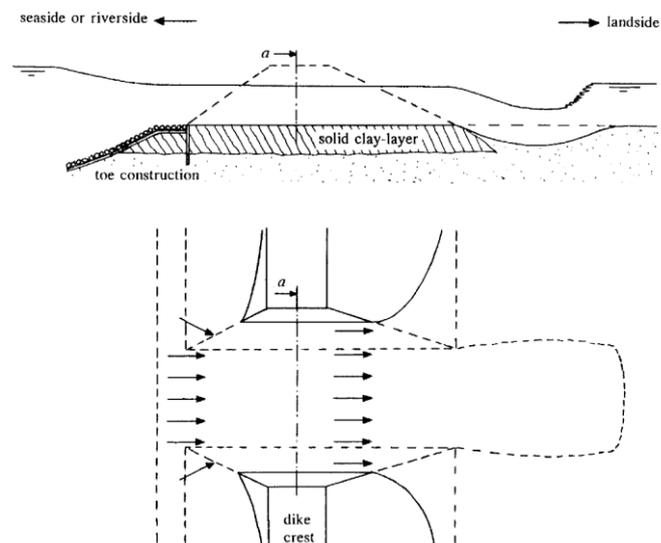
Type A is a breach that has a dike base which consists of a solid clay-layer and a toe construction at the outer slope of the dike, see Figure 3.6. If a breach occurs in this type of dike, the vertical erosion is hampered by the clay base and the toe protection at the outer slope. This is the most 'favourable' situation for a dike breach. The formation of a scour pit occurs at the downstream side of the dike. Reconstruction of the dike can take place at the same place as the original dike.

Figure 3.6: Type A breach (Visser, 1998)

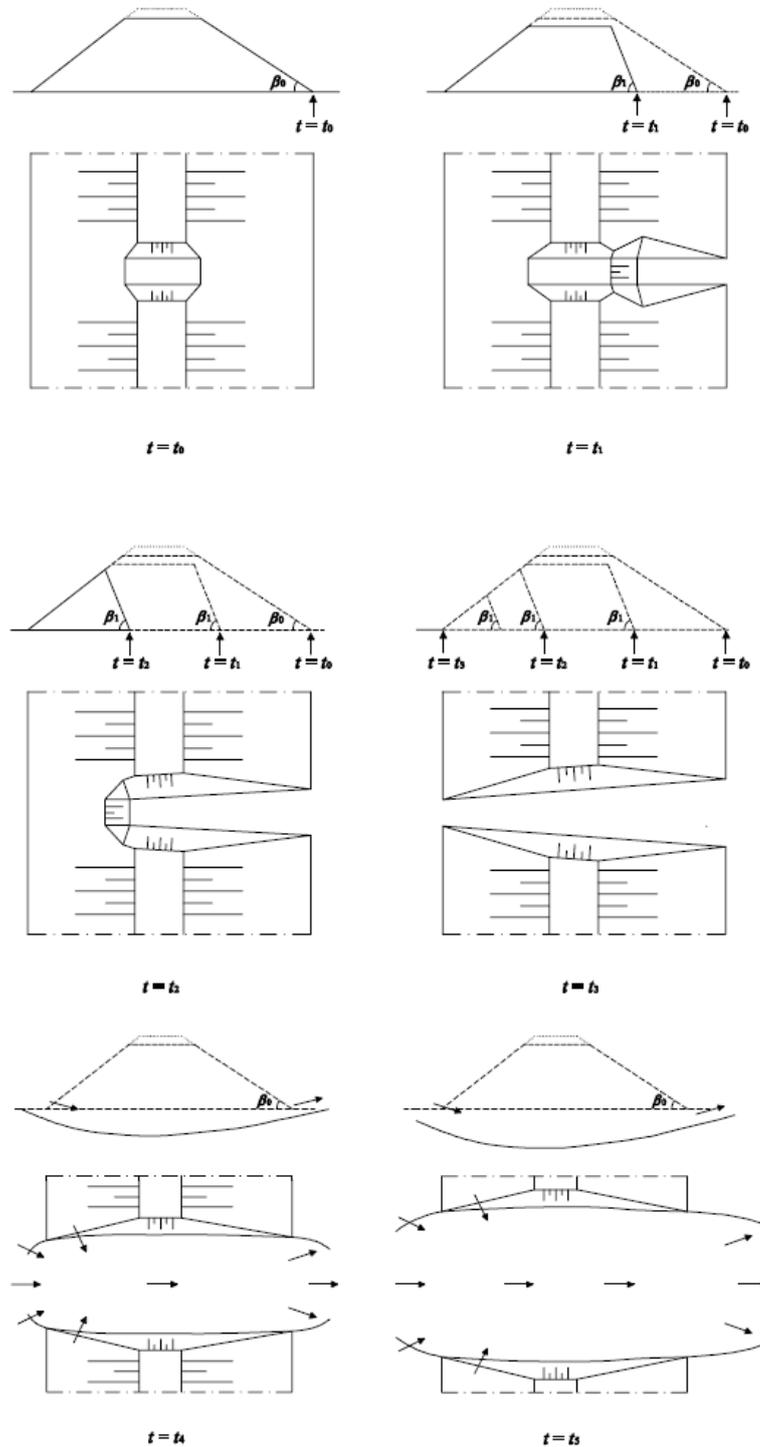
Figure 3.9: Breach development in cohesive dikes (Zhu, 2006)

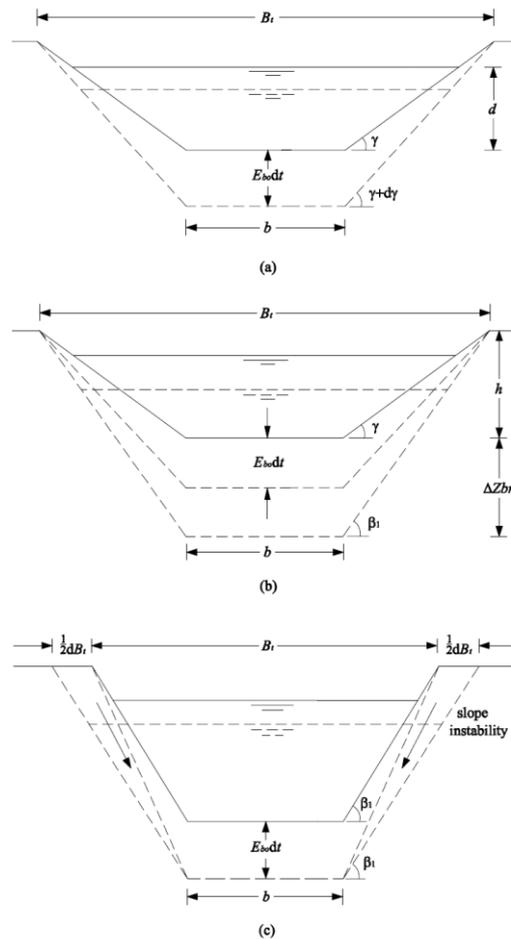
Figure 3.10 displays the breach development of the widening of the breach in stage I, II and III. In (a) the steepening of the side slopes is displayed. By the erosion of the bottom, the angle of γ increases. The critical angle is reached in (b). Vertical erosion over a distance of ΔZ_{br} was needed to reach this angle. In (c) breach enlargement after the arrival at the critical slope is shown. Any erosion after the angle β_c is reached causes a too steep slope. This is compensated by slope failure due to instability.

Figure 3.10: Breach width development during stages I, II and III (Zhu, 2006)

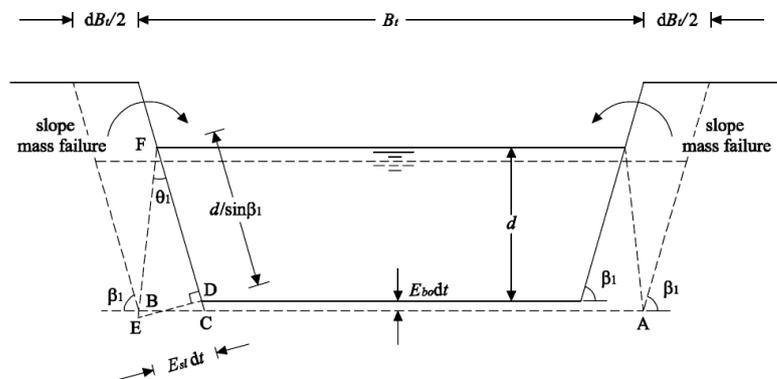
Figure 3.11: Breach development during stages IV and V (Zhu, 2006)

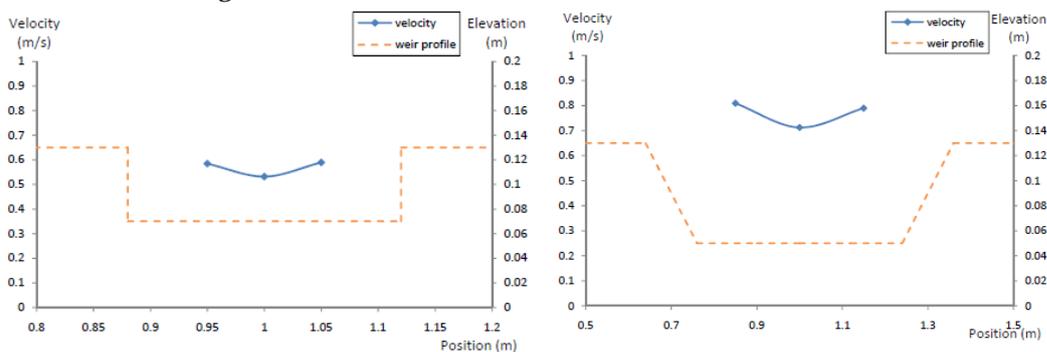
Figure 3.12 displays the flow velocity of a breach in flow direction. The observed velocity profile has its peak velocity near the slopes and the velocity decreases somewhat in the direction of the centre. The measured velocities are in meters per second. There is assumed that the shape of the velocity profile is the same for other velocities. It can be noted that the velocity in the centre is approximately 90% of the peak velocity. This is the case for the initial and the final stage.

Figure 3.12: Velocity profile in the flow direction at the first stage of the breach (left) and the final stage of the breach (right), (Ren, 2012)

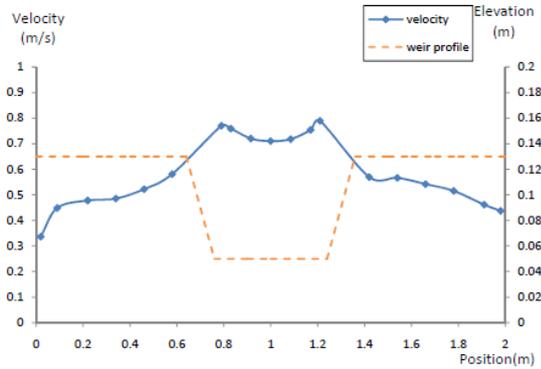
Figure 3.13: Velocity profile in the flow direction with an overtopped weir, (Ren, 2012)

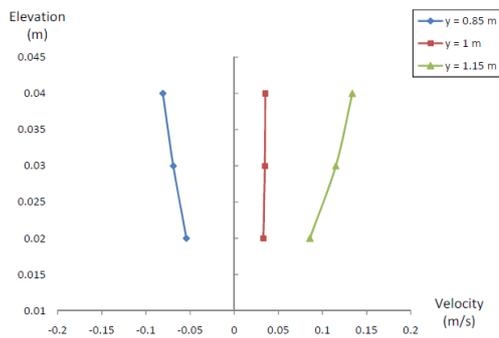
The average velocity over the breach is about 90% of the peak velocity. The velocity in the centre of the breach is equal to the averaged velocity. The measured velocity in the centre can be used as average velocity over the breach.

Figure 3.14: Velocity profile in transverse direction, (Ren, 2012)

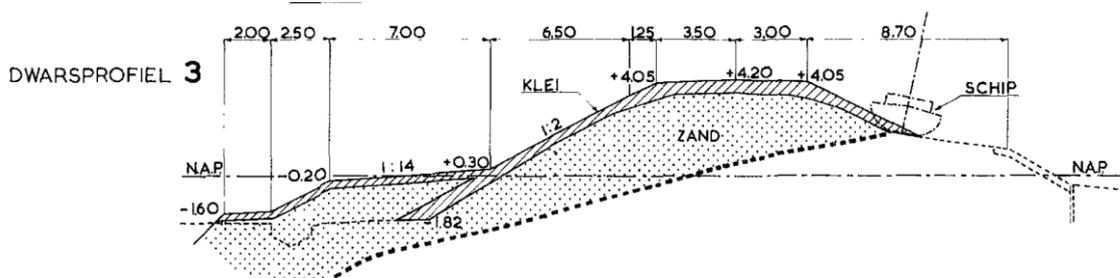
The geometry of the dike is presented in Figure 4.3. This is the cross section that is made at the location of the emergency closure. The dashed line represents the ‘old’ profile, the dotted, line shows the situation caused by the flood of 1953. The solid lines show the dike reinforcements. The crest level of the ‘old’ dike was +3.70 m NAP (Rijkswaterstaat, 2012b). The inner and outer slopes were 1:2 and an outer berm was present around +1.5 m NAP. A toe construction was present at the outer slope around NAP level. The subsoil consisted of a sand body with a clay cover.

Figure 4.3: Cross section of the ‘old’ and reinforced IJssel dike (Rijkswaterstaat & KNMI, 1961)

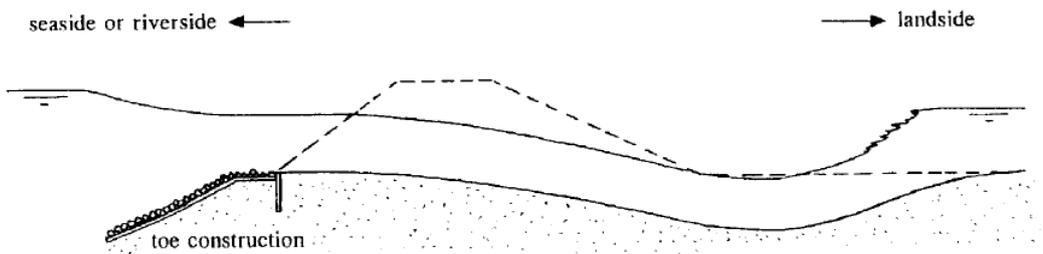
For this clay dike the breach development of Zhu (2006) is considered. The breach had 1.5 hour to develop before the emergency measure was implemented. In this 1.5 hour the breach did grow in the horizontal direction. The breach growth in the vertical direction was hampered by the toe protection. This makes the breach a type A breach (Visser, 1998). Chapter 3.2.2 described the breach processes in more detail. Figure 4.4 shows a cross section of a type A breach.

Figure 4.4: Breach stage IV, type A (Visser, 1998)

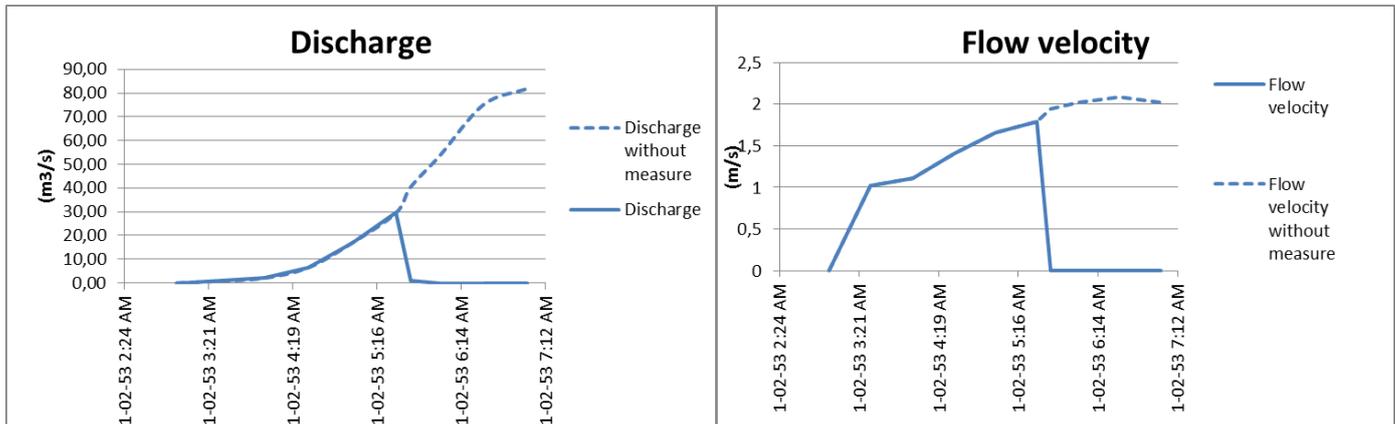
Figure 4.8: Development of discharge and flow velocity Nieuwerkerk aan den IJssel

Figure 4.8 displays the development of the discharge and flow velocity through the breach. Calculations can be found in Appendix II and are done with formulas (3-7) and (3-22) from Zhu (2006). Again the effectiveness of the measure can be seen by the increase in discharge if the measure would not have been applied. The flow velocity is an averaged one. Extreme velocities are larger, however, for the calculation of the forces on the ships the average velocity is a better representation.

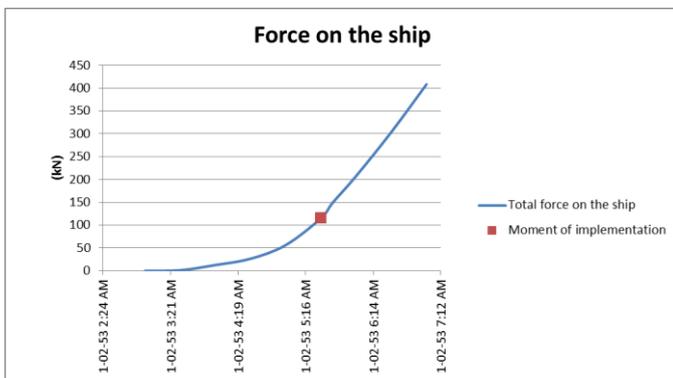
Figure 4.9: Force on the ship

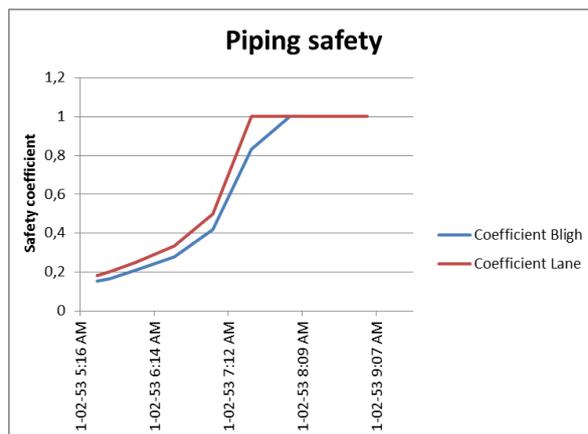
Another failure mode could have been piping. Since the hydraulic head is spread over a short horizontal distance, the gradient of the water over the ship increased. This could have induced piping under the vessel and around the stern which could easily have eroded another gap under the ship. Then, the vessel could have been pushed away through the newly eroded gap, leaving an even larger gap (Verhagen, et al., 2012).

Figure 4.11: Piping safety

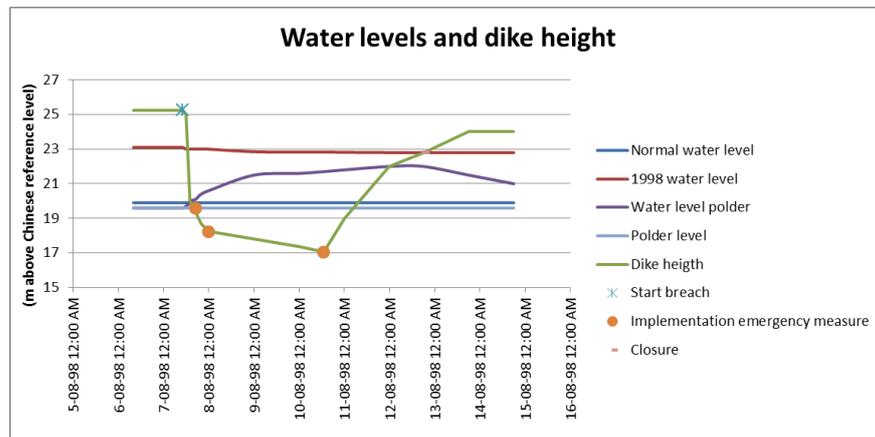
Figure 4.13: Water levels and dike height Jiujiang

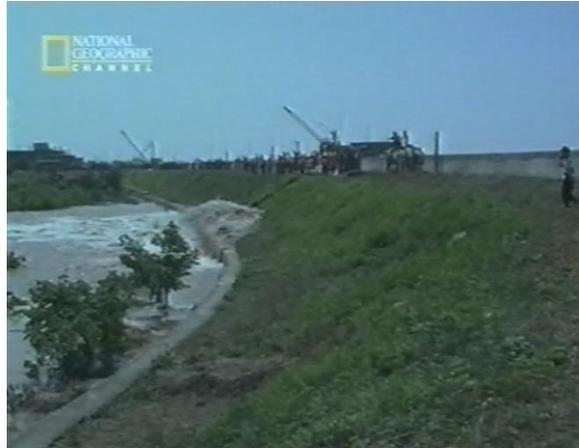
The breach in the City Defence Dike was initiated by piping. An ‘early’ stage of the piping phenomenon can be seen in Figure 4.15. A lot is said about the missing reinforcement in the flood wall. However, the flood wall seems not well designed for piping failure. A large hydraulic head due to the high water level in the river in combination with the geometry of the water defence and the lack of a seepage shut off screen started the piping mechanism.

Figure 4.15: Early stage of piping at the City Defence Dike (Rage of the River Gods, 2001)

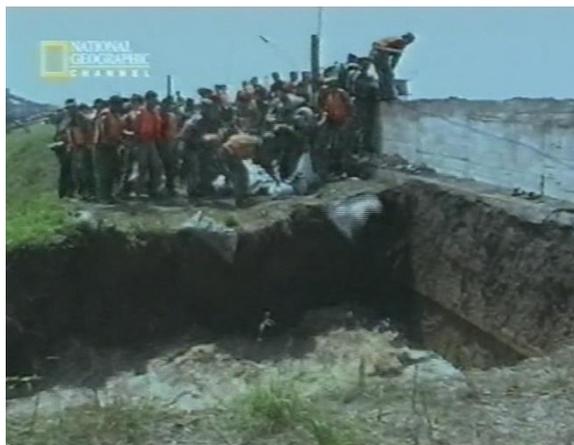
Figure 4.16: Development of the breach under the flood wall (Rage of the River Gods, 2001)

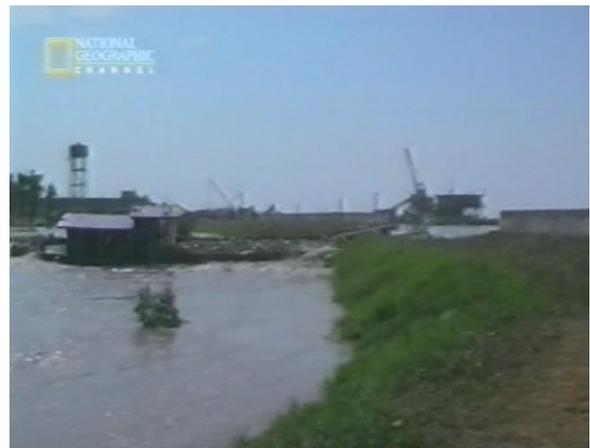
When the breach was at an initial stage, the local authorities tried to close the breach by all means possible. They tried to avoid a disaster. Due to panic, the decision was made to throw whatever large object they could find in the breach. Precious assets like trucks and ships were sunk down into the gap. The current however was too strong and washed away the objects almost immediately. In Figure 4.19 can be seen how a vessel is pushed through the breach by the enormous currents, having absolutely no chance on closing the breach. This shows that there was no engineering view, just panic.

Figure 4.19: Failed emergency closure by means of a vessel (Rage of the River Gods, 2001)

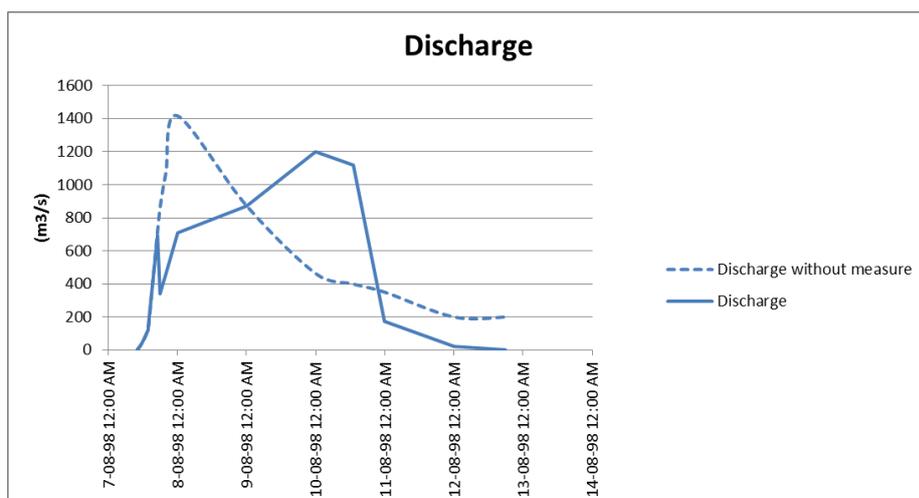
Figure 4.25: Discharge through the breach Jiujiang

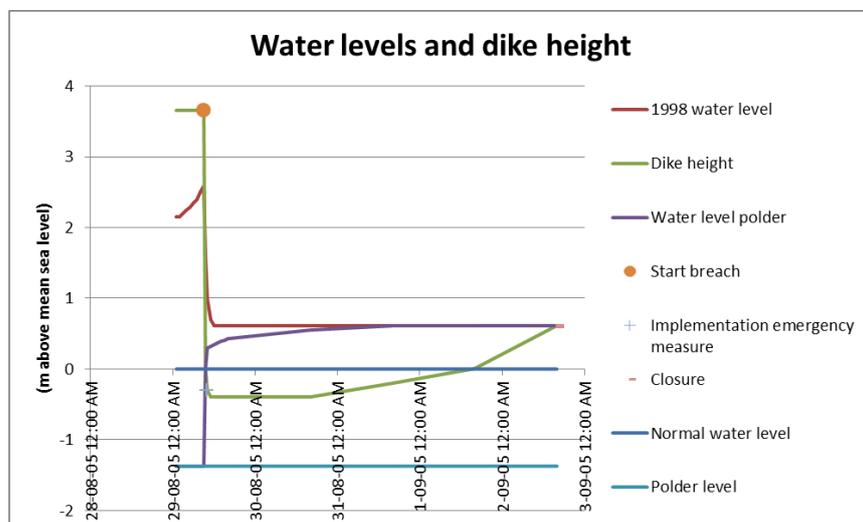
Figure 4.27: Water level and dike height New Orleans

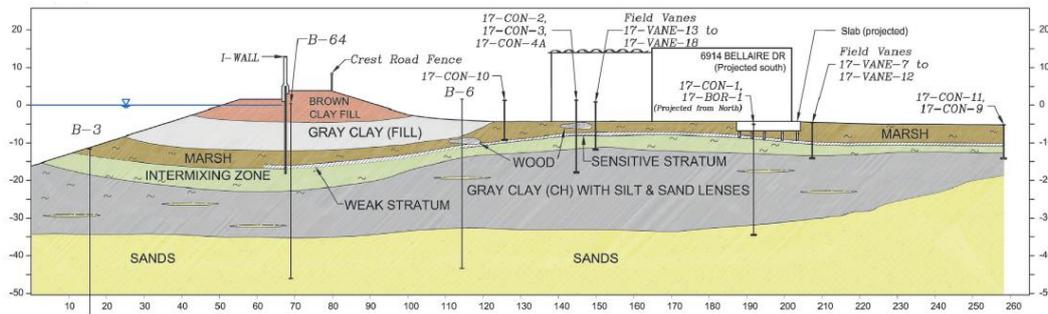
The cross section of the flood defence including the subsoil of the 17th Street Canal is displayed in Figure 4.28. The flood defence consists of a concrete I-shaped flood wall on top of an earthen embankment and a sheet piling below the flood wall. The top of the floodwall has an elevation of 12 ft above mean sea level. The crest of the embankment has an elevation of about 6 ft above mean sea level. The hinterland, on the protected side, lies at a height of 4.5 ft below mean sea level. Since the water level reached a maximum level of 8.5 meter above mean sea level, the flood wall was high enough for this event to prevent overtopping. The subsoil of the flood defences had a wide spread erosion rate (Briaud, et al., 2008). The erosion rate of the soil has an enormous influence on the development of a breach in the time. During the design these different erosion rates were not taken into account.

Figure 4.28: Cross section flood defence 17th Street Canal, before failure (Seed, et al., 2008c) measures in feet

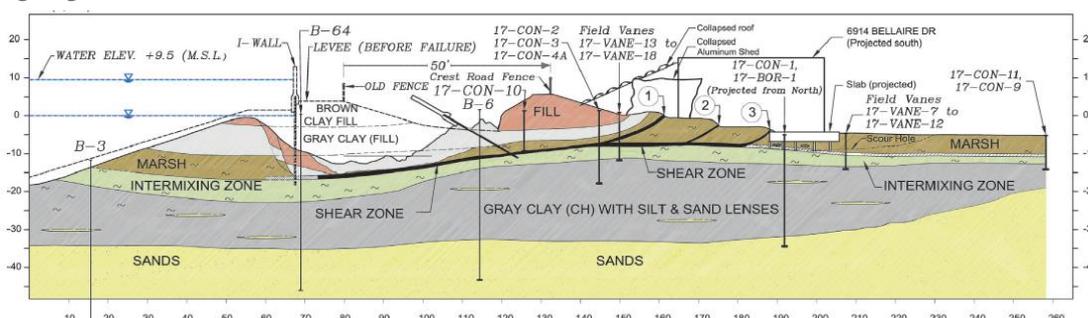
Failure of the flood defence was caused by horizontal sliding of the inner slope. The layer over which the slope sheared was undetected during the design of the flood wall. This layer was a layer with deposits of a hurricane. It consists of organic silty clay. That layer became the critical shear surface for the lateral translational failure. Some other too optimistic assumptions and interpretations during the design had their effect on the failure. In Figure 4.29 the cross section of the dike after the failure is displayed. The shear plane is highlighted in black.

Figure 4.29: Cross section flood defence 17th Street Canal, after failure (Seed, et al., 2008c)

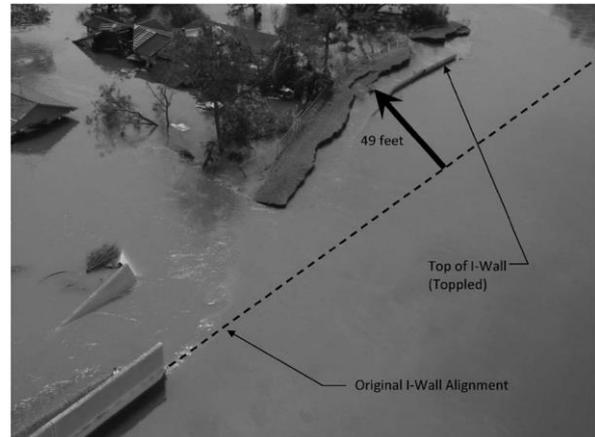
Figure 4.30: Top view of the breach (Seed, et al., 2008c)

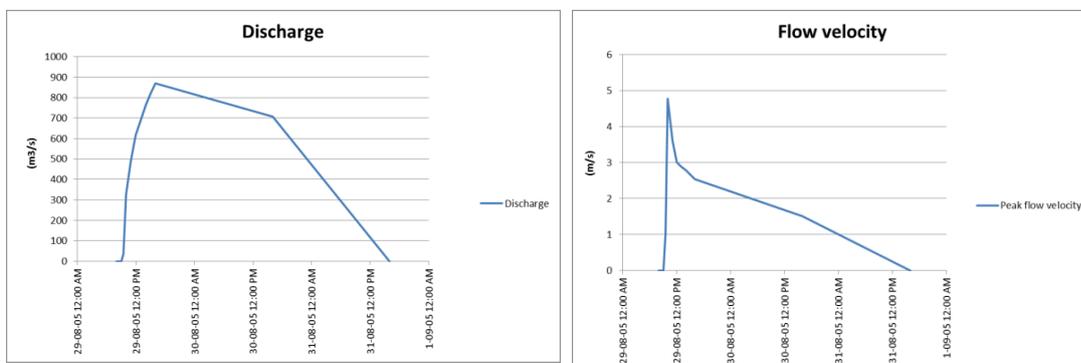
Figure 4.33: Development discharge and flow velocity New Orleans

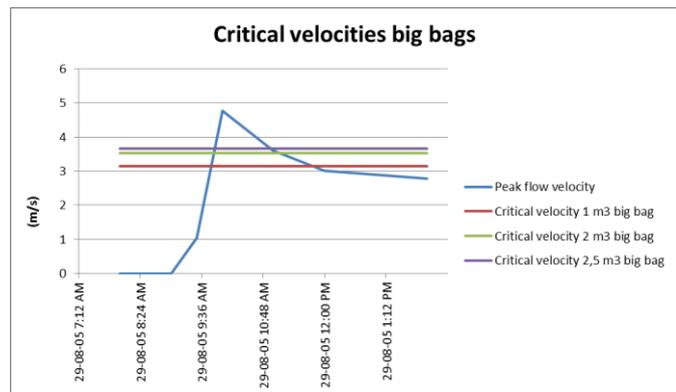
Figure 4-34: Critical velocities of Big Bags

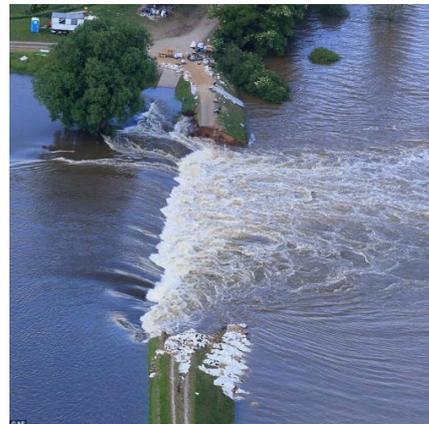
Figure 4.36: Dike breach in Fischbeck, source: AP

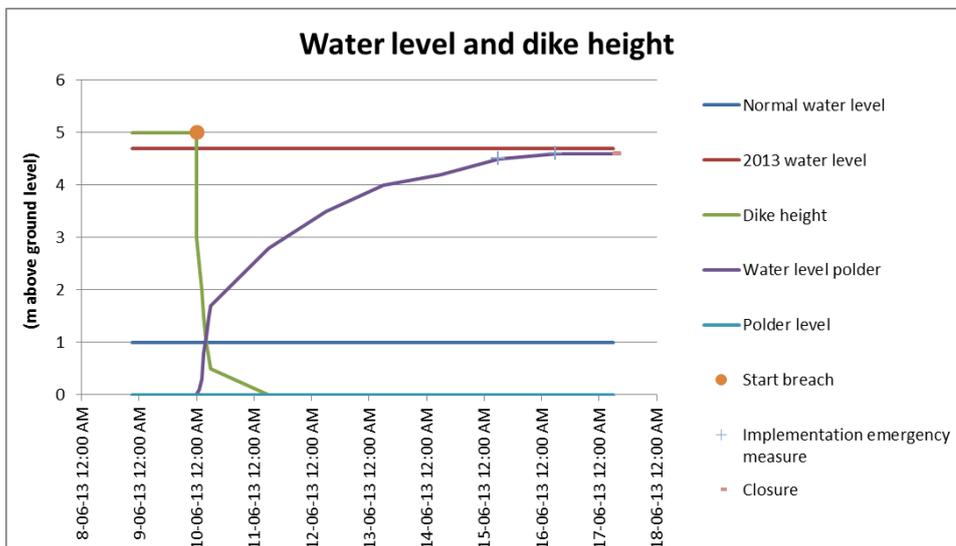
Figure 4.37: Water levels and dike height Fischbeck

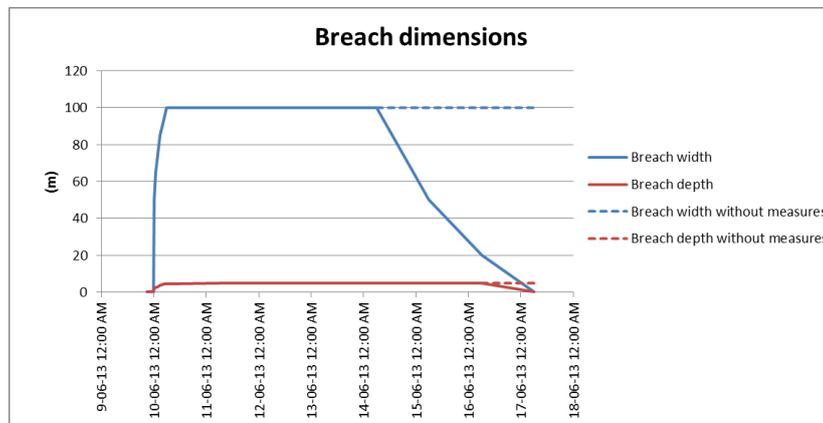
Figure 4.39: Development breach dimensions Fischbeck

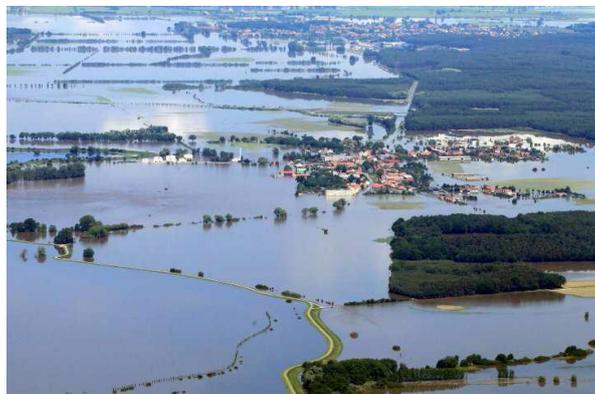
Figure 4.41: Post flood situation Fischbeck, source: dpa photo

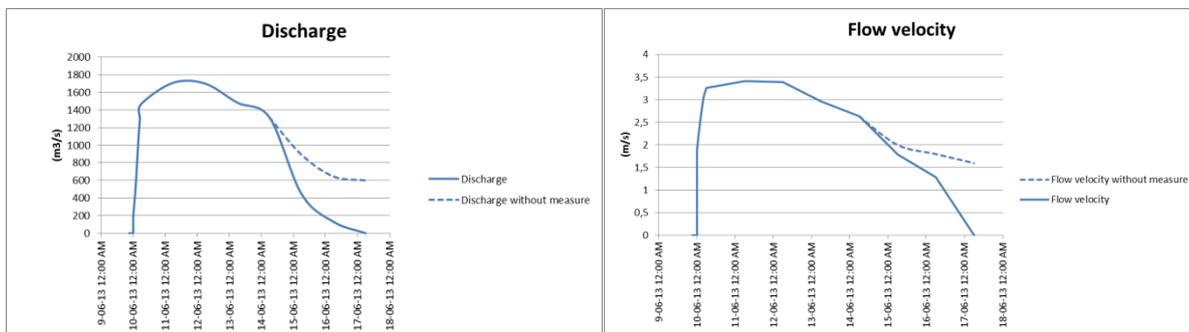
Figure 4.42: Development of discharge and flow velocity Fischbeck

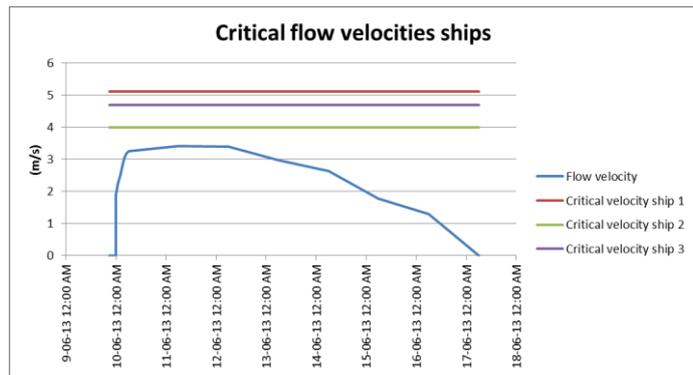
Figure 4.43: Critical velocity of the ships

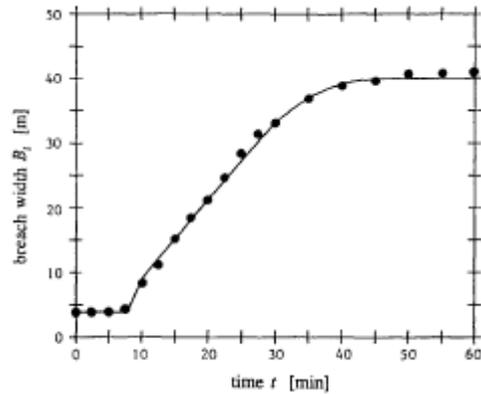
Figure 5.1: Comparison of BRES with Zwin '94 field experiment from: (Visser, 1998)

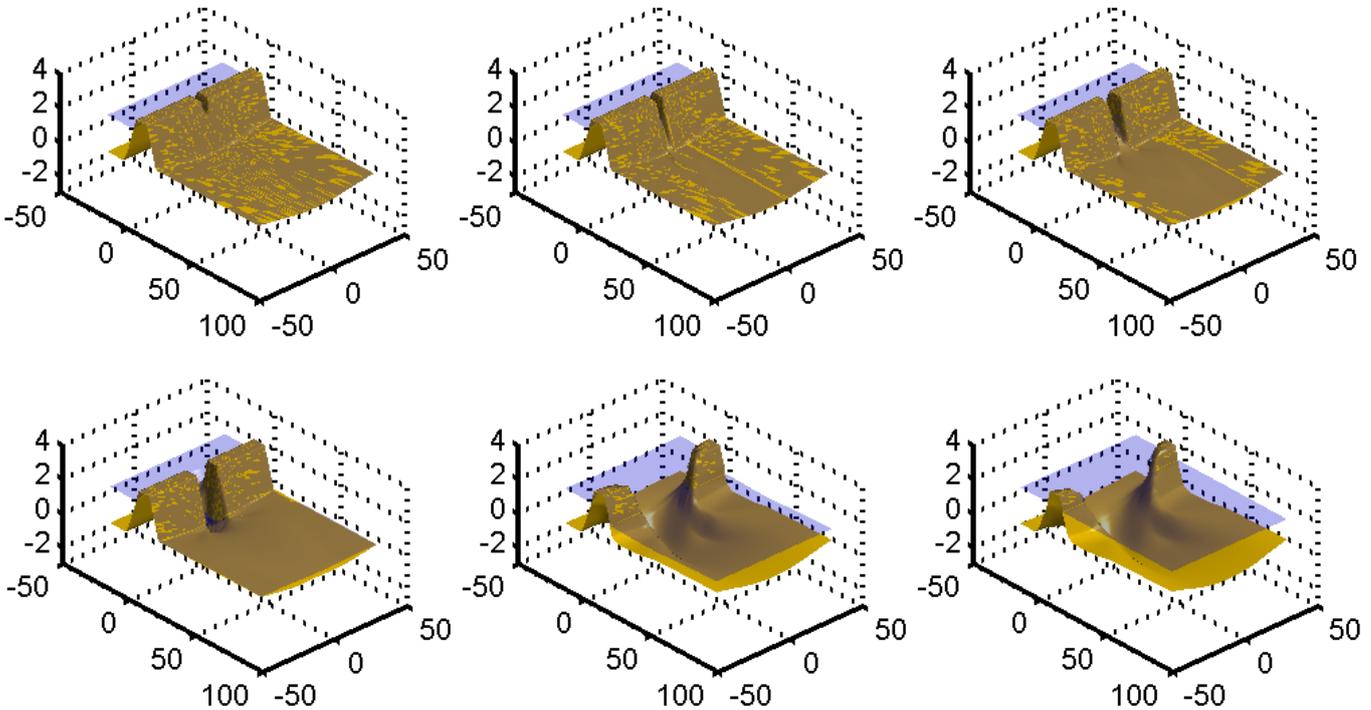
Figure 5.4: Do nothing scenario, snapshots taken at t = 0, 8, 15, 20, 40 and 65 minutes

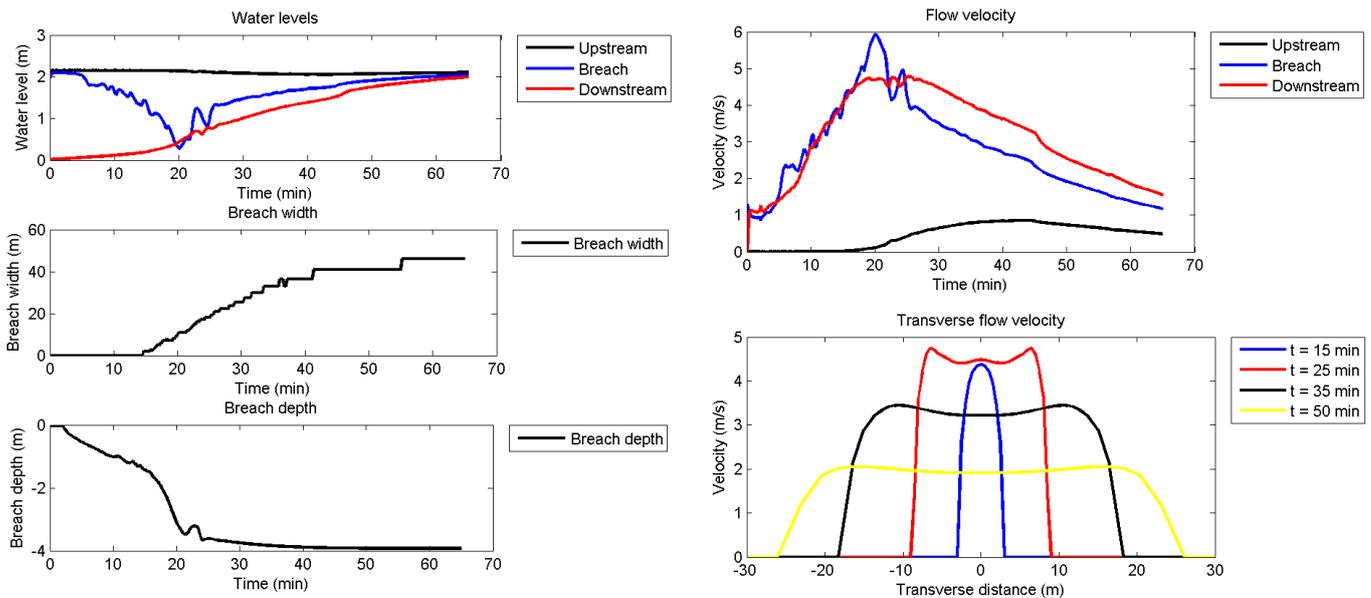
Figure 5.5: Water level, breach dimensions, and flow velocities of a non-interfered breach

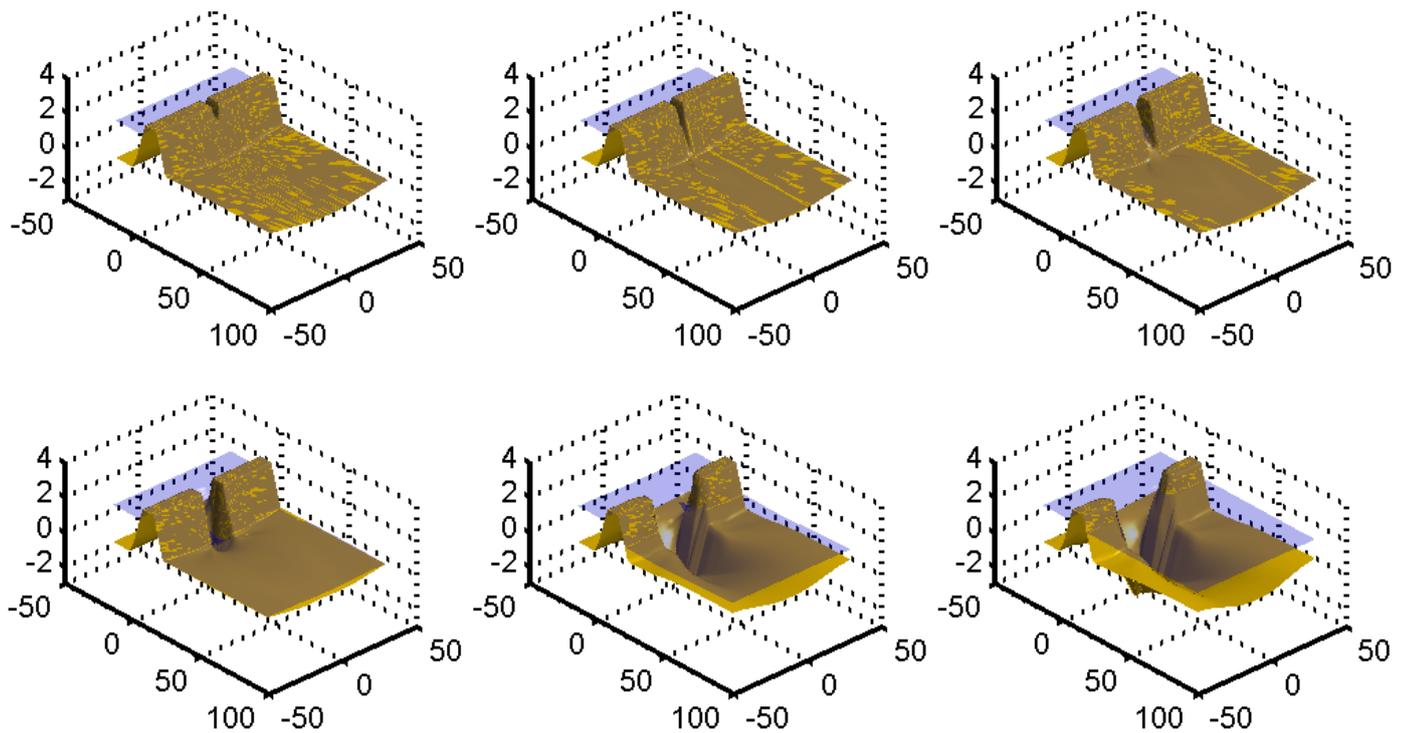
Figure 5.7: Effect of Big Bags in a developing breach, snapshots taken at $t = 0, 8, 15, 20, 40$ and 65 minutes

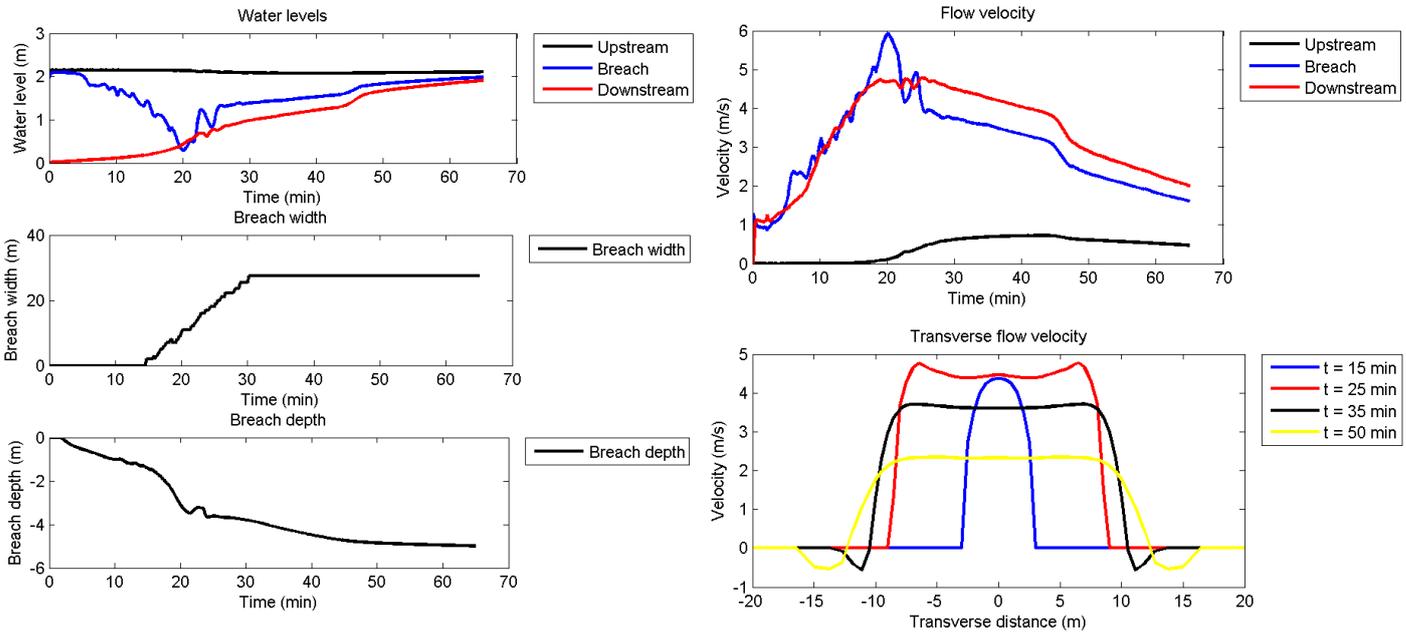
Figure 5.8: Water levels, breach dimensions and flow velocities of a breach with emergency measure Big Bags

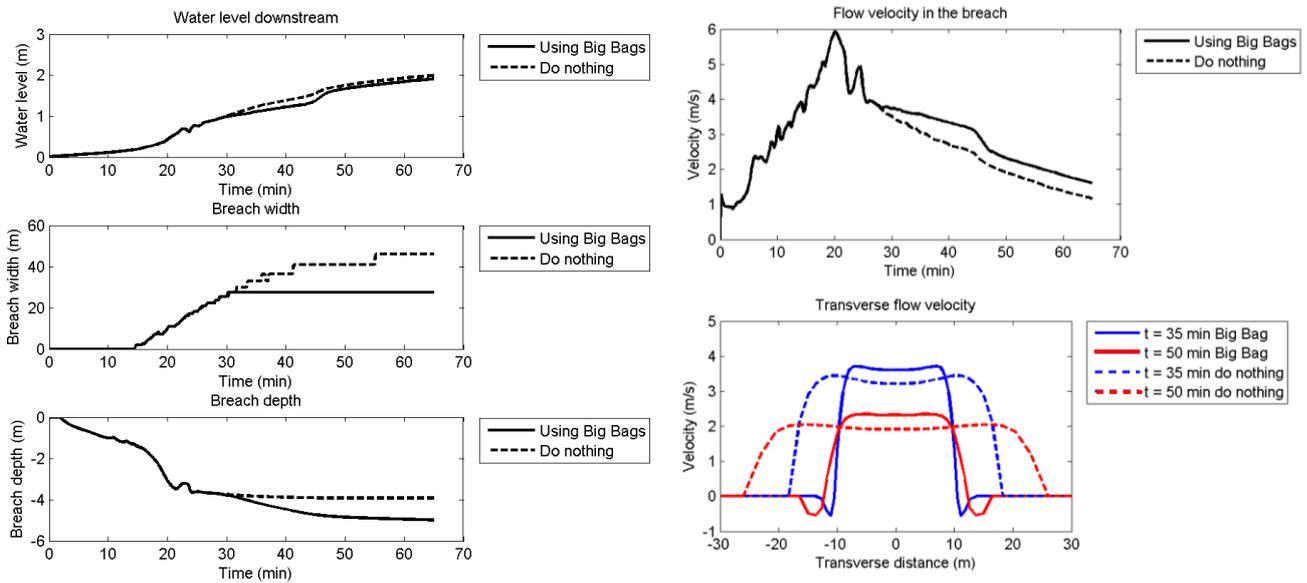
Figure 5.10: Differences water levels, flow velocities and breach dimensions Big Bags and 'do nothing' case

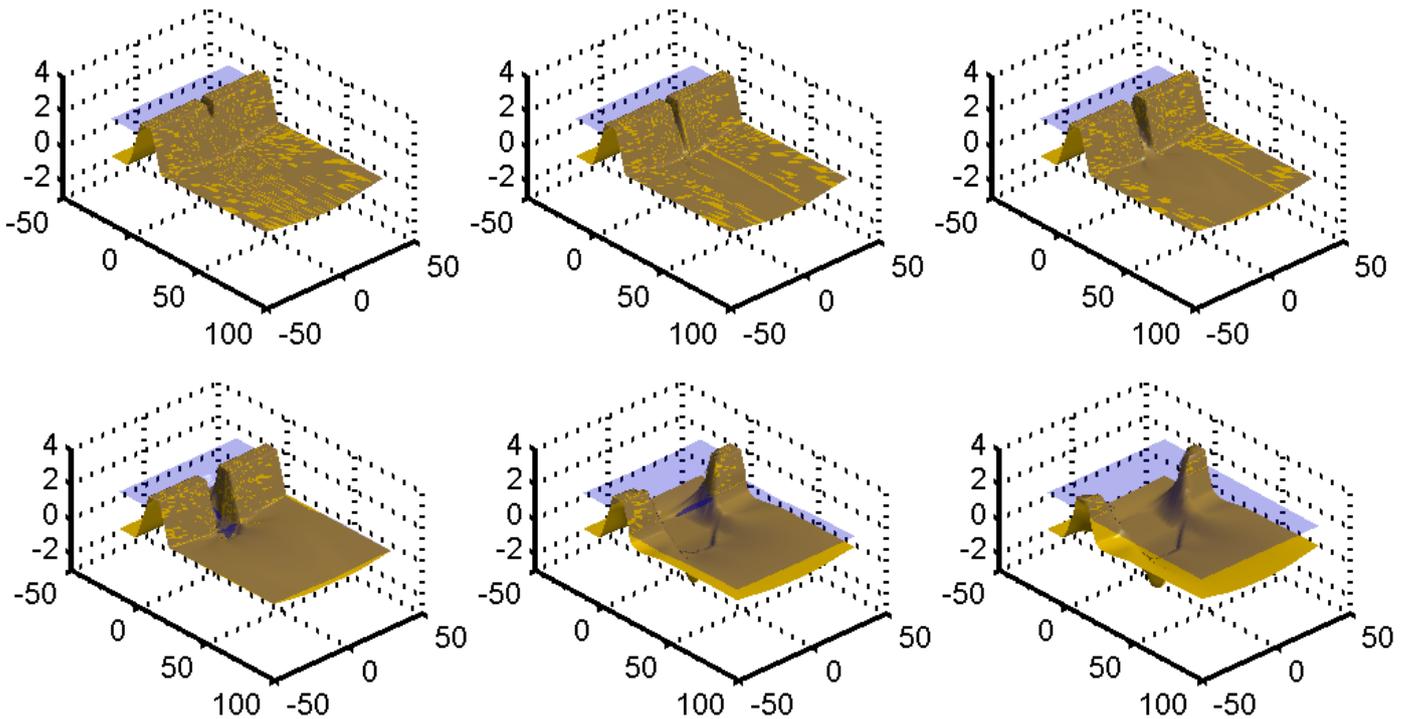
Figure 5.14: Effect of a scaffold in developing breach, snapshots taken at $t = 0, 8, 15, 20, 40$ and 65 minutes

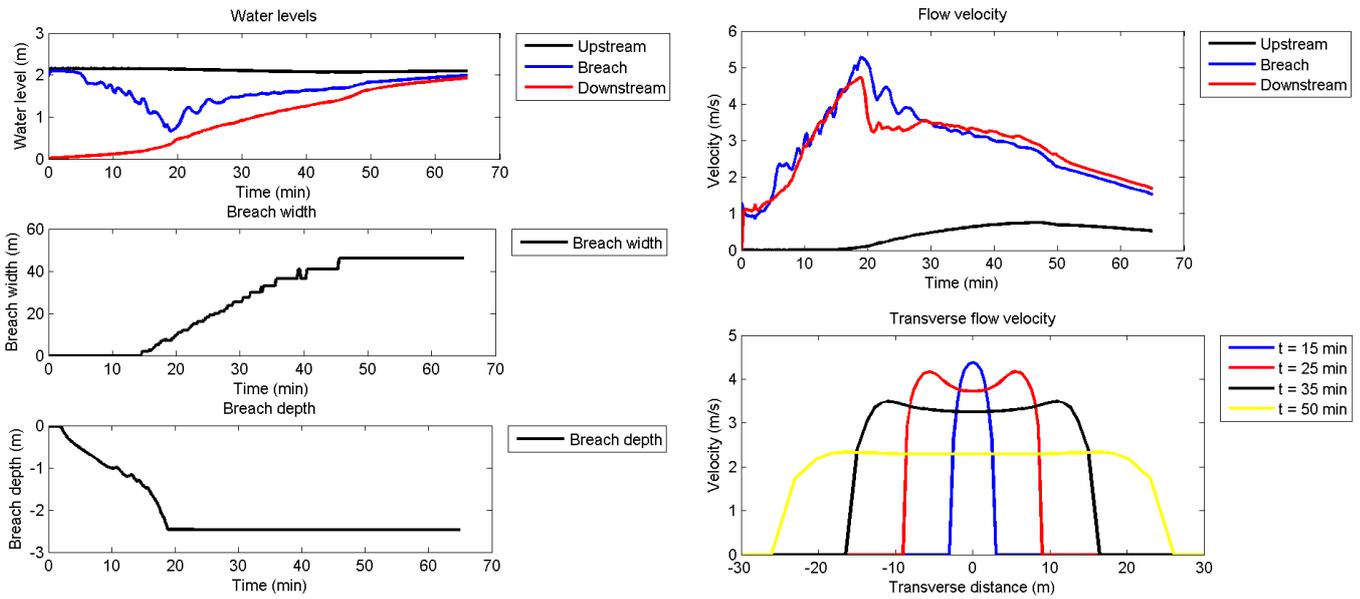
Figure 5.15: Water levels, breach dimensions and flow velocities of a breach with emergency measure scaffold

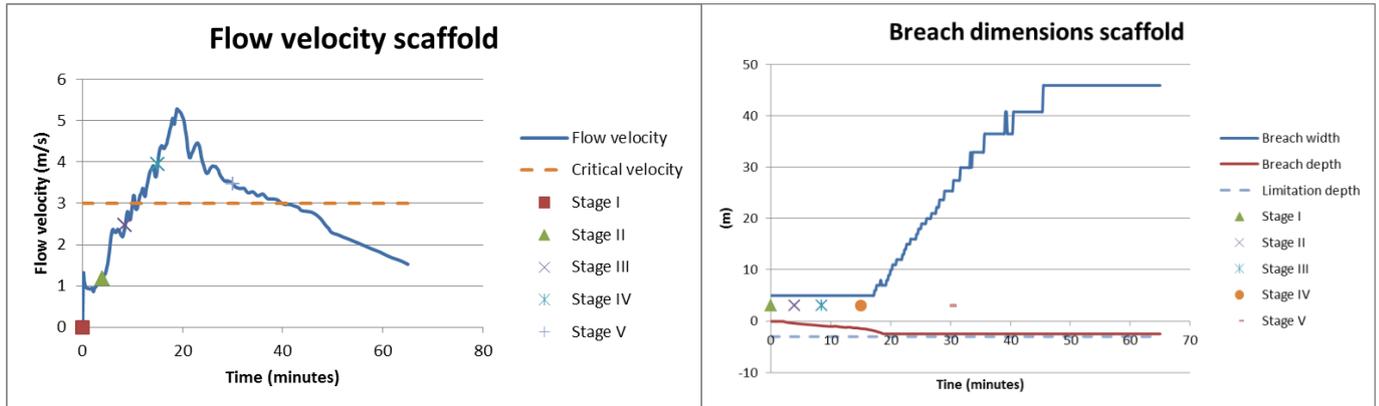
Figure 5.18: Limiting flow velocity and breach dimensions of a scaffold
