Emergency closure of dike breaches

The effect and applicability of emergency measures

Master Thesis

T.S. Albers

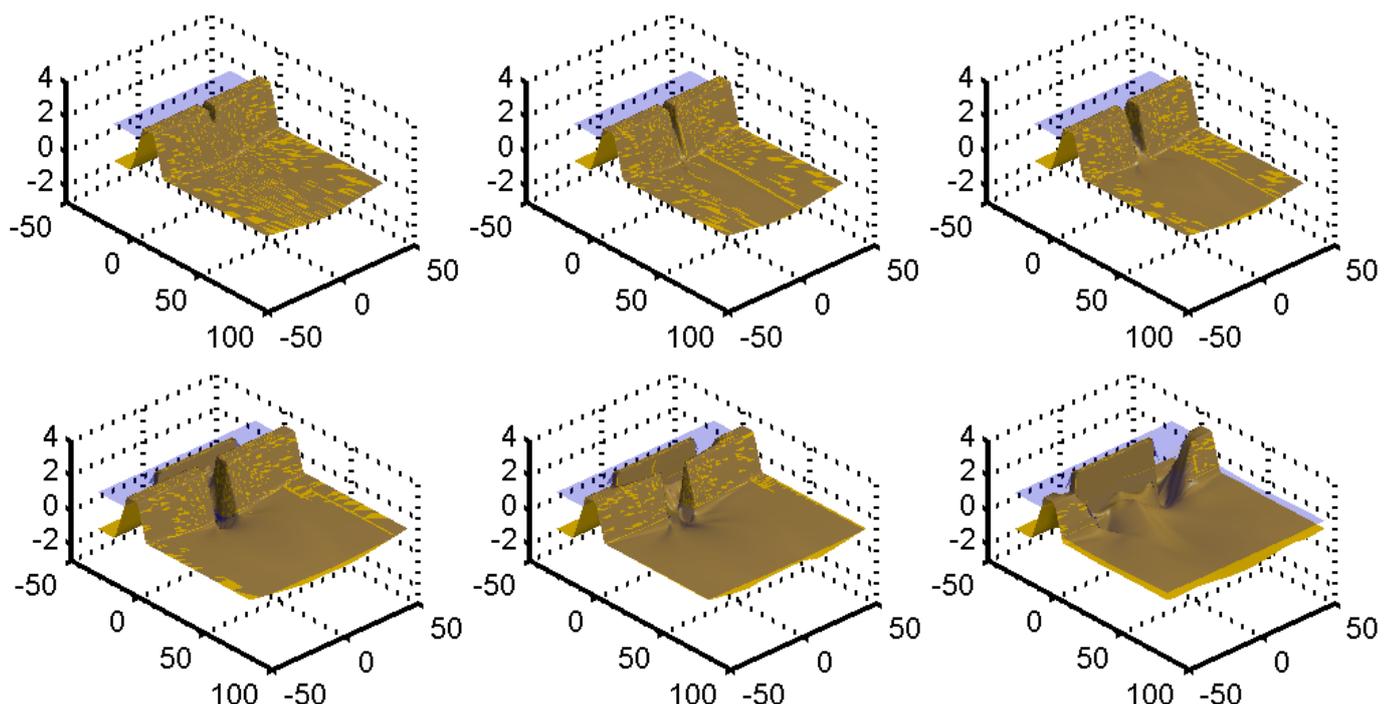
Figure 5.21: Effect of a sunken down vessel in front of a developing breach, snapshots taken at $t = 0, 8, 15, 20, 40$ and 65 minutes

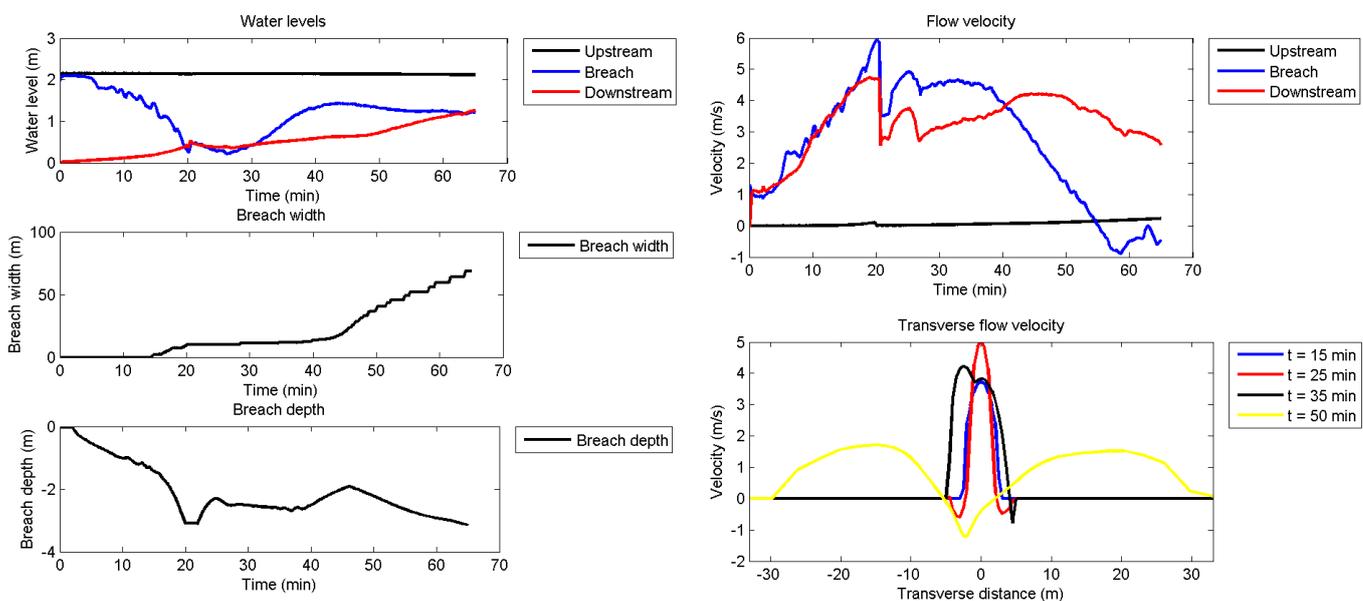
Figure 5.22: Water levels, breach dimensions and flow velocities of a breach with emergency measure vessel

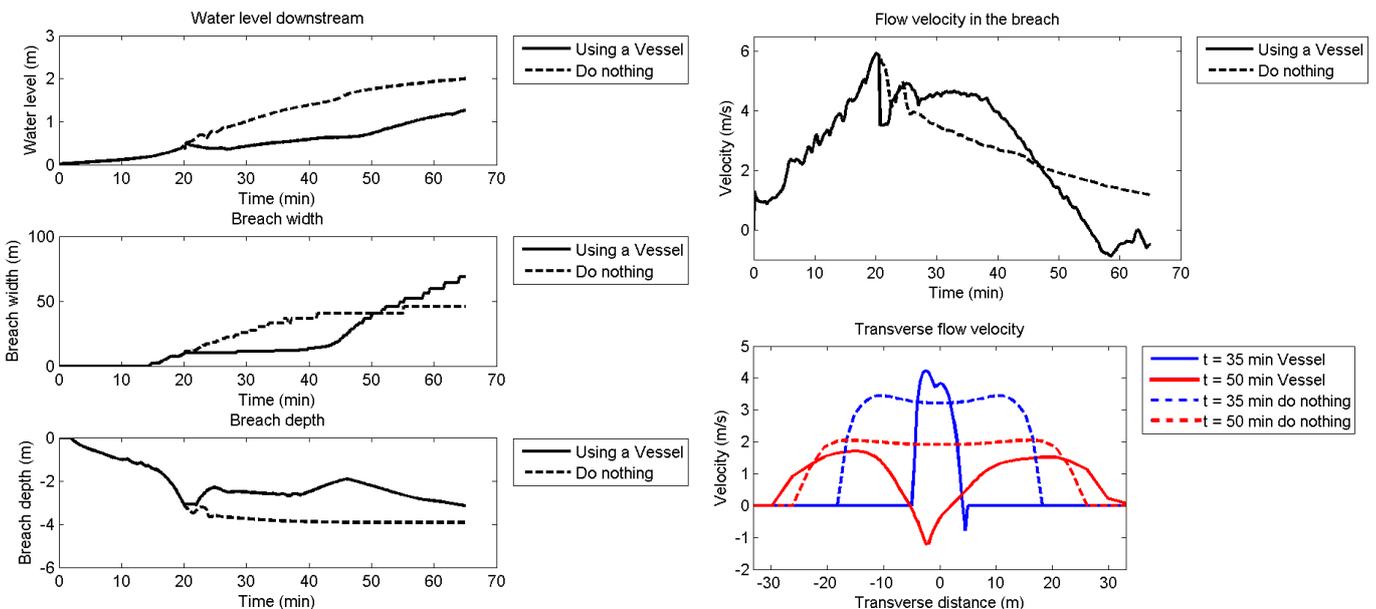
Figure 5.24: Differences water levels, flow velocities and breach dimensions vessel and 'do nothing' case

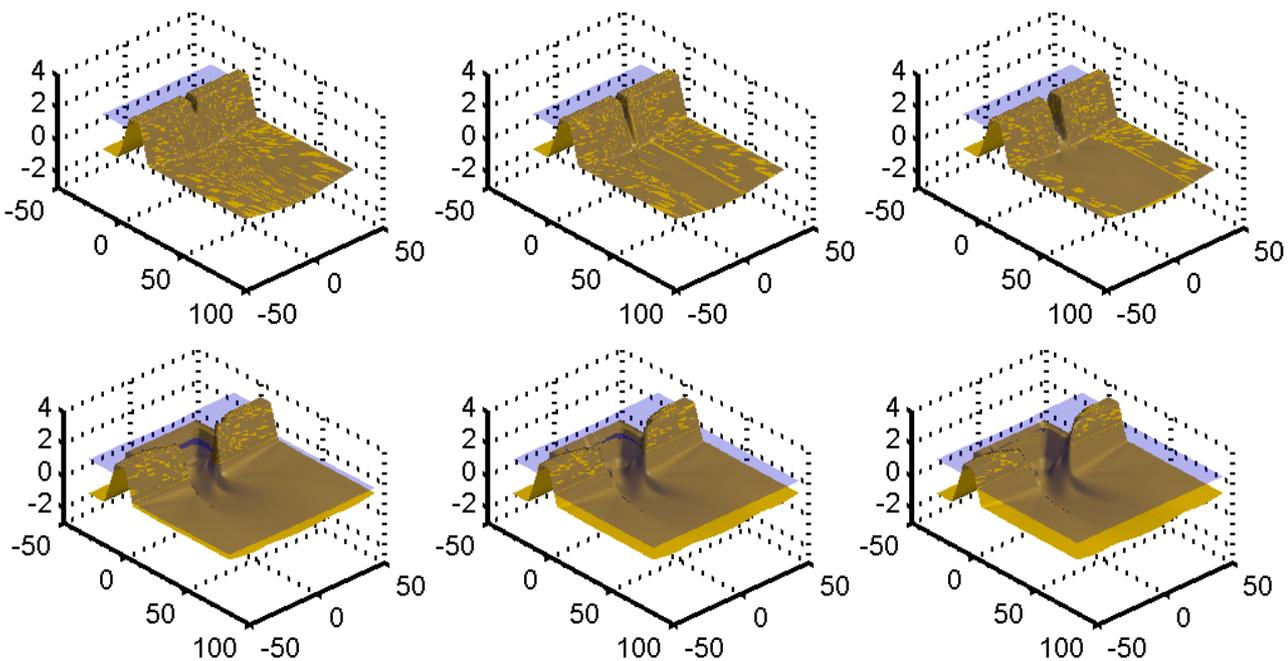
Figure 5.28: Effect of an emergency dike in front of a developing breach, snapshots taken at $t = 0, 8, 15, 20, 40$ and 65 minutes

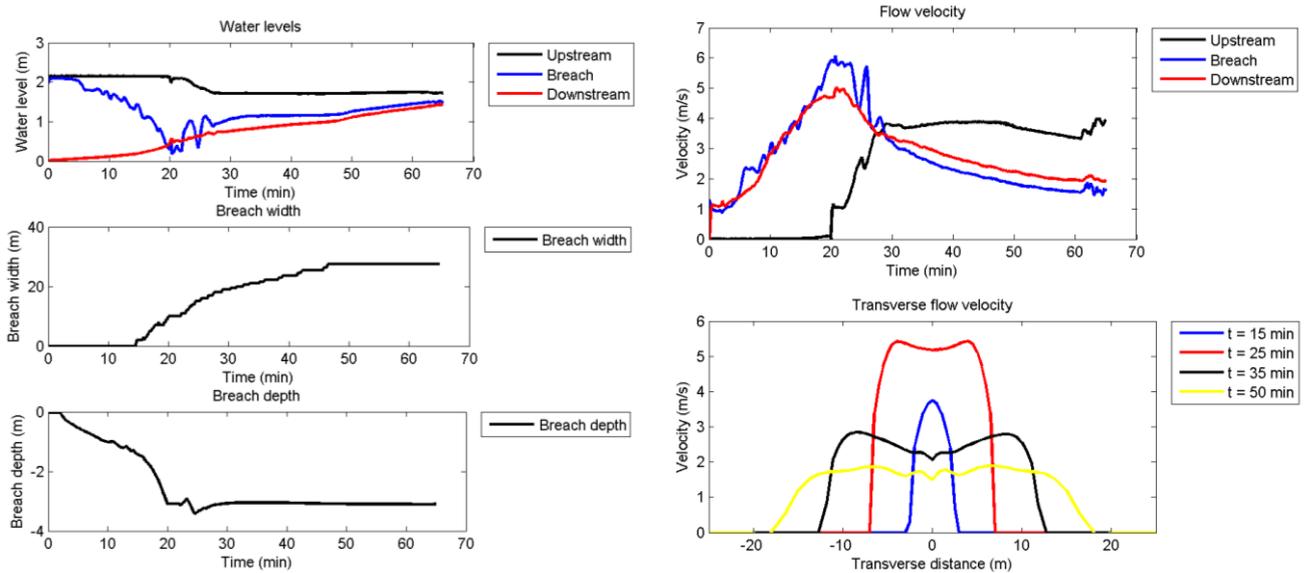
Figure 5.29: Water levels, breach dimensions and flow velocities of a breach with an emergency dike

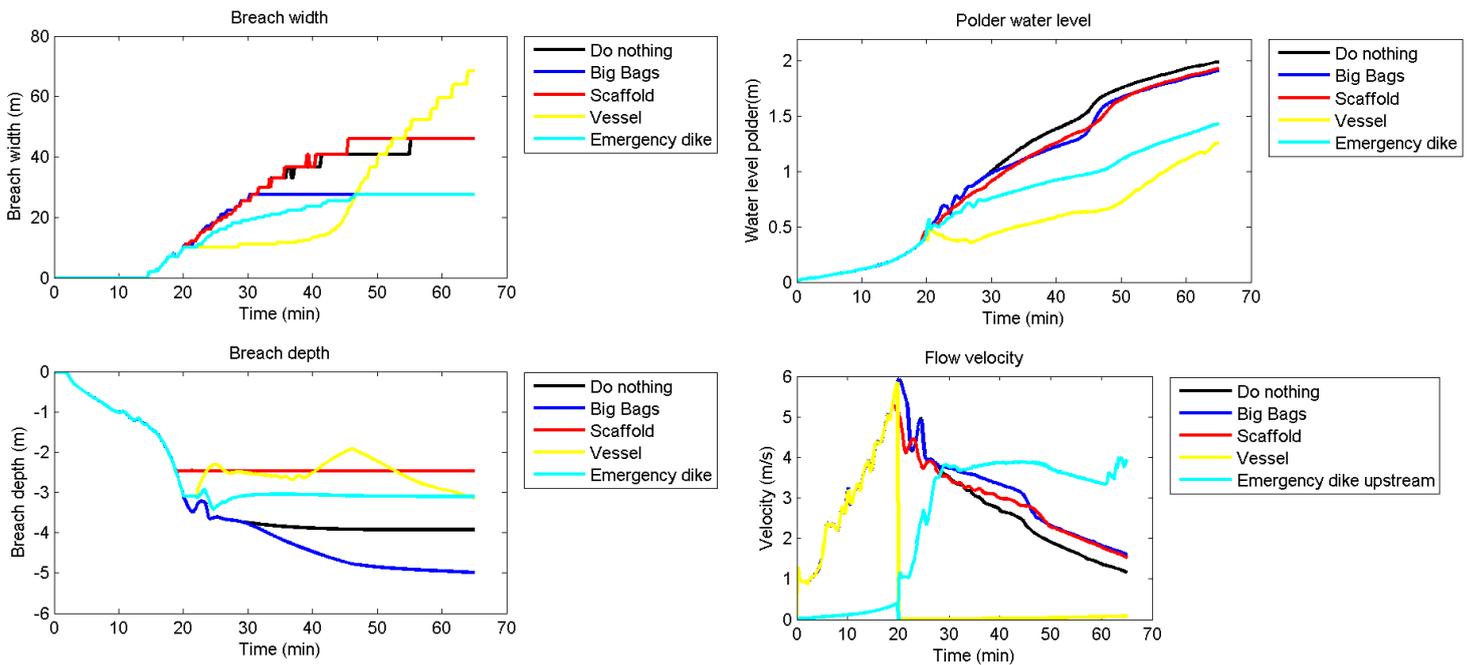
Figure 5.33: Comparison of discussed closure methods

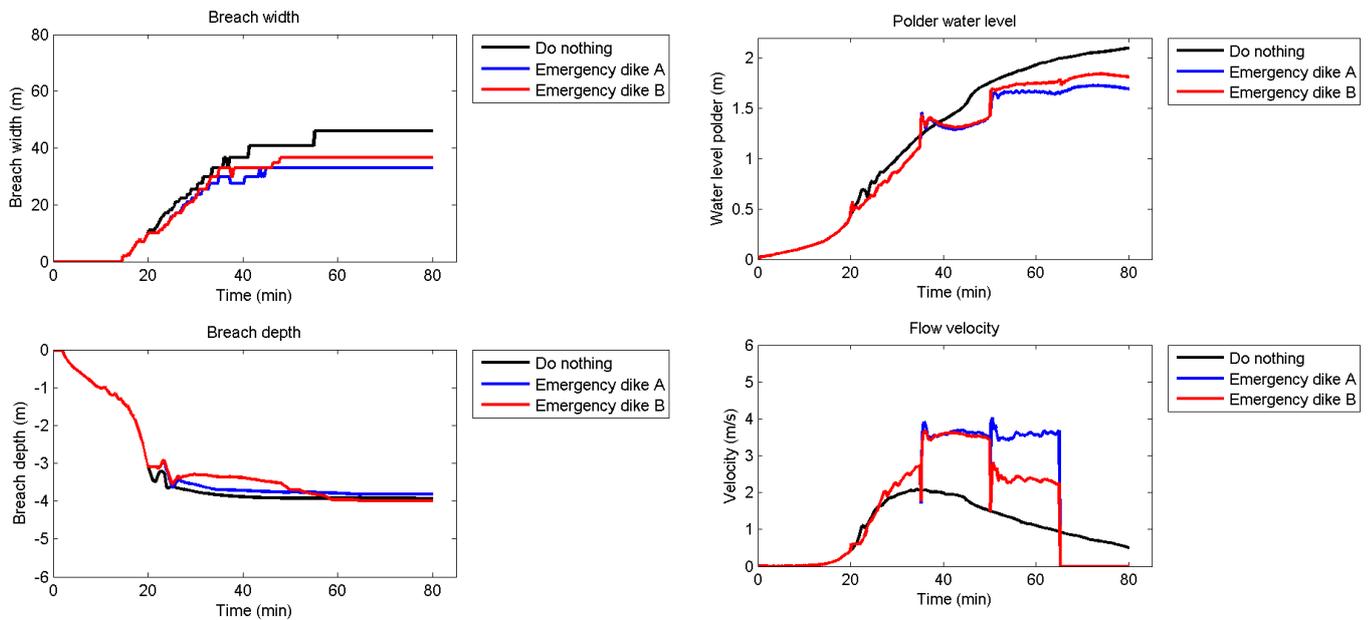
Figure 5.34: Comparison of complete closure with strategy B to 'do nothing'

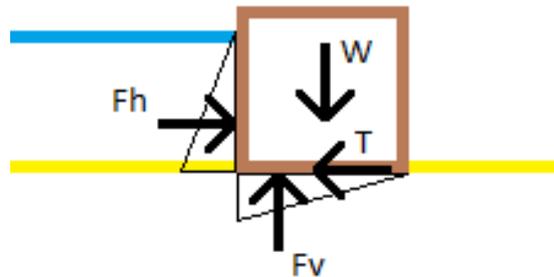
Figure 5.36: Forces on the emergency dike

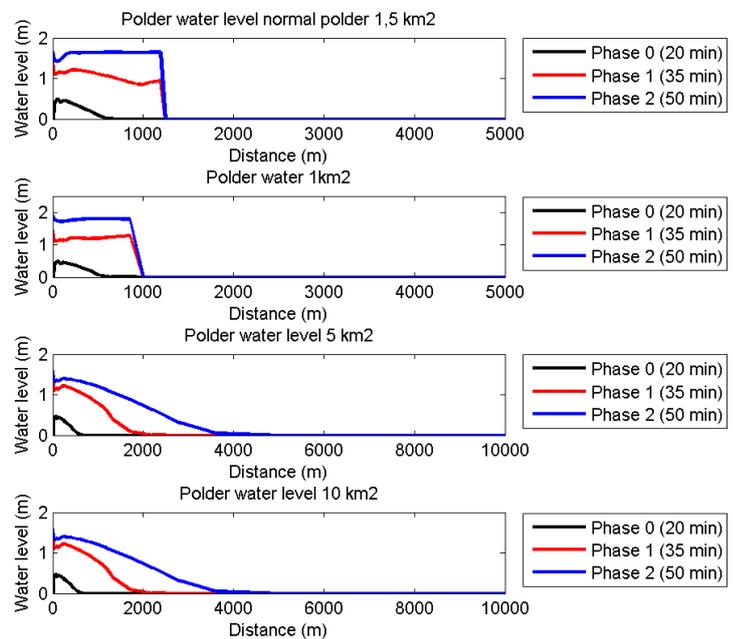
Figure 5.37: Water levels in different polder area sizes

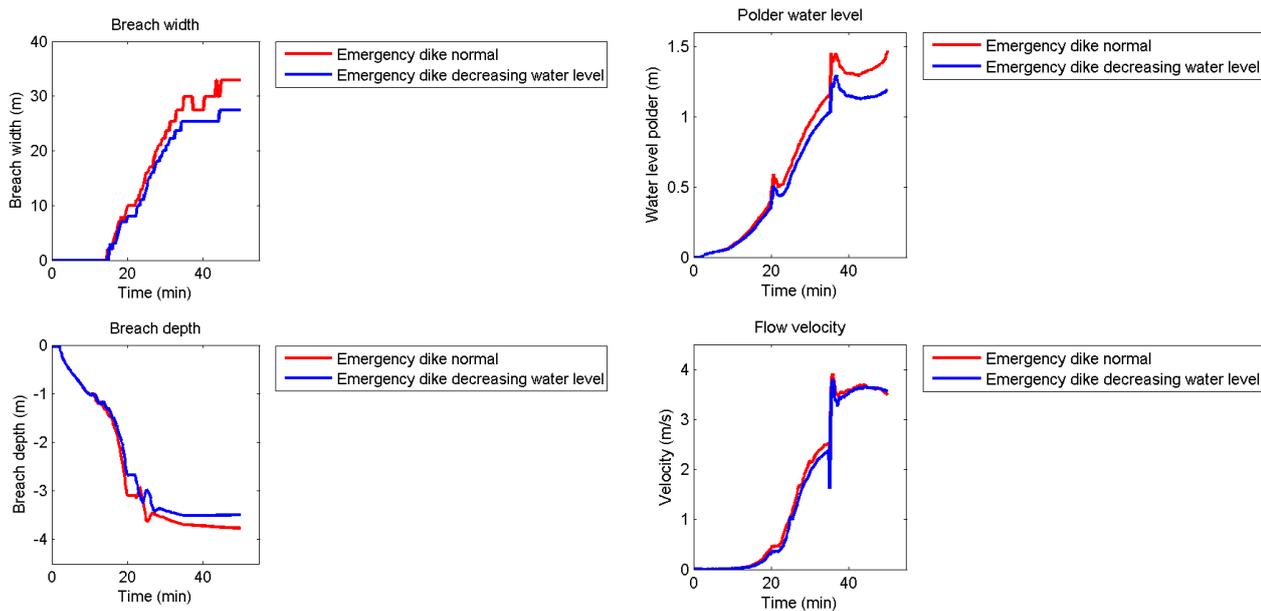
Figure 5.41: Effect of a decreasing outer water level

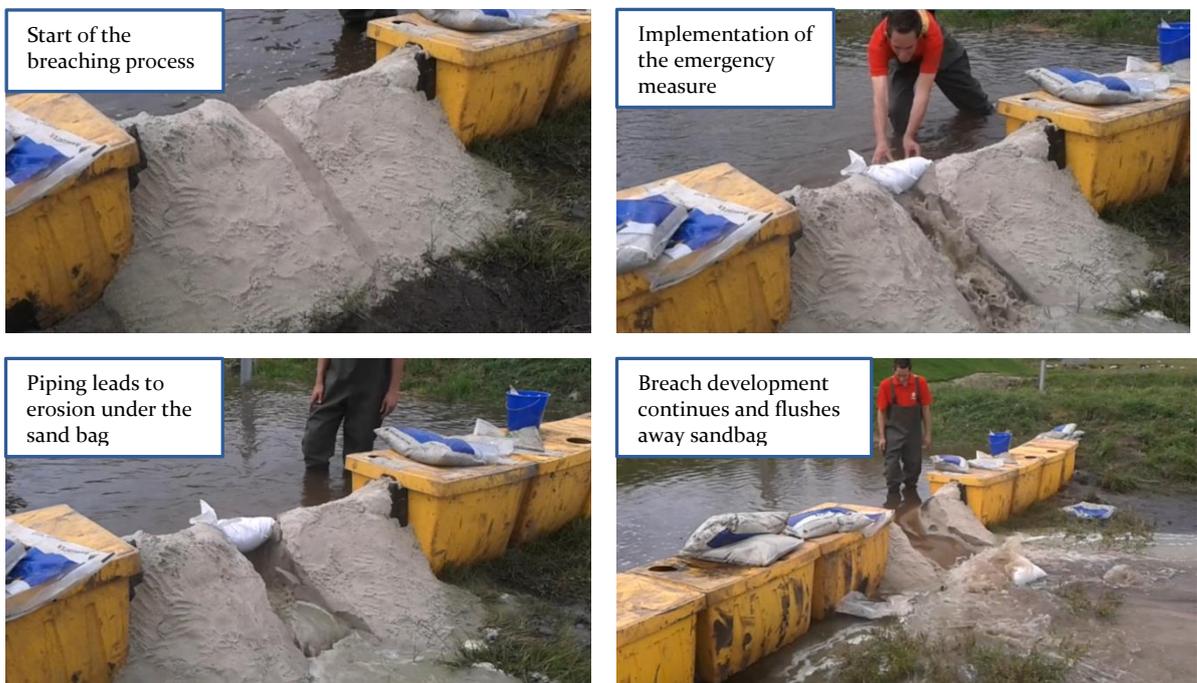
Figure 6.4: Experiment 1, snapshots are taken at $t = 5$ s, 40 s; 55 s and 80 s after overtopping

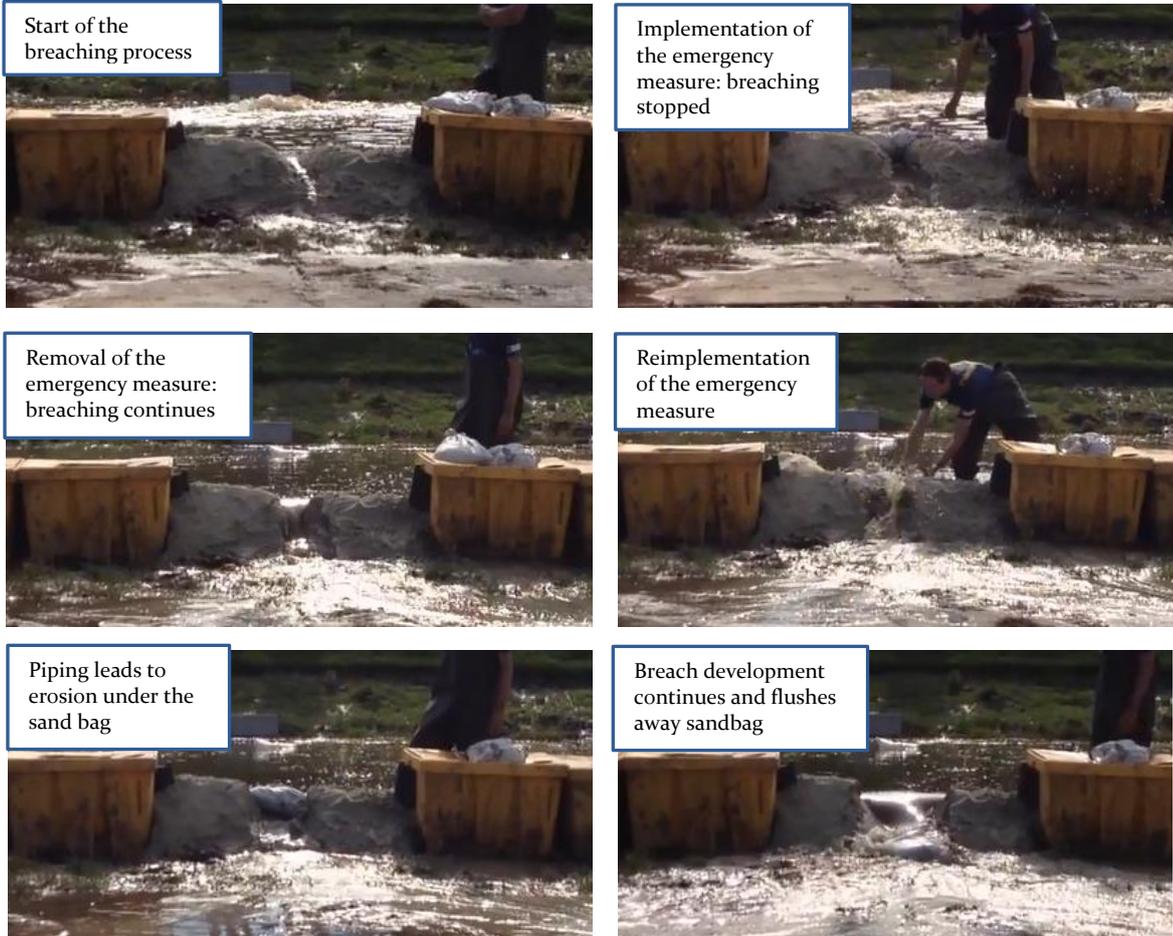
Figure 6.5: Experiment 2, snapshots are taken at $t = 5$ s, 30 s; 55 s, 70 s; 80 s and 95 s after overtopping

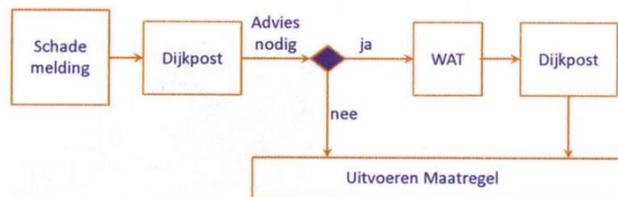
Figure 7.3: Emergency procedure Water Board Rivierenland

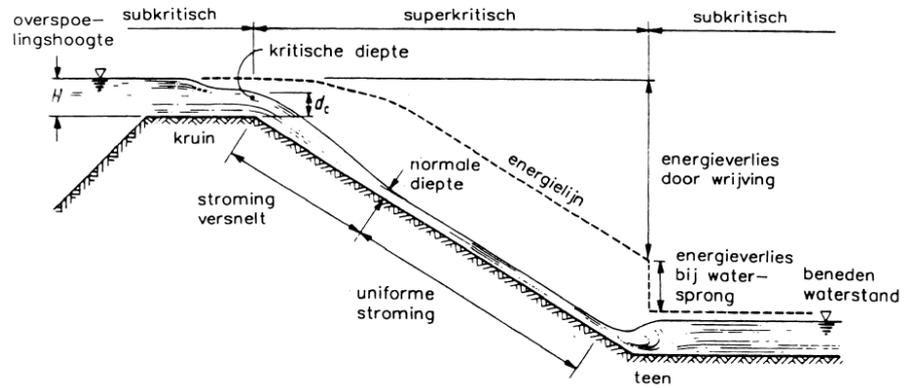
Figure 1.1: Flow over a dike with low inner water level (Gerven, 2004)

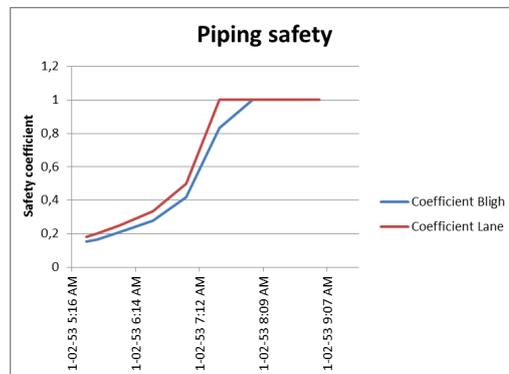
Figure II.6: Piping safety

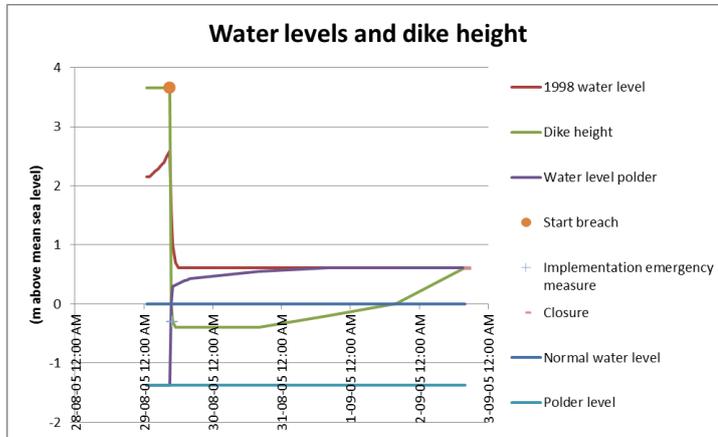
Figure II.11: Water level and dike height New Orleans

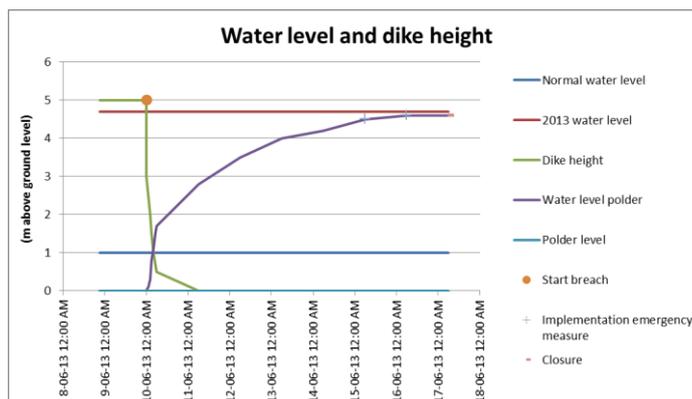
Figure II.14: Water levels and dike height Fischbeck

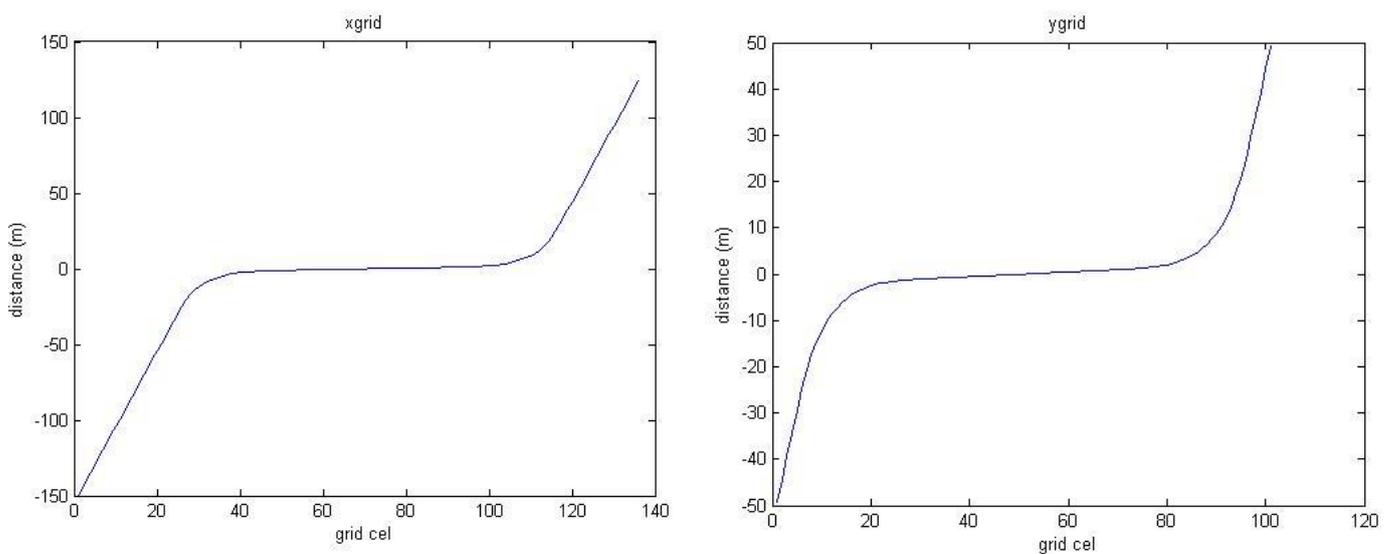
Figure III.1: Grid composition

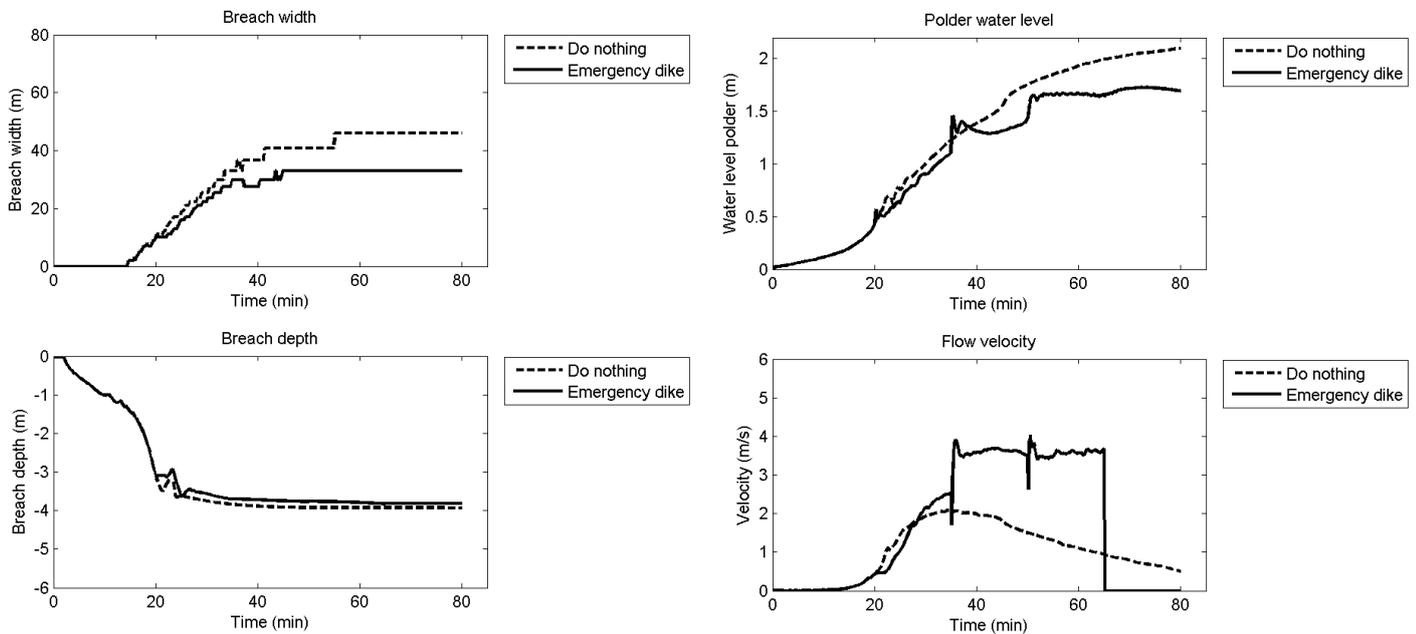
Figure IV.6: Comparison of complete closure with strategy A to 'do nothing'

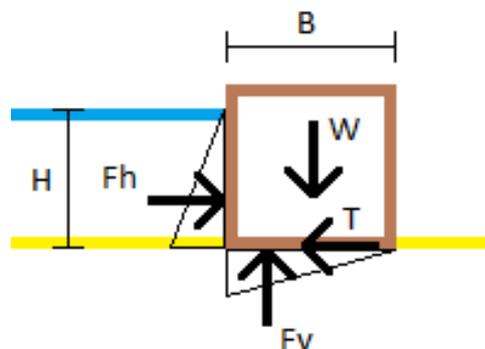
Figure V.1: Forces on the emergency dike
